Our Ref: CP/15924/Geotechnical Letter Report

GEOTECHNICAL SITE INVESTIGATION: DRACAENA CENTRE, FALMOUTH

Maverick Industries has requested that a Geotechnical site investigation be performed in order to determine the prevailing ground conditions beneath the ground adjacent to the current grass pitch and the permeability of the site soils.

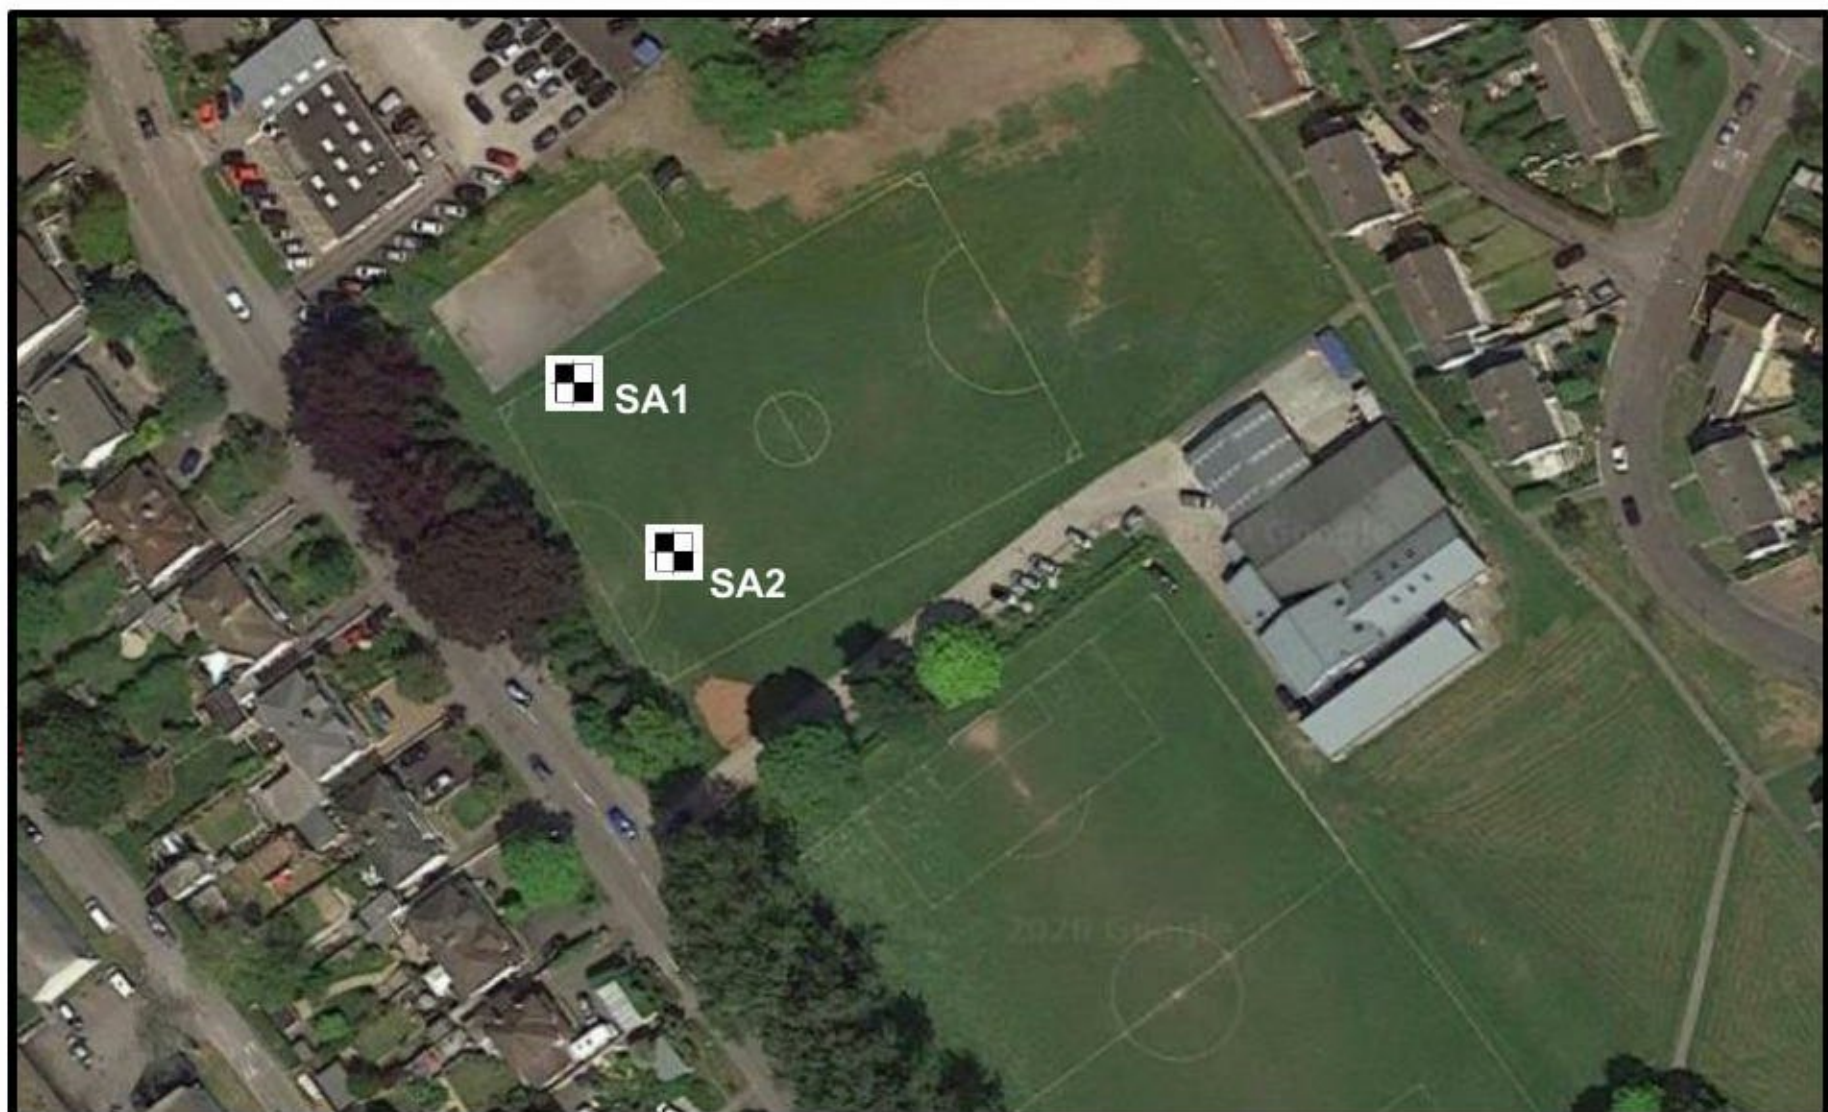
Figure 01 – Site Layout

The location of the trial pits are shown on **Figure 01** and the trial pit logs are presented in **Annex A**.

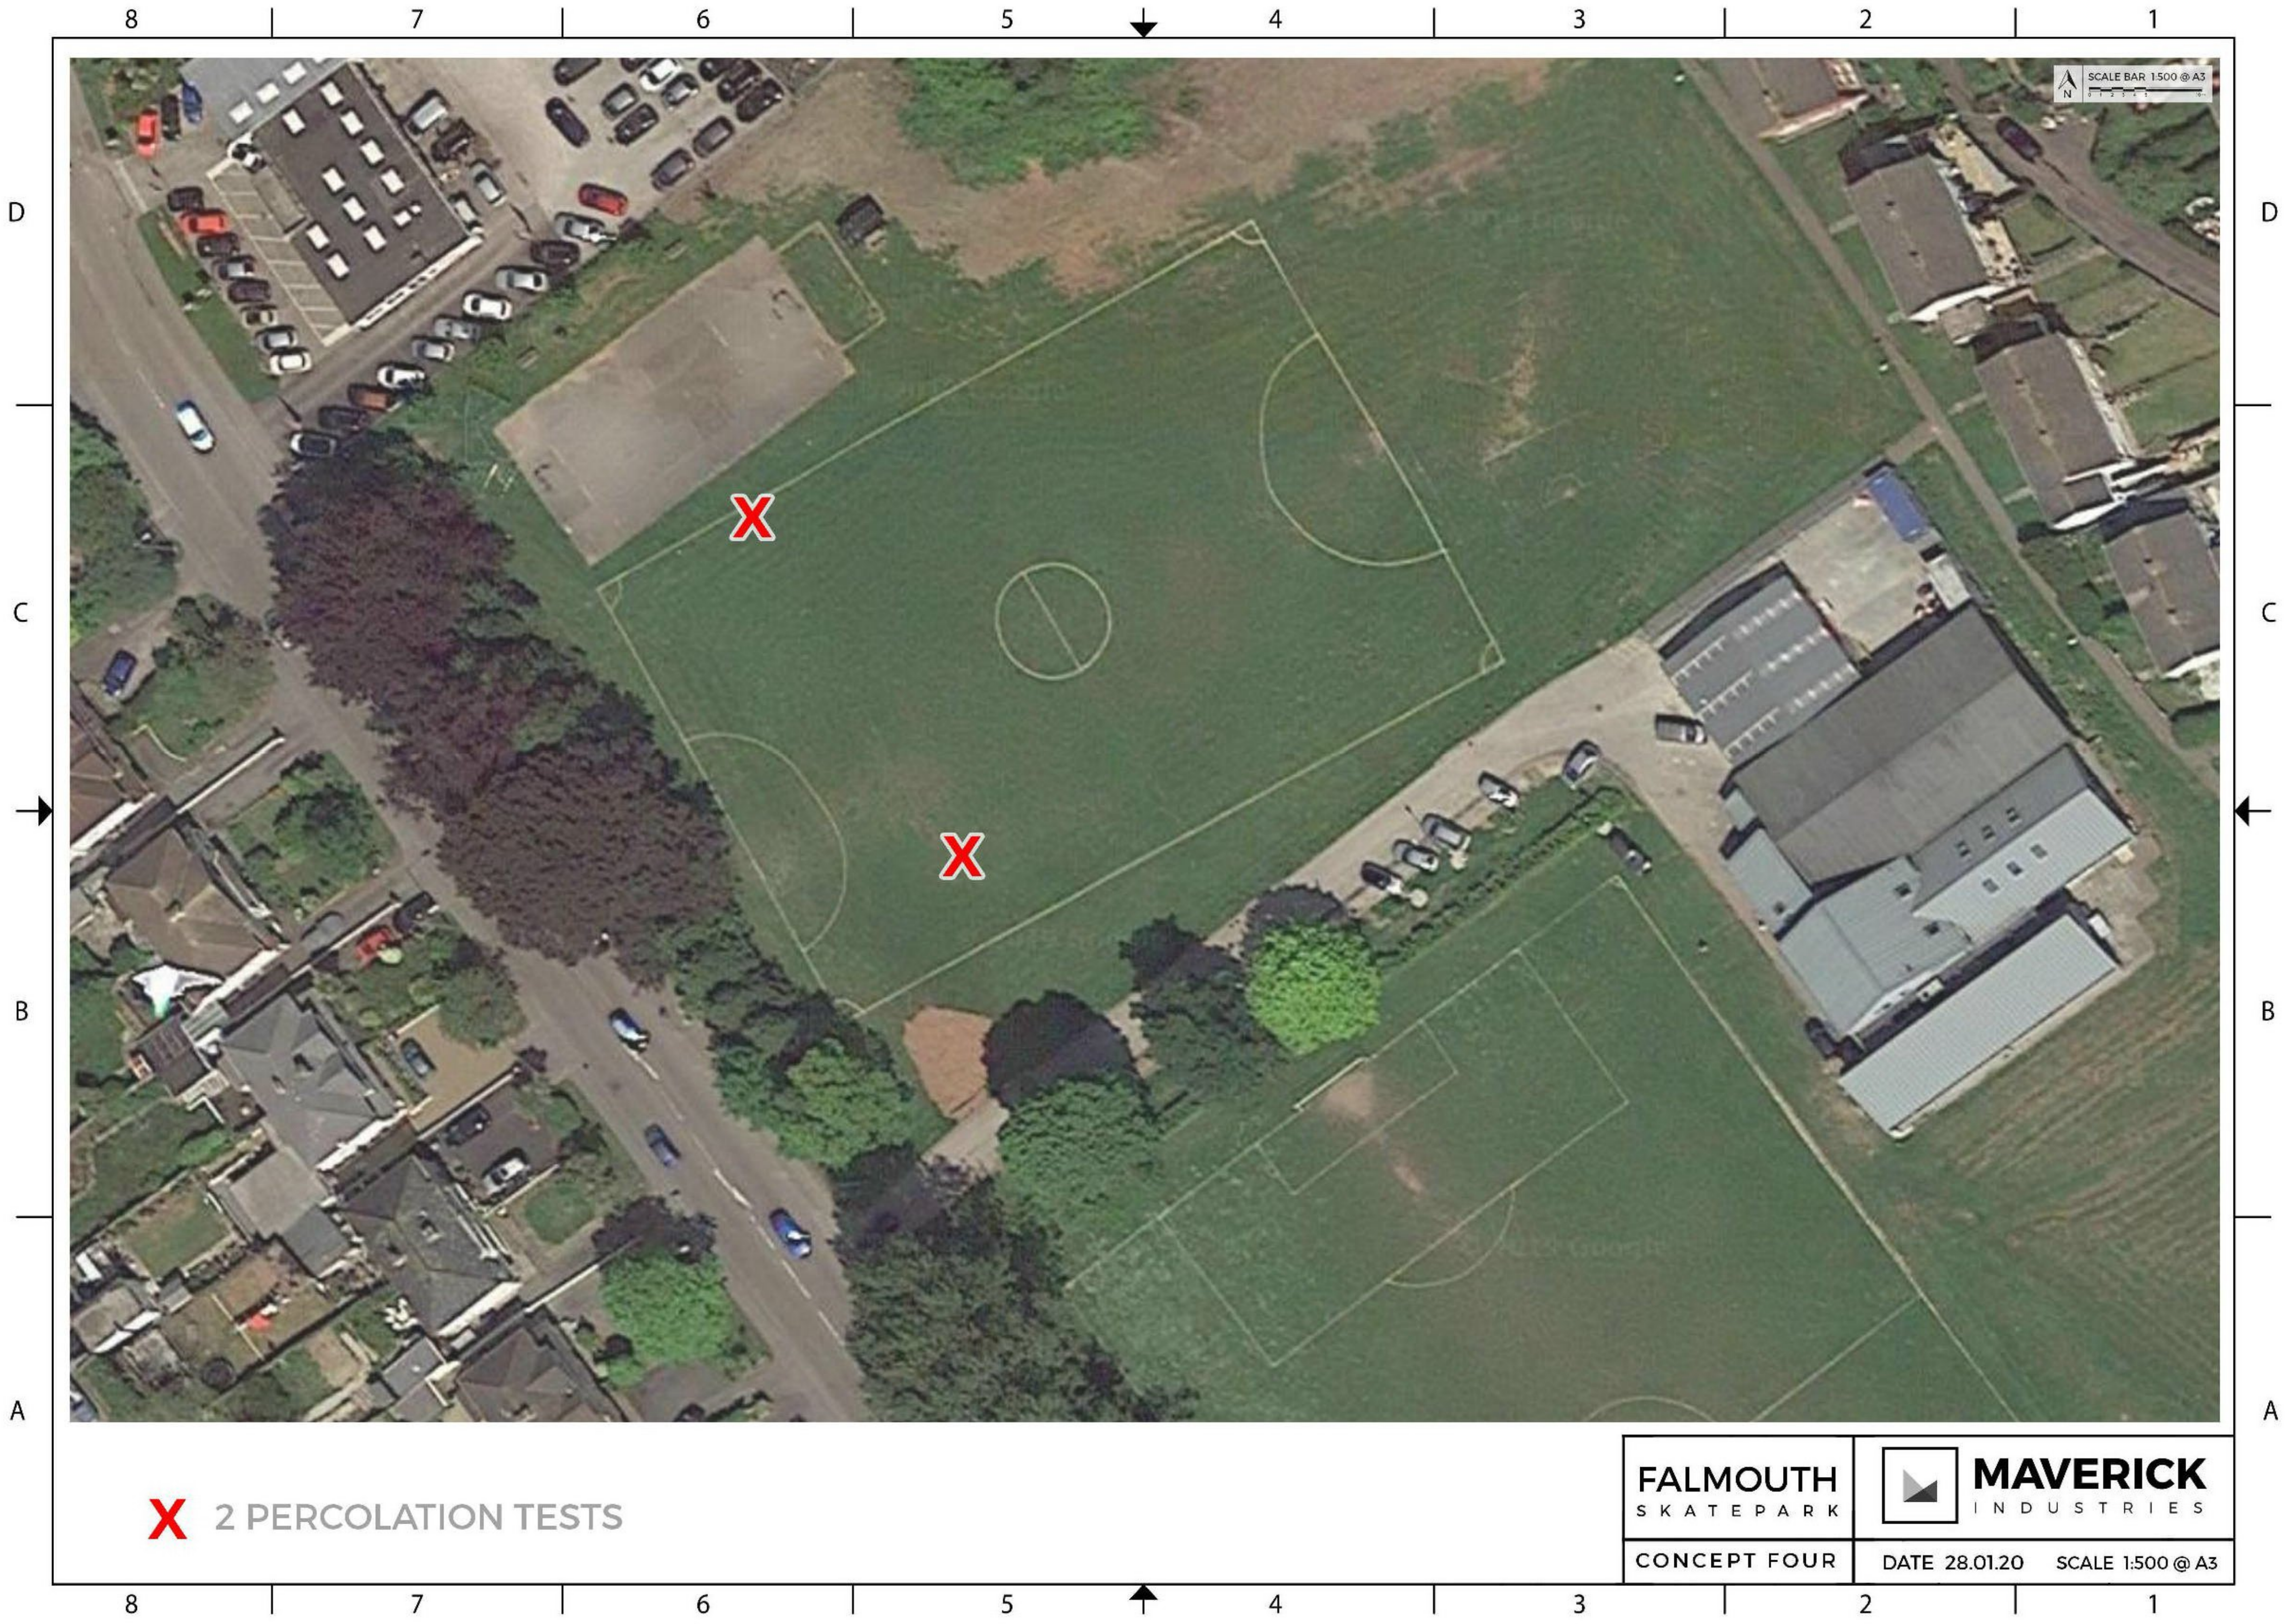
X 2 PERCOLATION TESTS

The fieldwork was supervised by Terra Firma (Wales) Limited, who logged the exploratory holes to the requirements of BS5930:2015. Test locations were chosen in advance by Maverick Industries, as seen in **Drawing 01**.
