HERITAGE, DESIGN AND ACCESS STATEMENT FOR PROPOSED ALTERATIONS TO THE CHIMNEY OF 1 MANOR LANE GOSBECK

INTRODUCTION

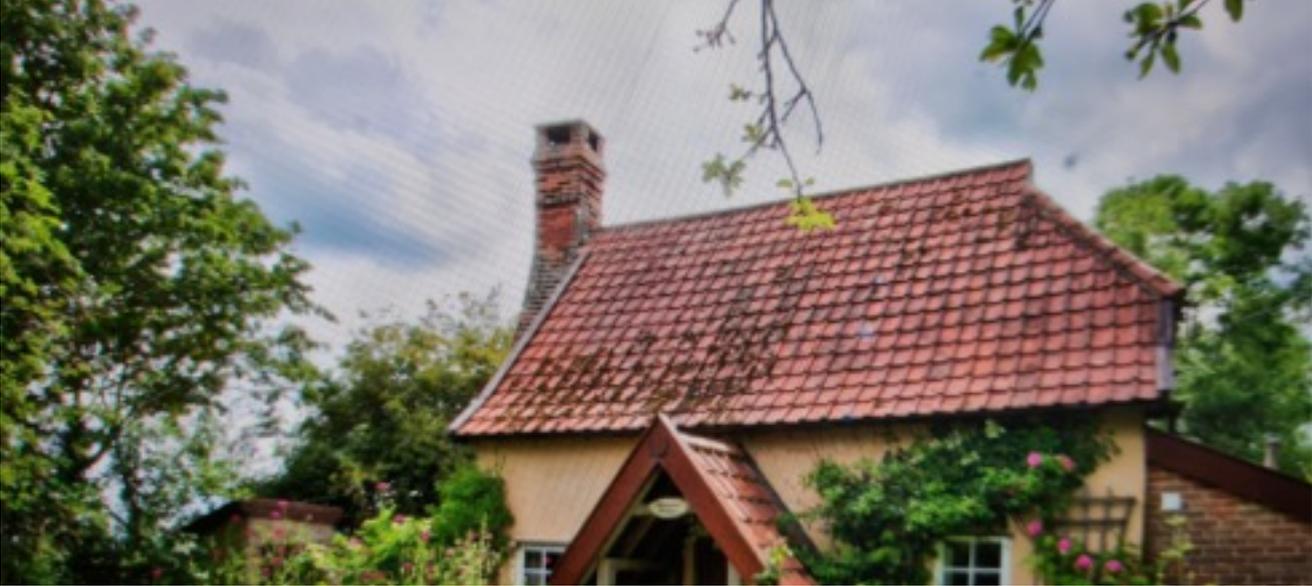
Figure 1
Current Chimney design

This heritage, design and access statement has been prepared in support of an application for permission to replace the current sheet steel wood burning stove with a new cast iron wood burning stove and to install a flexible flu liner in the chimney and remove the slab on the top of the chimney and replace it with a traditional clay chimney pot and bird guard.

Advice has been sought from Edwins Installation Services who have advised on materials to be used and need for listed building consent due to removal of the chimney slab in order to fit flexible flu liner. A traditional period chimney pot will replace the slab.

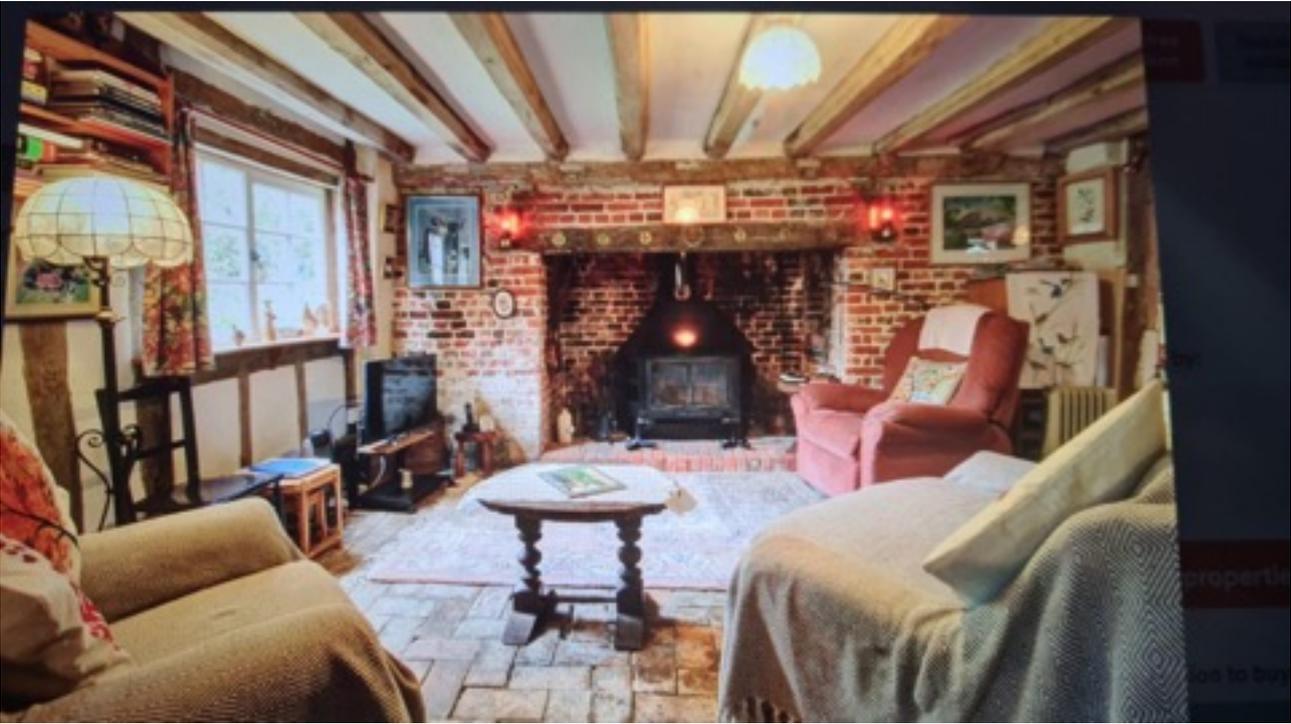
Figure 2.
Current wood burning stove

The replacement of the wood burning stove will be in keeping with the traditional style of the cottage and improve the overall appearance. Installation of the chimney pot will be in keeping with the age and style of the property.
