# 01 South Elevation Repairs

Project Name  
**Old Bodmin Library  
 Regeneration and Repair**

Drawing  
**South Elevation  
 Condition Survey & Repairs**

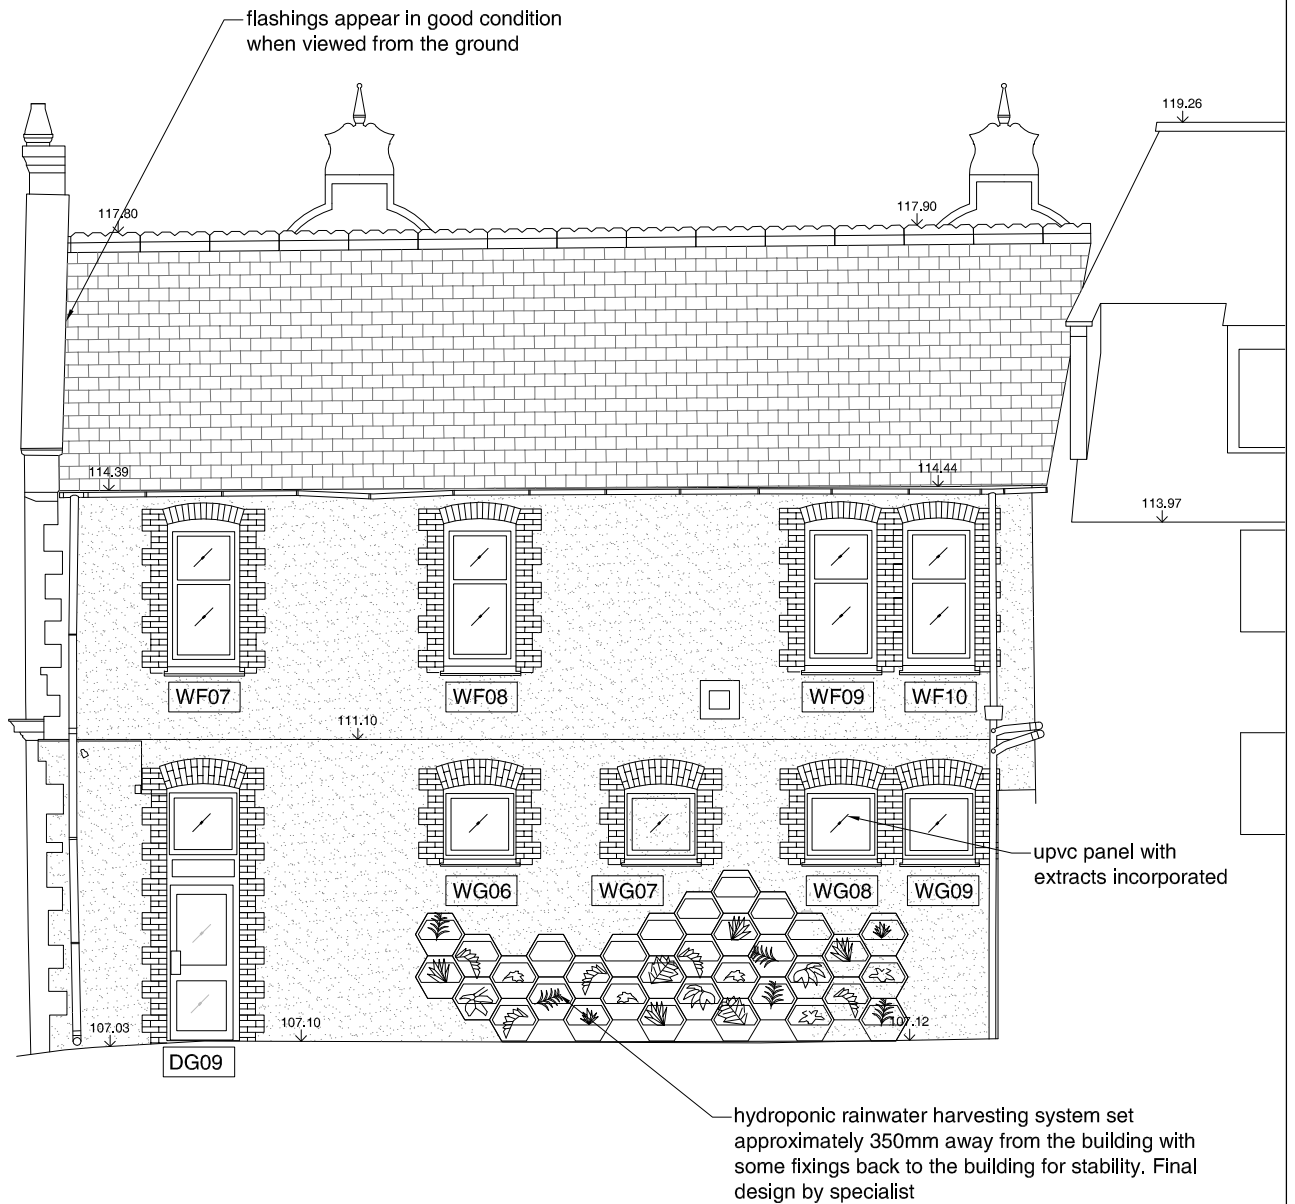
All upvc guttering - good condition but not in-keeping with the historic fabric of the building

Some staining to the render - no proposed repairs

All windows to this elevation are white upvc and 2 no. require repairing due to not opening.
