Project Name
**Old Bodmin Library
 Regeneration and Repair**

Drawing
**West Elevation
 Condition Survey & Repairs**

Scale	1:100 @ A4		
Drawn by	CS	Date	June 2021
Checked by	ALP	Date	June 2021
Project No.	J21/012	Drawing No	AD 05
		Revision	A

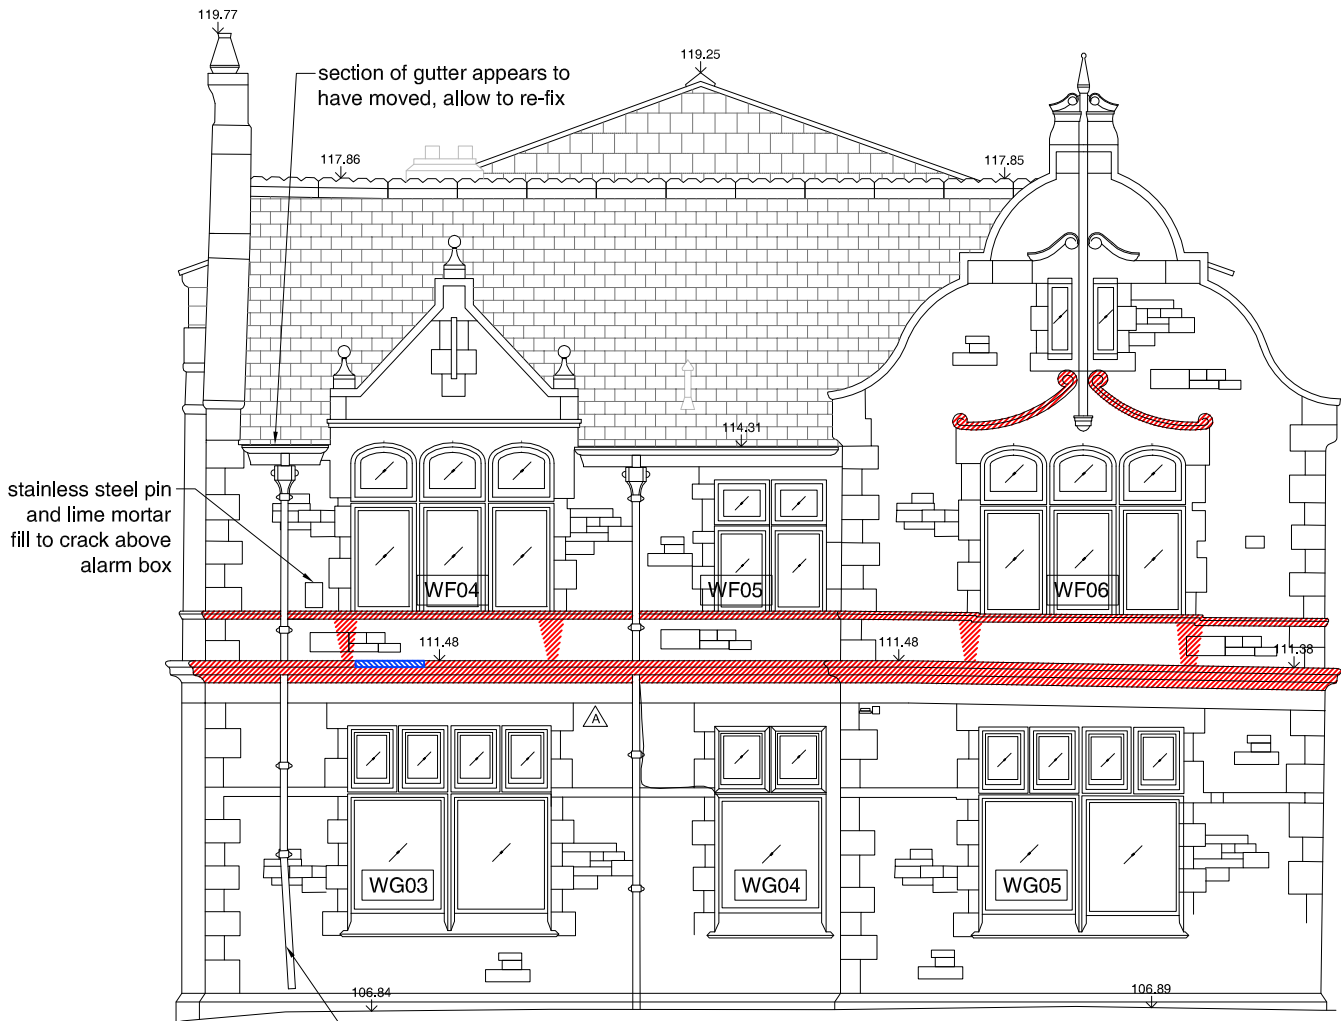
01 West Elevation Repairs

- section of damaged stone to be pieced in
- areas of moss growth and carbon staining to string course and stonework over, allow to clean with Doff system (steam)

allow for stone cleaning to window stonework, in particular the top side of the transoms where discoloured

replace timber windows with new hardwood timber historic windows with slim profile double glazed units. Cills to WG05 and WG06 are badly rotten and will require replacement along with windows.

WF05 is assumed to be original style and will have repairs carried out as per drawing AD 36

lower section of RWP to be refixed and new cast iron shoe to match original rectangular style, size and colour to be installed

Carefully remove, repaint and refix all rainwater pipes and gutters - any replacements required to be cast iron or the same profile as the existing

Allow for 50% repointing of this elevation to be determined on site. Mix to be NHL based, samples of existing to be taken for analysis and final mix to be matched. min 3 no. samples of different potential mixes to be reviewed on site prior to confirming mortar mix
