Arboricultural Method Statement

For Trees On

Land At Maple Avenue, Shildon

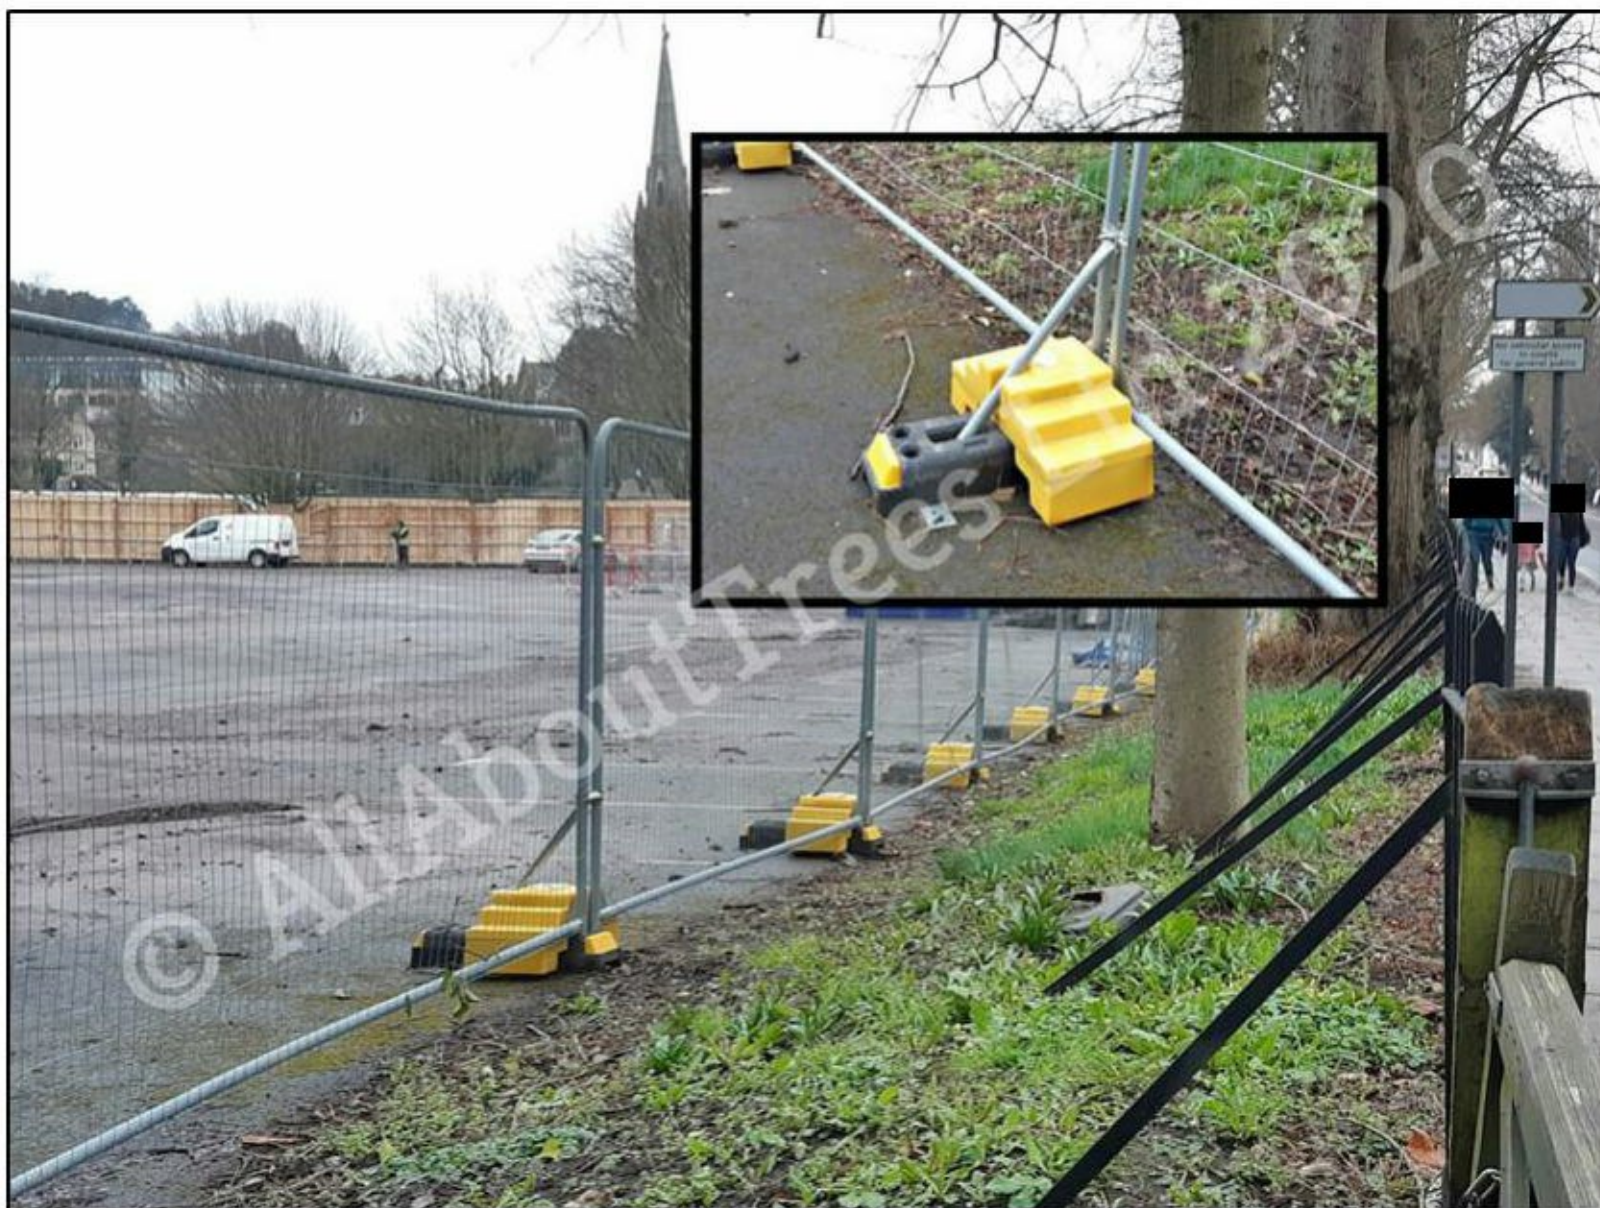
Figure 2 – An example of a barrier erected on a site

3.3.4 The barrier should consist of proprietary 2m tall welded mesh panels mounted on rubber or concrete feet. The panels must be joined together with a minimum of two anti-tamper couplings situated at least 1m vertically apart and installed uniformly throughout the barrier so that they can only be removed from inside the barrier. The panels must be supported on the inner side by stabilising struts mounted on a block tray.

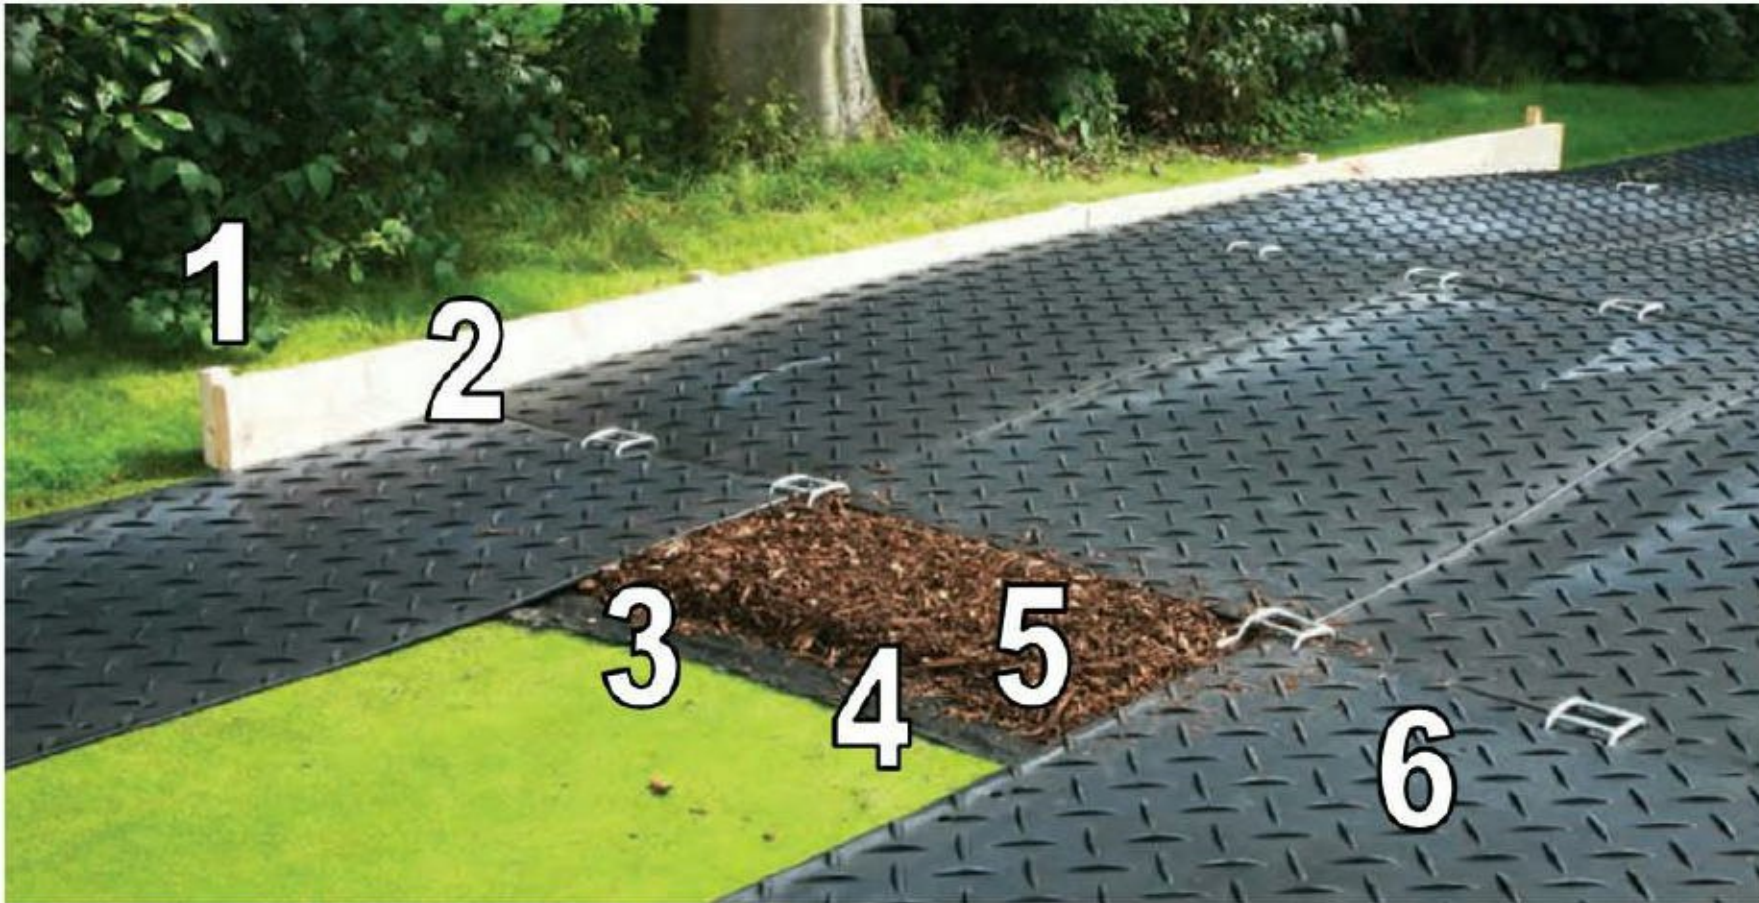
Figure 6

Suitable For Wheeled Or Tracked Construction Traffic Exceeding 2t Gross Weight

- 1) 50mm X 50mm X 500mm timber stakes
- 2) 200mm x 50mm timber rails
- 3) Geotextile membrane
- 4) Base layer of Ground Guards by Greentek
- 5) Wood chippings or other compressible material
- 6) Interlinked Ground Guard plates

3.4.5 If the likely loading is to exceed 2t gross weight it will be necessary to produce an engineered solution with arboricultural advice to accommodate the likely load safely. One such example is shown below. In some cases, it may be necessary to install a temporary road using a 3D cellular confinement system (such as Cellweb by Geosynthetics Ltd).
