Planning Statement to accompany LBC approval of details reserved by conditions.

LBC conditions this application relates to:

8, 10, 12, partial 16 areas TBC following removal of render, 17, 18 & 19

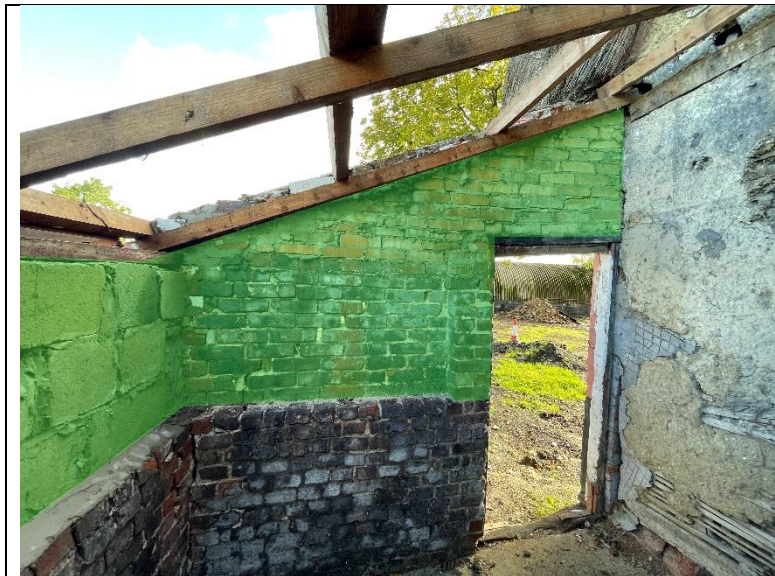
West lean-to store. Internal elevation of north wall, area indicated to be carefully taken down, brickwork cleaned and re-used where in good condition. Shortfall to be up from Weinerberger Olde Essex Red Multi laid in stretcher bond and 6mm deep mortar joints formed from 1:3, NHL 2 to mixed well graded sand/sharp

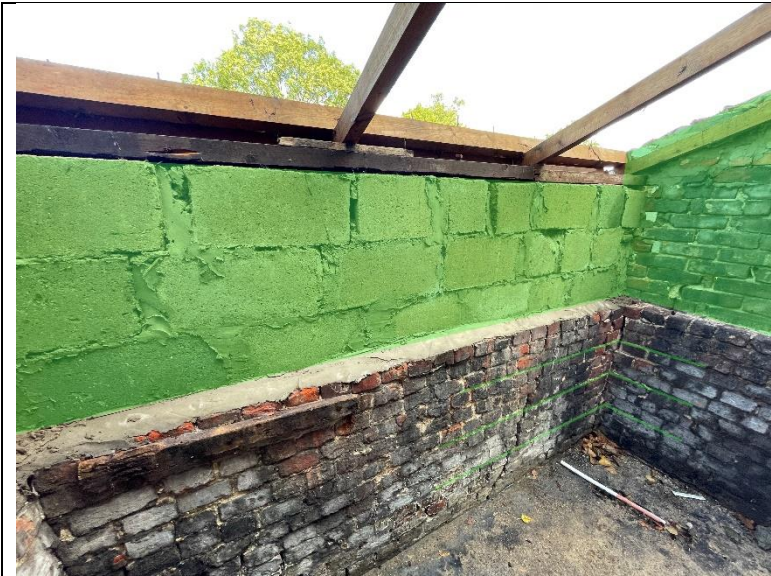
West lean-to store. Internal elevation of west wall, area indicated to be carefully taken down, brickwork cleaned and re-used where in good condition, blocks disposed of. Shortfall to be up from Weinerberger Olde Essex Red Multi laid in stretcher bond and 6mm deep mortar joints formed from 1:3, NHL 2 to mixed well graded sand/sharp.

Helifix reinforcement ties to crack in plinth, as indicated on photo and corner as structural engineers specification.

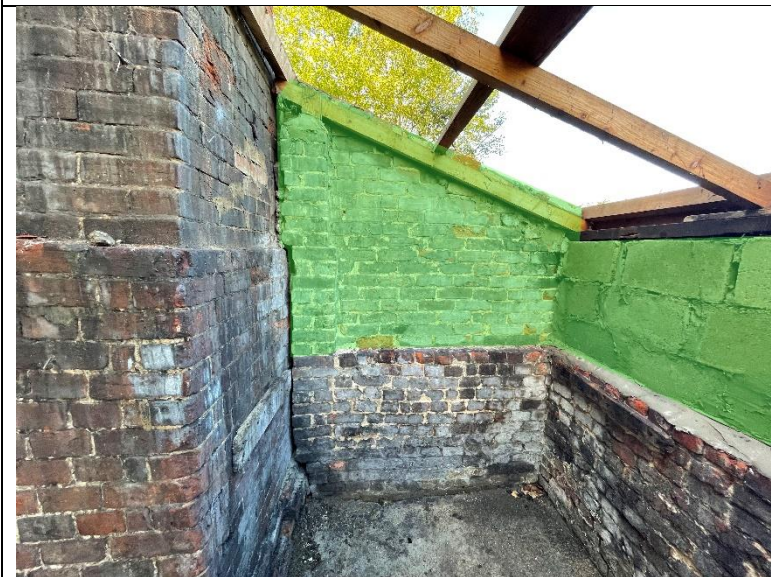
West lean-to store. Internal elevation of south wall, area indicated to be carefully taken down, brickwork cleaned and re-used where in good condition. Shortfall to be up from Weinerberger Olde Essex Red Multi laid in stretcher bond and 6mm deep mortar joints formed from 1:3, NHL 2 to mixed well graded sand/sharp

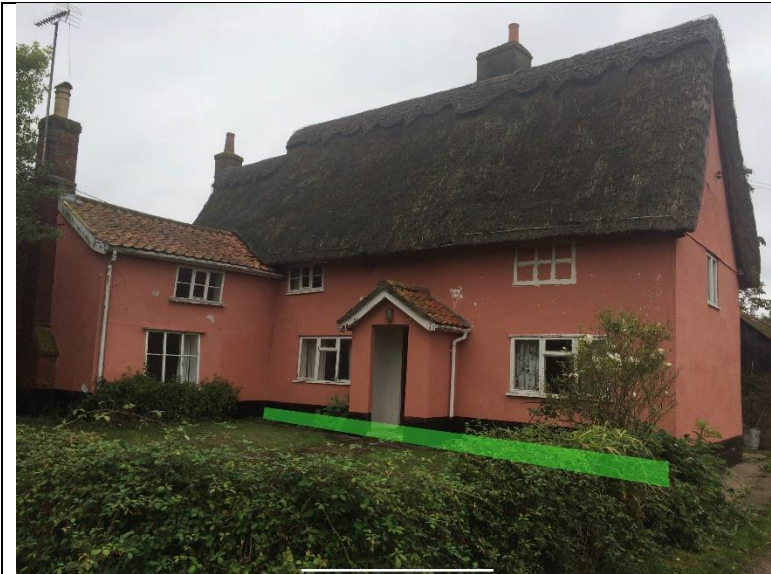
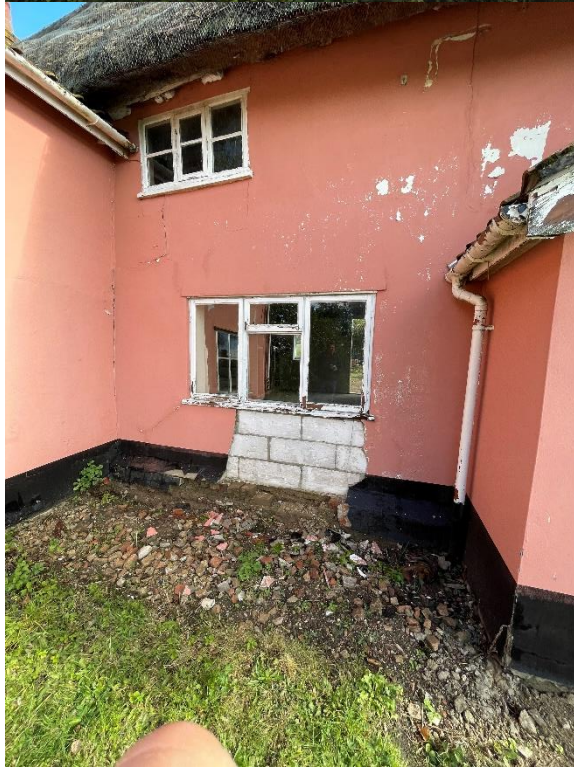
Front Elevation. Timber frame has been removed upto the mid rail of the dwelling (visible to top of ground floor internal walls). Modern blockwork built directly off of concrete slab. Brickwork decorative 'plinth' has been formed separate from structure with large cement fillet to top, this has degraded and water has deeply penetrated into half skin of brickwork damaging bricks and mortar, as shown in photos. Existing timber frame to be propped (design by structural engineer), concrete floor, blockwork and plinth all to be removed and rebuilt with new foundations as structural engineers details and recommendation. Area of brickwork indicated to be carefully taken down and disposed of, all in poor condition. New plinth to be formed as details, from Weinerberger Olde Essex Red Multi laid in Flemish bond and 6mm deep mortar joints formed from 1:3, NHL 2 to mixed well graded sand/sharp.

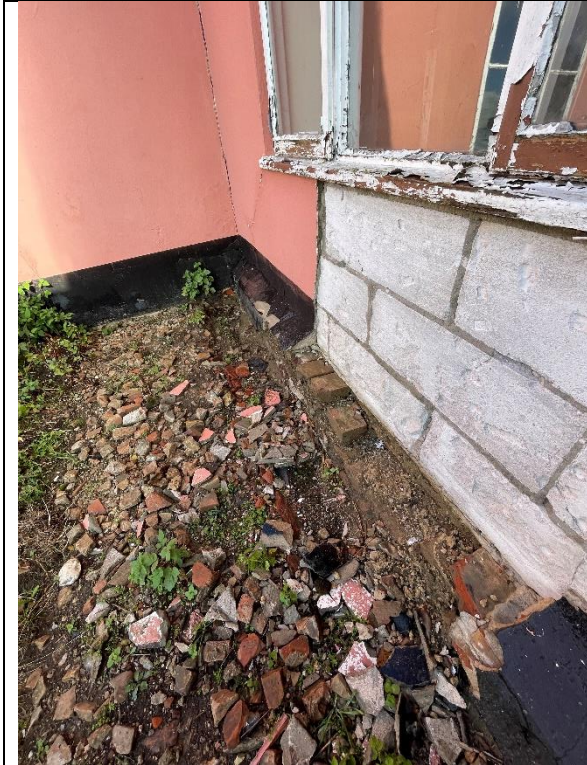
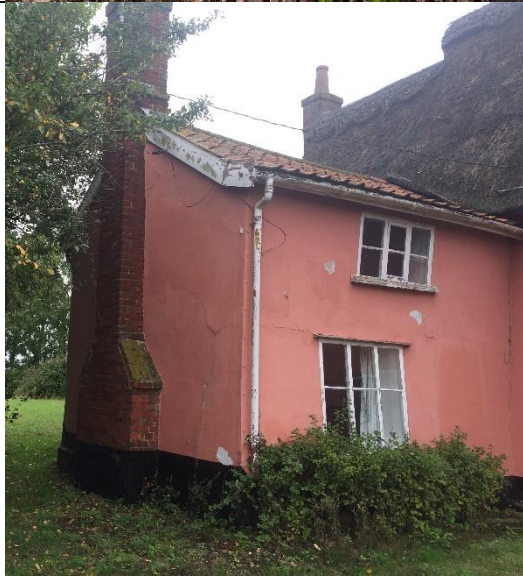
The entire plinth of the clay lump range will be rebuilt. As detailed within the application this is structurally unsound and is suffering ongoing movement. The structure will be rebuilt as per the drawings reusing materials in good condition. New plinth match the height of the existing dwelling and is to be formed as details, from Weinerberger Olde Essex Red Multi laid in Flemish bond and 6mm deep mortar joints formed from 1:3, NHL 2 to mixed well graded sand/sharp.
