DESIGN, ACCESS AND HERITAGE STATEMENT OCT 2021

Job No: 53404

The Thatched Cottage, Wix Road, Bradfield, Essex. C011 2UX

This design, access and heritage statement (DAHS) accompanies the Listed Building Application for the reconstruction of the top of the main brickwork chimney stack at The Thatched Cottage, Wix Road, Bradfield, Essex. C011 2UX following fire damage. The DAHS has been written to meet the requirements of the local planning policy.

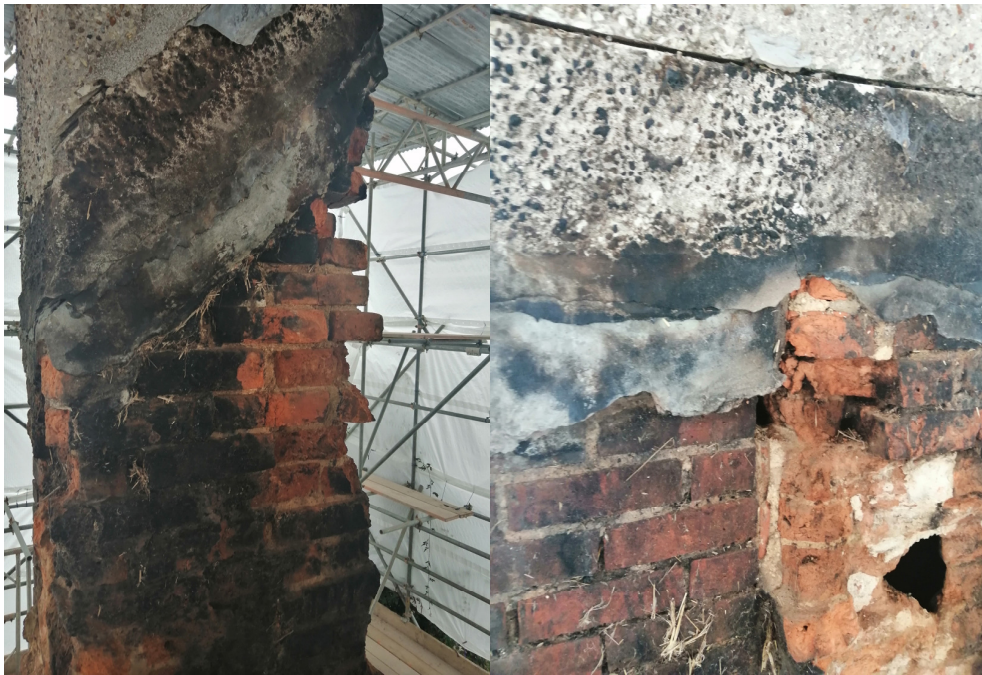
The proposal associated with this application is to restore the integrity of the main chimney stack following the fire damage and uncovering of brick deterioration, erosion and loss of section to the stack at high level, as the main works has progressed. See photos below illustrating damage and loss of section.

Works commenced on the property in association with the granted applications. However, the chimney stack is in far worse condition than was anticipated at the time of the original applications and the loss of brick section around the original chimney at roof line requires this area to be completely rebuilt. With loss both internally and externally and a number of holes all the way through, and do not consider we can carry out an effective repair safely in its condition.

We therefore propose to take the chimney down to the course just below the erosion and re-build, this will mean taking the top 2.8m of the chimney down. Any reusable bricks will be put to one side for reuse, however this will be very limited. In terms of the re-construction, whilst we note that there has been a later stack added to the right of the original, we would prefer to re-construct as one from the line we are taking down to, alternatively we could use bed joint reinforcement to ensure the two stacks are tied together.

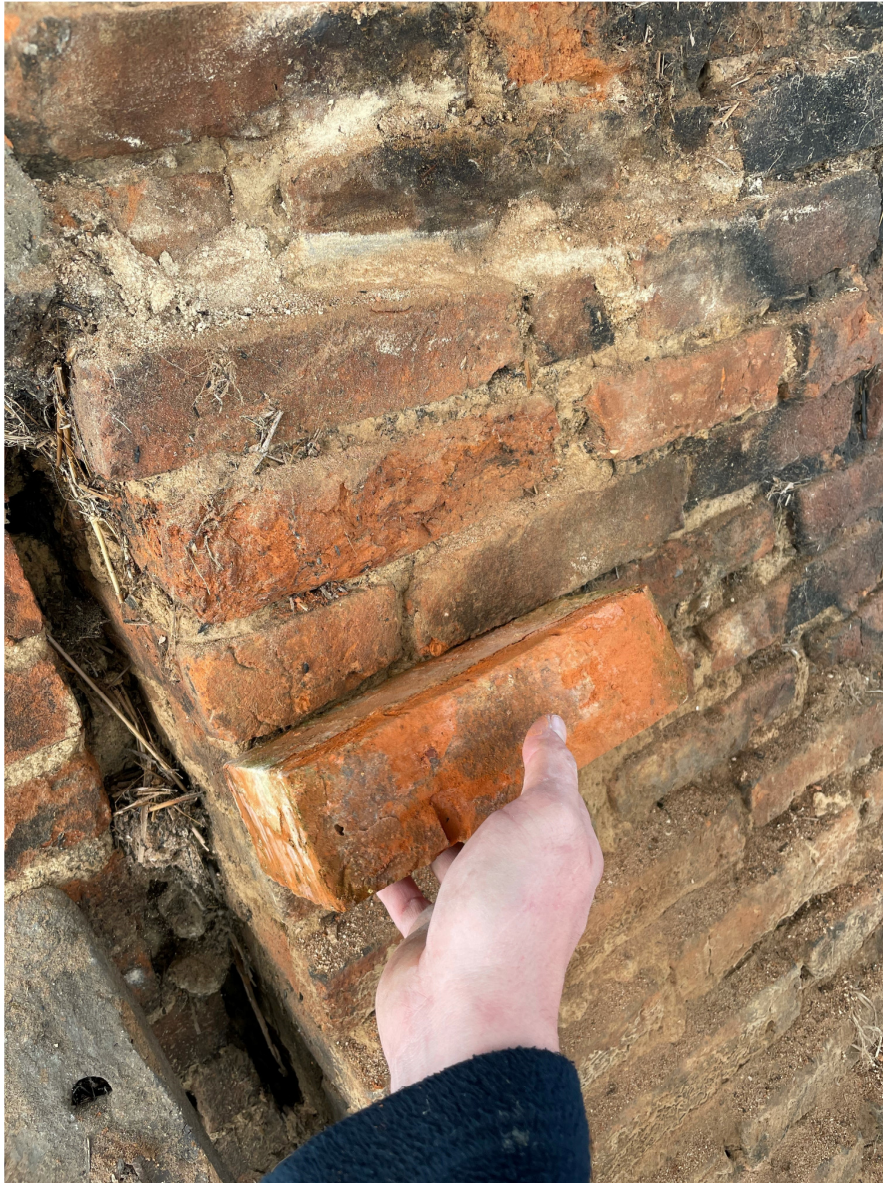
The defective height of chimney will be constructed in matching reclaimed brickwork. See photo below illustrating the matching brickwork sample. These will be supplied from J Purdy & Sons who stock reclaimed materials.

The existing chimney bond is a mixture of lateral bond at low level forming a traditional stretcher bond at high level. The proposed brick bond at high level will be a traditional stretcher bond to match existing with the bricks laid in a mortar mix consisting of a 3 part sharp sand to 1 part NHL 2. The render will not be reintroduced to the top section of the chimney as existing, with reclaimed brick in a traditional stretcher bond visible.
