**Heritage Impact
Assessment
&
D&A Statement**

**Repairs to Vehicle impact
damaged building**

**99 High Street
Westerham
Kent
TN16 1SF**

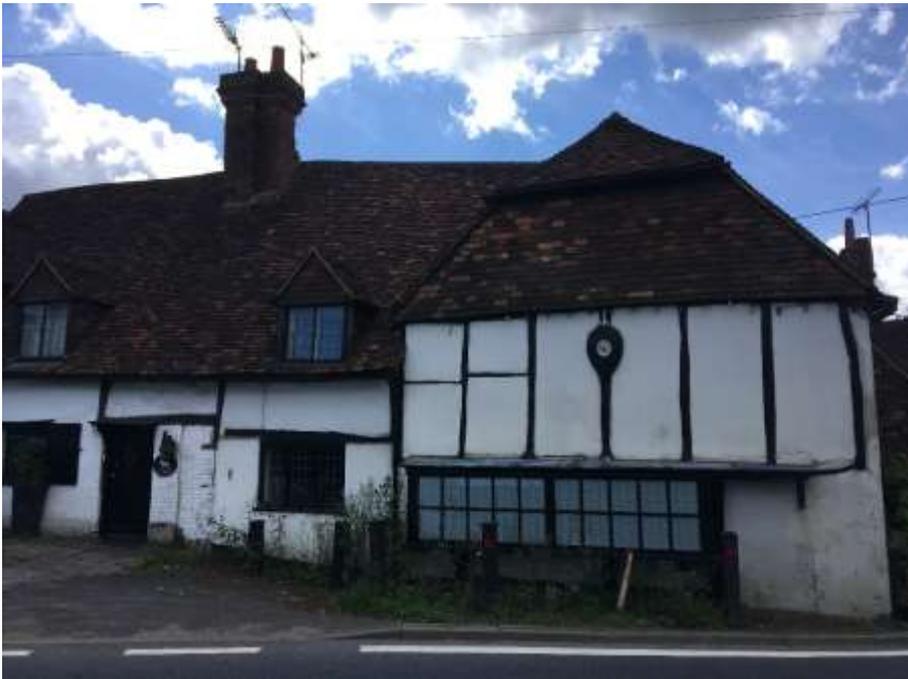
Photograph 1

North elevation further to impact

The repairs to the external damaged sections of the structure are sympathetic and are a direct like for like replacement.

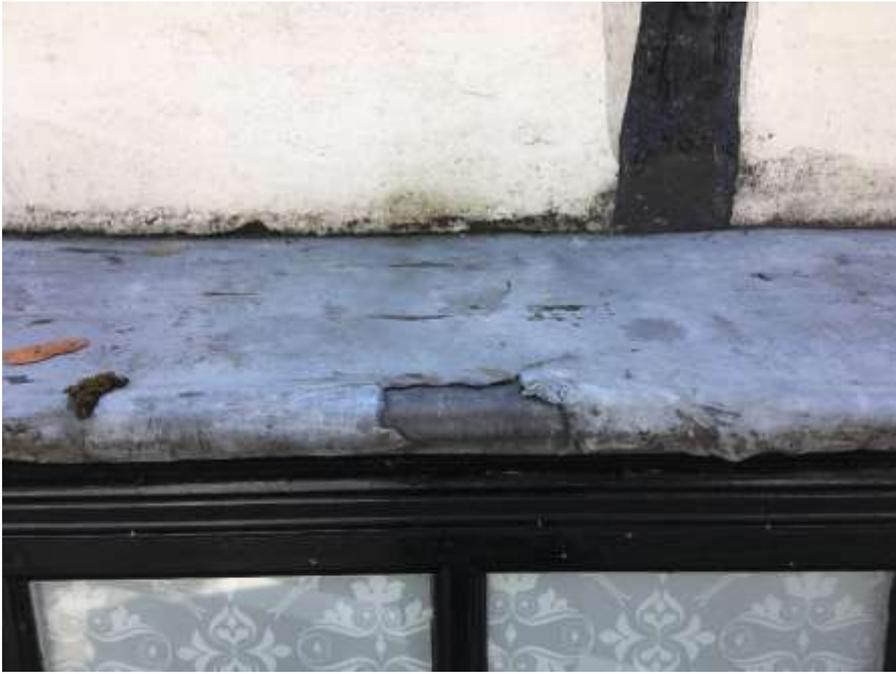
Photograph 2

Temporary repair to existing lead

The lead to the flat roof over the bay window is proposed to have a welded lead insert applied so as to repair the damage and retain the original material.

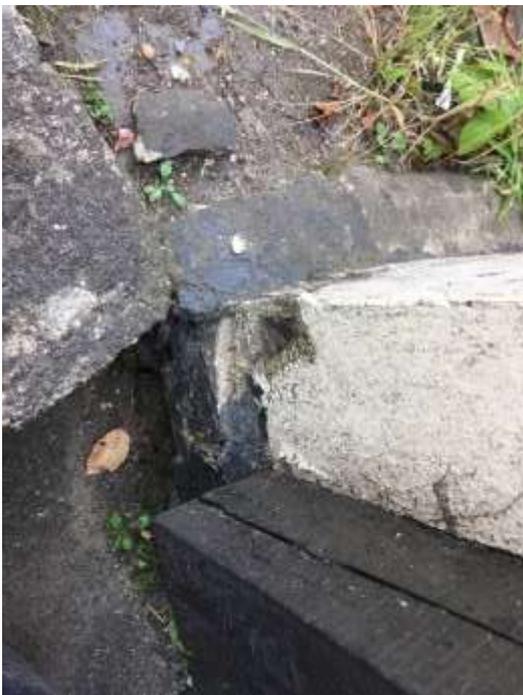
Photograph 3

Damaged render to north west corner

The existing render to the external of the structure is a sand and cement finish and the property owners are keen to replace this damaging material with a lime putty based render. This may result in minor repairs being carried out to the underlying brick infill panels and these will be carried out using the existing materials. All works to these infill panels will be carried out with using a non-hydraulic lime putty and sand mortar.

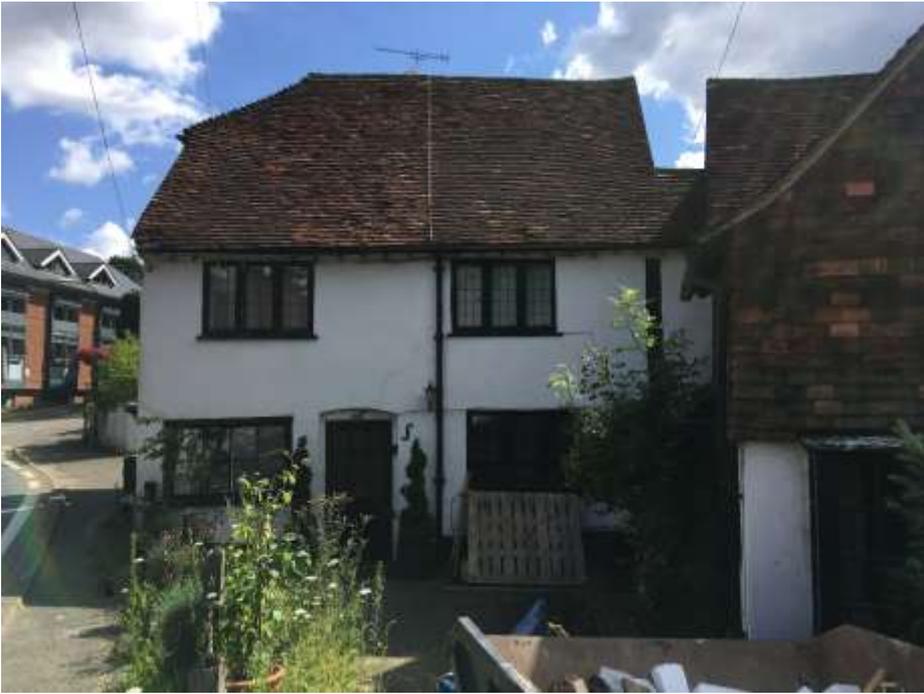
Photograph 4
Existing west elevation

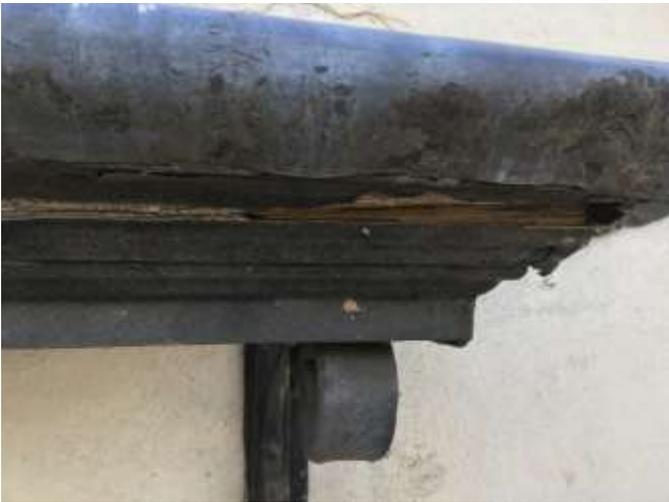
Photograph 5
Damaged timber to flat roof

The timber repairs will be carried out by removal of the damaged sections with new timber installed with the existing profile retained.

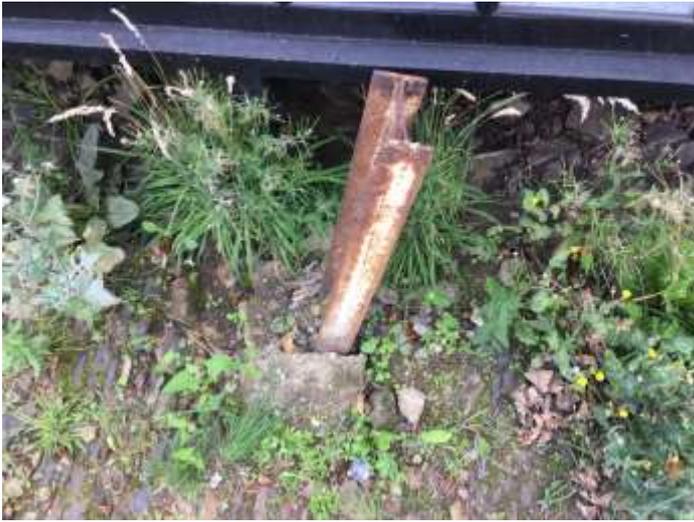
Photograph 6

Damaged Bollard and cobbles to north elevation

The new bollard will be installed in the same place and form as that of the existing and new timber cladding to match.

The damaged section of cobbles will be repaired to match those existing and suitable materials to match will be sought.
