DESIGN, ACCESS & WASTE MINIMISATION STATEMENT

THE PROPOSED REPLACEMENT OF THE FASCIAS, SOFFITS,
RAINWATER GOODS & BALUSTRADE TO THE EXTERNAL METAL
STAIRCASE

74-94 GERTRUDE ROAD, BELVEDERE, KENT, DA17 5AT

15-21 UPPER ABBEY ROAD, BELVEDERE, KENT, DA17 5AE

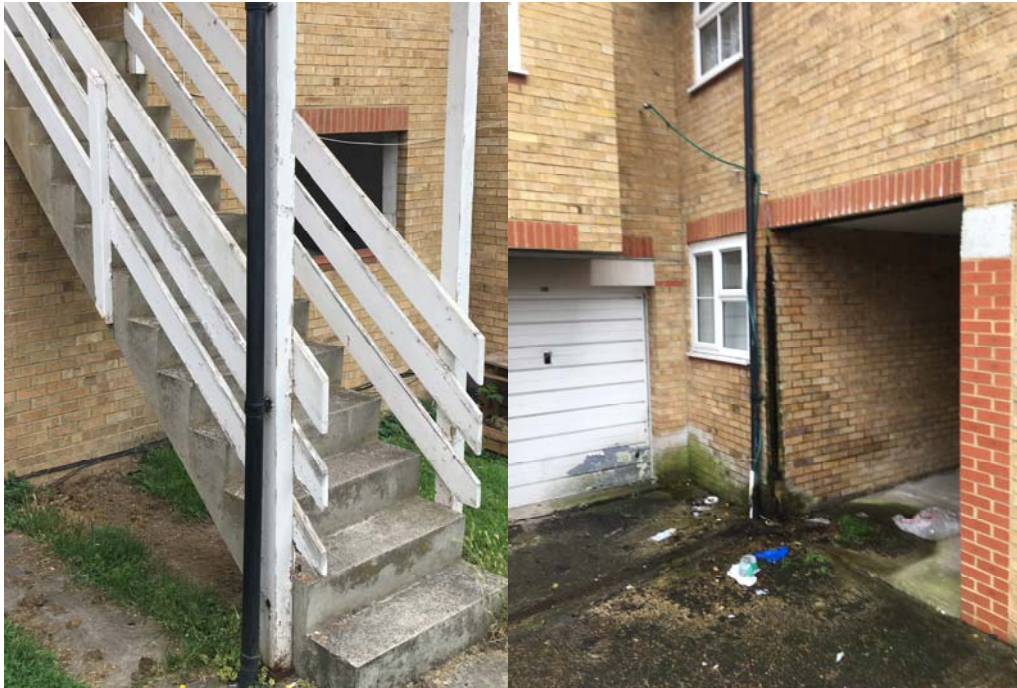
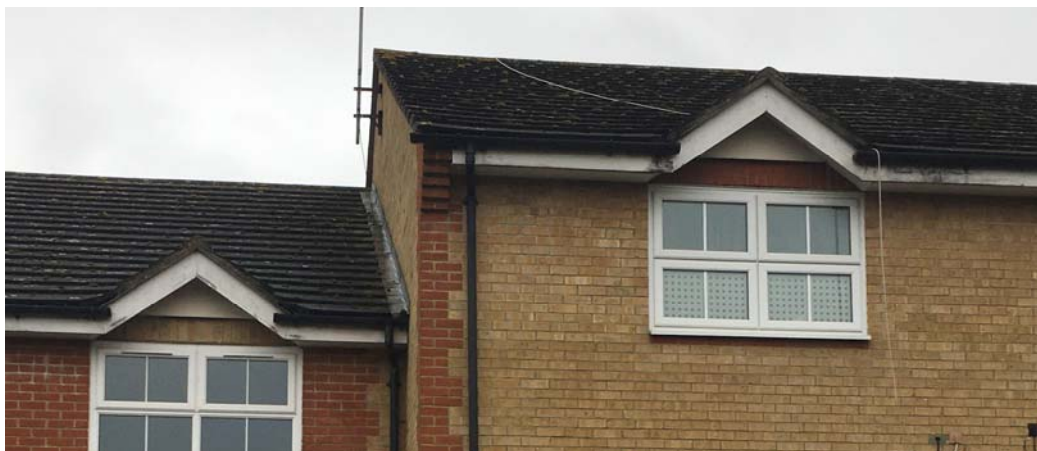
The exterior of the premises has been inspected and the premises is in need of cyclical repairs, redecoration and general maintenance. It has been identified that the existing fascias and soffits have become rotten and defective in numerous locations due to ongoing issues with the rainwater goods. In addition, the balustrade to the external staircase access 1no. Unit located to the rear of the premises is rotten, non-compliant with current Part K regulations.

Fig 1, 2 & 3: Rotten balustrade to rear external staircase, defective rainwater goods and rotten fascias and soffits.

After assessment, it has been deemed by the client to be neither practical nor cost effective to repair the existing eaves therefore it is being proposed that the existing timber fascias and soffits are replaced with new UPVC equivalent that will match the existing in terms of size, profile and colour as part of the work. Thereafter new stormflow gutters and downpipes will be provided throughout. Furthermore the non-compliant timber balustrade will be replaced with a complaint metal balustrade, powder coated black. These works will be

The proposal is for replacement fascias, soffits, rainwater goods and balustrade to the external staircase only. All replacements fascias and soffits will be white to match existing. All replacement rainwater goods will be black UPVC to match existing. The replacement balustrade will be powder coated black. The design aims to maintain uniformity with the existing external appearance as closely as possible.
