## Design and Access Statement & Listed Buildings

Honesty Cottage

Water Stratford Buckingham MK18 5DU

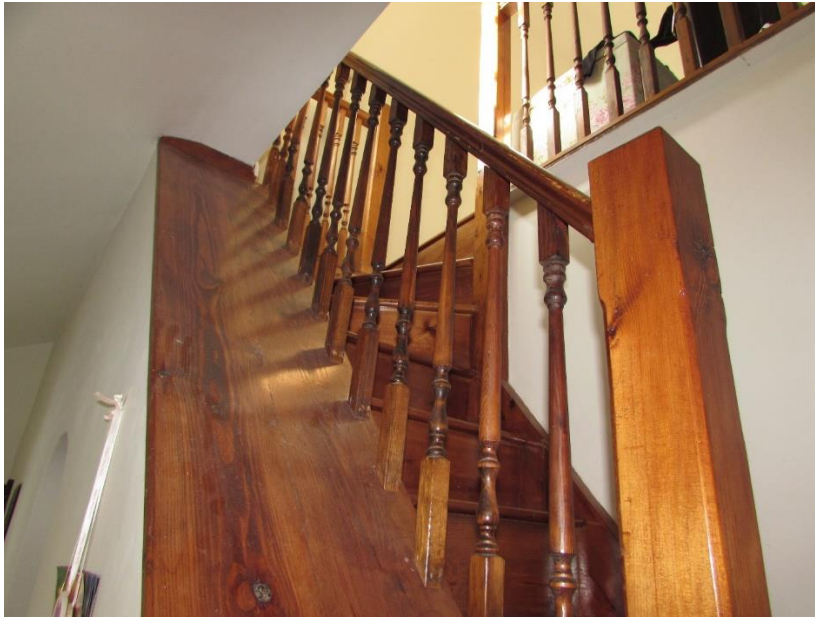
Figure 1 - narrow steep staircase

The existing stairs in the newer brick element of the dwelling are steep and narrow, Figure 1, the front extension and new staircase will provide safer access to the first floor.

The current stairs leading to bedroom 1 are very narrow, steep and are a hazard, Fig1. By moving the wall between the living room and hall above and creating the first-floor extension a new staircase can be installed which complies with building regulations along with a wider hall. A first-floor rear extension will provide additional space for an en-suite bathroom. An additional dormer will provide extra space while maintaining the neighbour's privacy with a non-opening window 1.7m from the internal floor level.

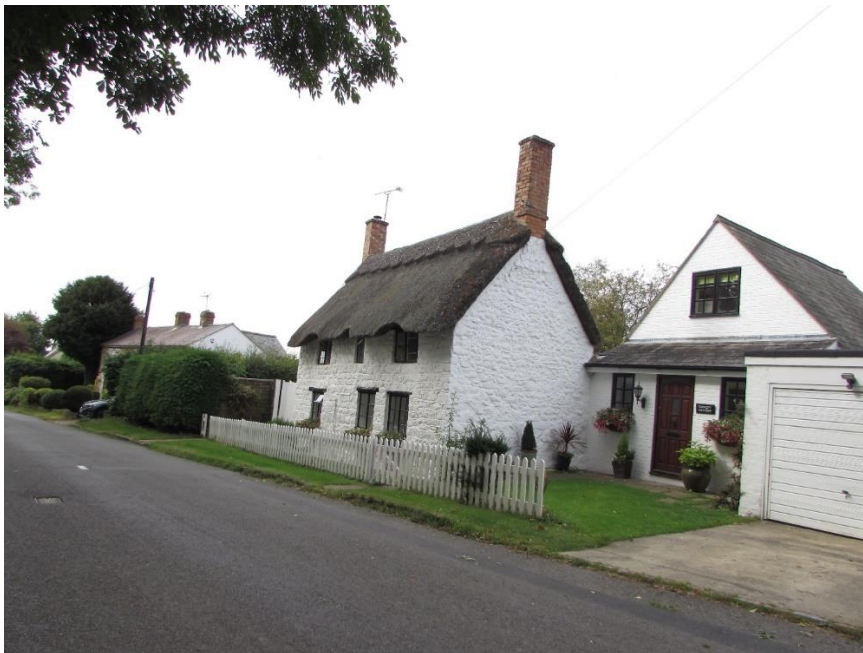
Figure 2- limited parking in front of the garage.

The porch will provide shelter while improving the character of this newer part of the dwelling with the use of oak and thatch. The current off-road parking is inadequate due to there not being enough room to park a car safely in front of the garage, Figure 2.

The proposed double garage has been set back behind the line of the front elevation of the house providing adequate space for off road car parking. The current layout and garage position does not provide adequate space in front of the garage for a car to be parked safely.

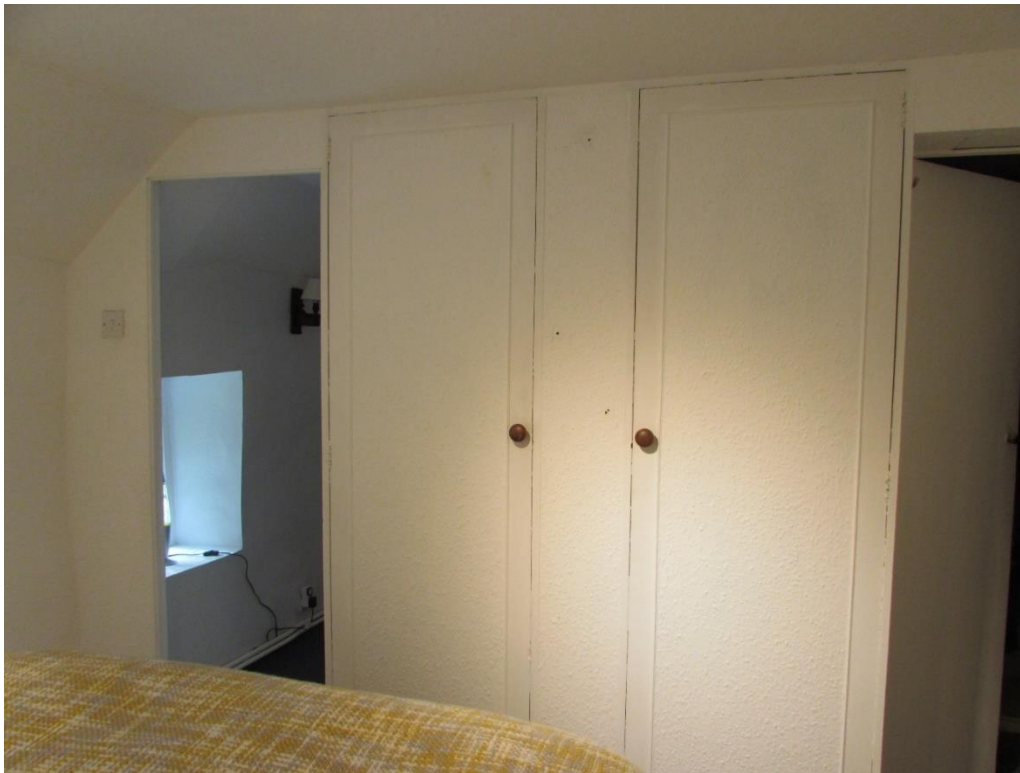
Figure 3- cupboards and wall to be removed.

The property only has one bathroom on the ground floor, the proposal is to re-locate the family bathroom to the first floor in bedroom 3 and to create additional space for an en-suite bathroom to bedroom 1. The current location of the bathroom in the old stone cottage will be used as a new utility. A modern timber stud wall and built-in cupboards between bedroom 3 and the landing are to be removed and replaced with a banister, in keeping with the style of the existing staircase, Figure 3 and Figure 4.

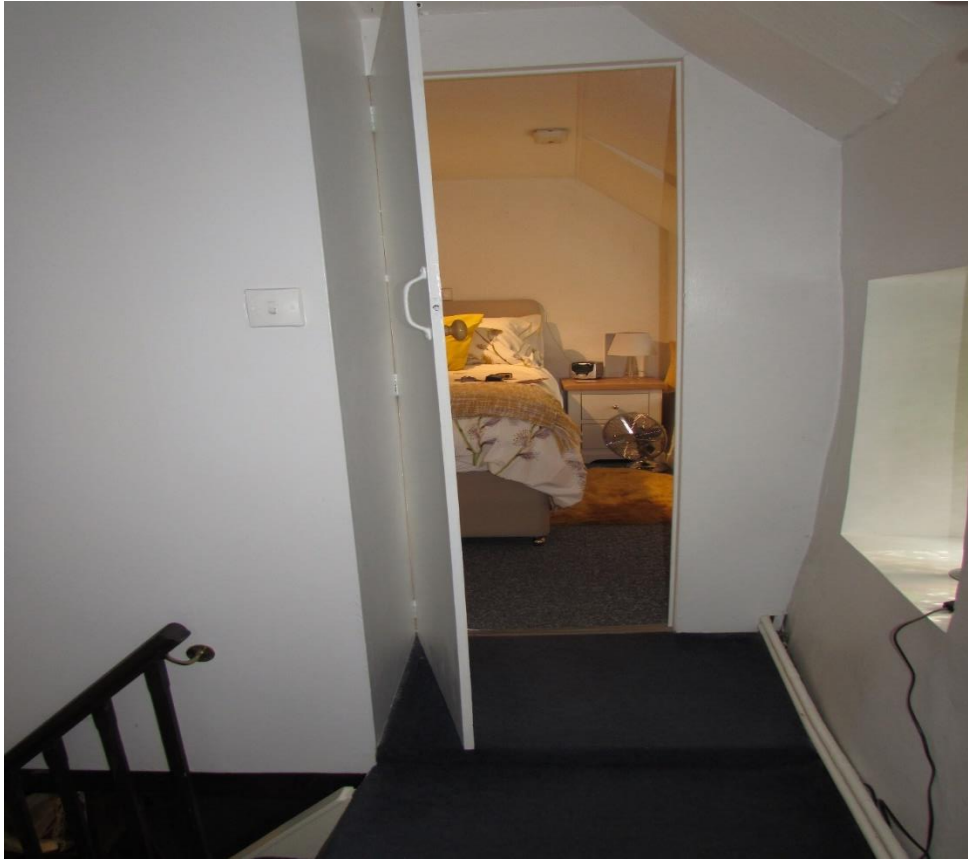
Figure 4 - cupboards, and wall to be removed, view from landing.

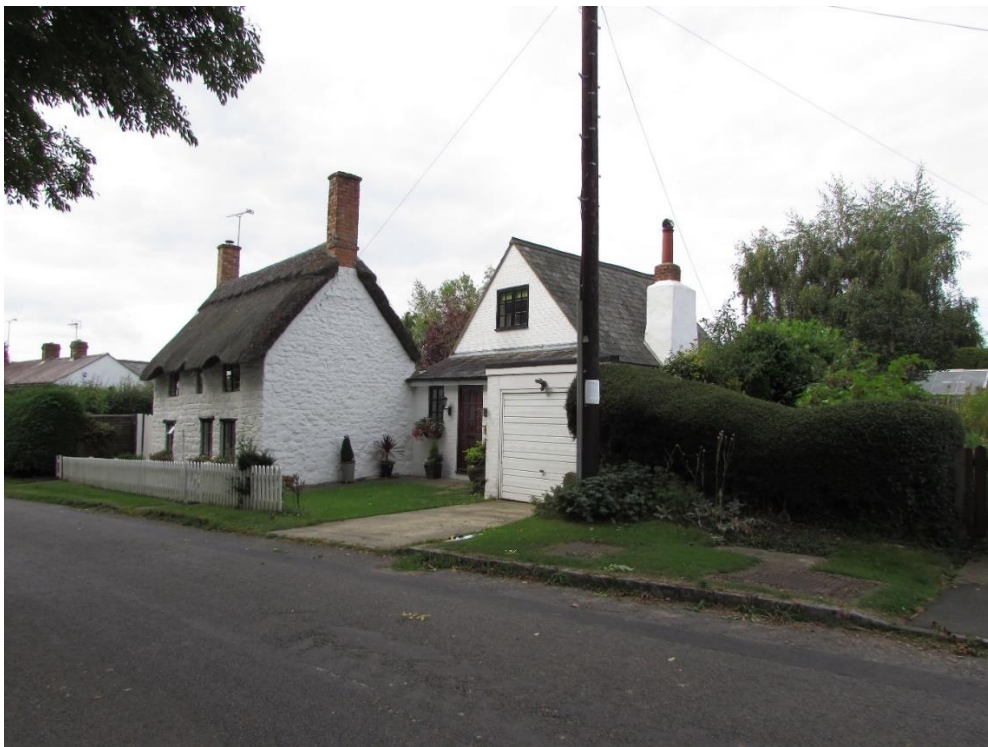
Figure 5- showing garage and chimney stack to be demolished.

There will be a new lawn and garden where the existing garage and drive is to be demolished, Figure 5. and a new stone path from the road to the main entrance and thatched porch.

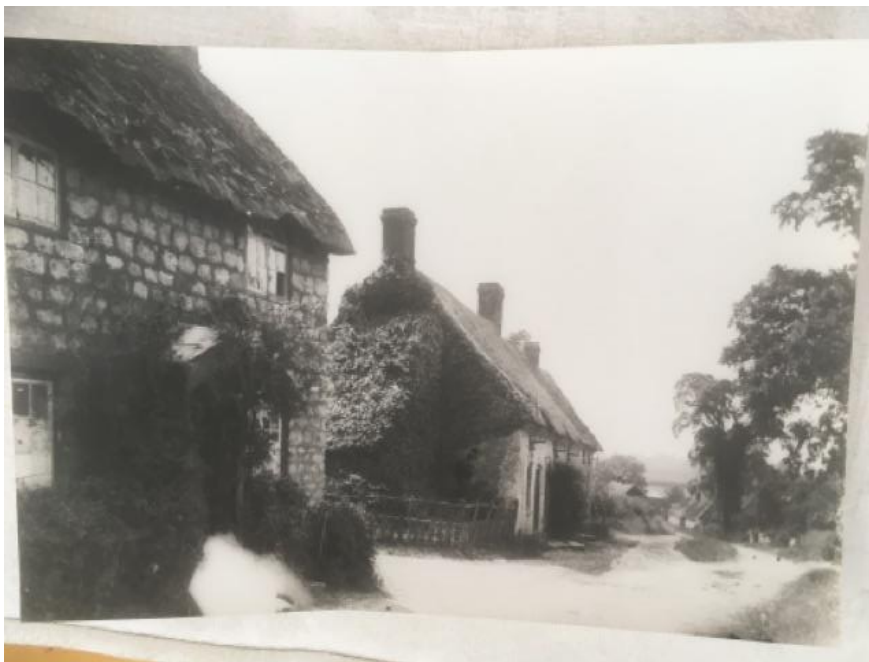
Figure 6 - Water Stratford

The oldest stone part of the property is proposed to have the white paint removed exposing the natural stone. The existing painted brick extension and proposed extension will be finished in a sand and cement render painted with a colour complimentary to the natural stone. The rear single storey extension will have a sand and cement render to match the two-storey element of the property. Figure 6 shows the property in 1910 without exterior paint (bottom left of the photograph).

The old stone cottage currently suffers from damp, this situation would be improved by removing the paint from the exterior walls and allowing it to breath. Repointing will be carried out where necessary with a traditional lime mortar. Removing the white paint would also return the cottage to its original finish.

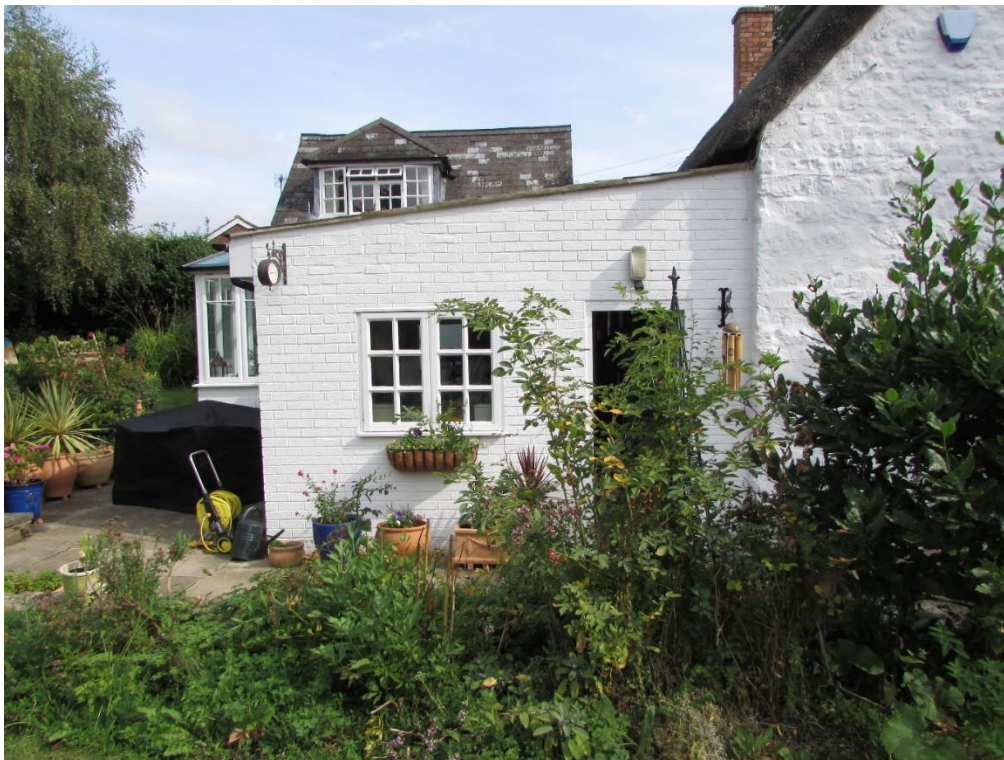
Figure 7 – Showing low pitch.

The existing conservatory is poorly insulated with large amounts of glazing which means it is prone to over heating in the summer and expensive to heat in the winter. The existing pitched roof extension at the rear has a slate covered roof, slates should be fitted with a minimum 28° pitch. The pitched roof only has a 6° pitch and as a result of this leaks. This extension had been approved in a previous planning application with the implications of the low pitch having not been considered (Figure 7).
