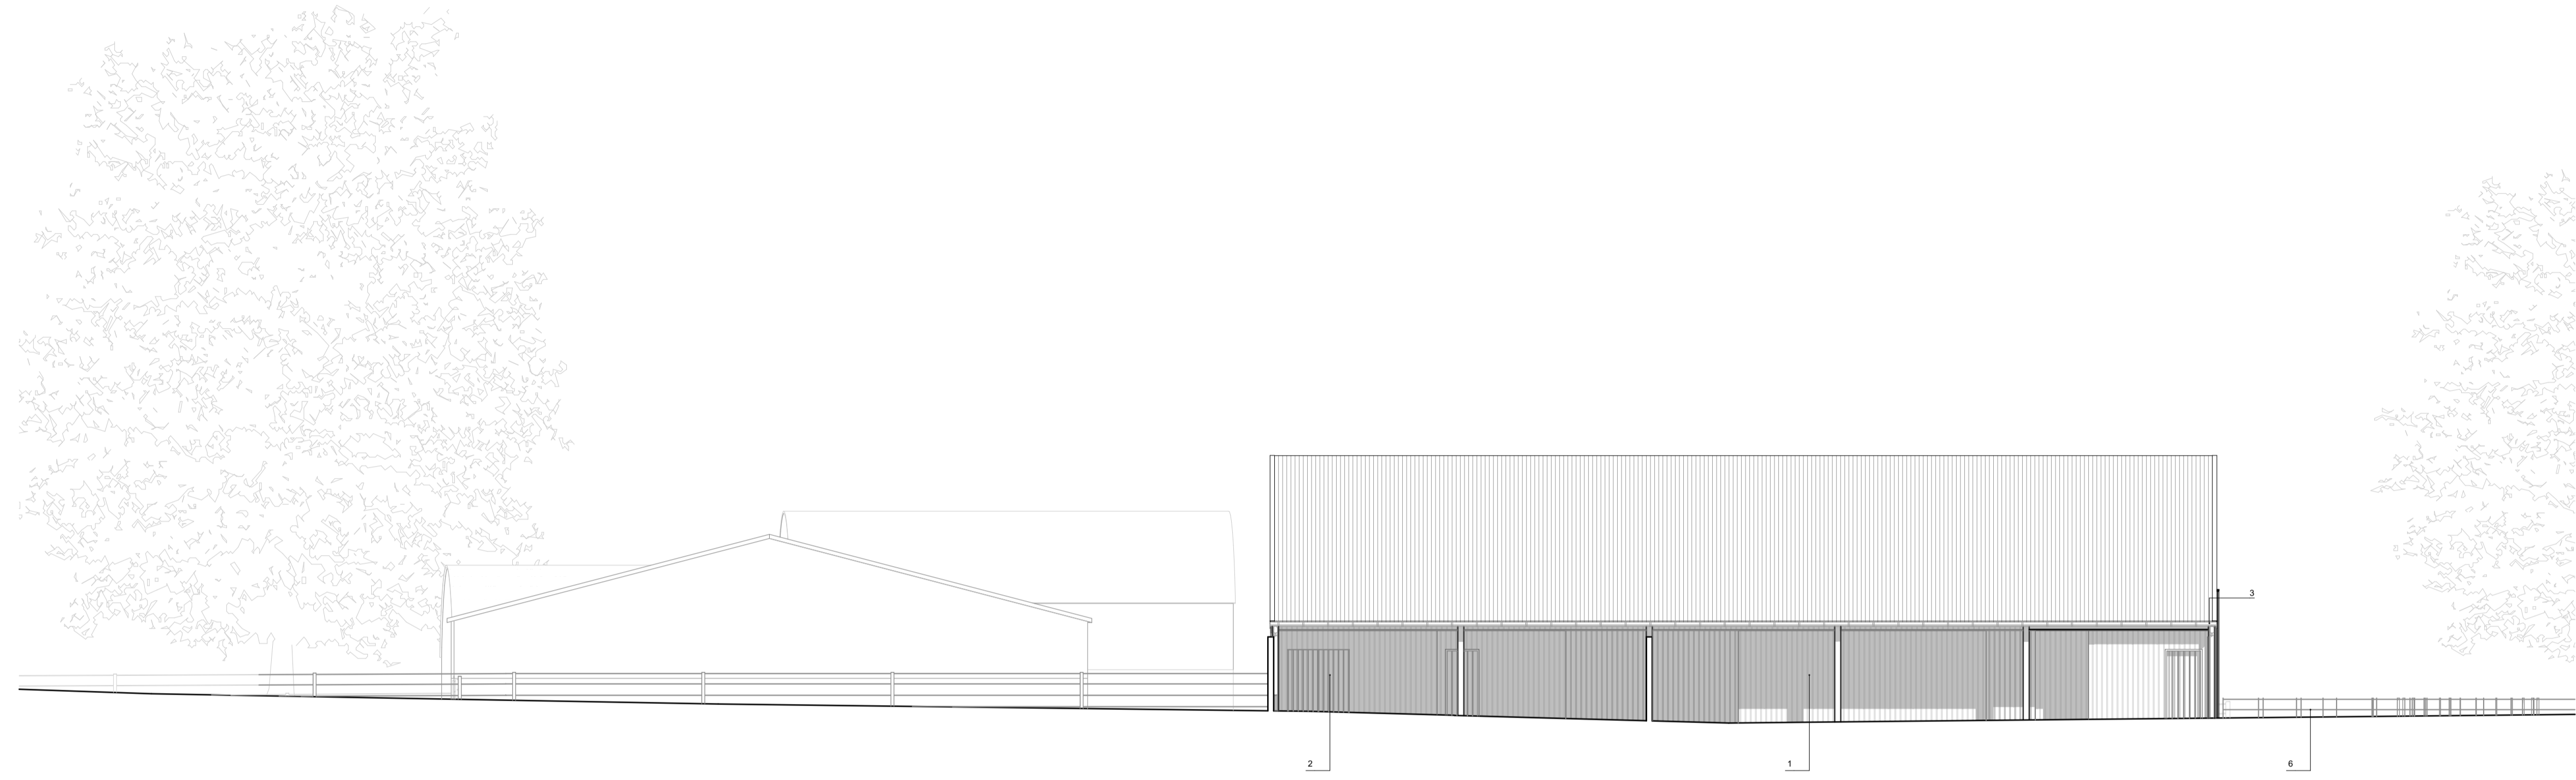
- 1. Vertical hit & miss timber cladding boards
- 2. Vertical hit & miss timber cladding boards on barn doors and window.
- 3. Steel rainwater goods to match existing
- 4. Timber fascia to match existing
- 5. Edge bracing joists between steel beams
- 6. Wrought iron fencing
