Monitoring Visit: **2** of **4**

Monitoring Plus Report

Owners name	Mrs. Julia Oakley	Suspected cause	To be advised	Monitoring type	Levels & Cracks
Address	9 Rudlands Ipswich Suffolk IP8 3RQ	Principal area of damage	To be advised	Installed	24/10/2020
Home phone		Damage category	To be advised	No of visits / weeks	4 @ 8.7
Work phone		Surface geology	To be advised	Completion date	
Correspondence address		Feedback from last visit	0		
Comment	Max movement 21.4 Focal area 0	Sketch showing location of monitoring points			
		<p>Points 7 & 8 Long screws</p> <p>Conservatory</p> <p>Garage</p> <p>Crack B</p> <p>Crack A</p> <p>EXT</p> <p>No 9</p> <p>Front Elevation</p>

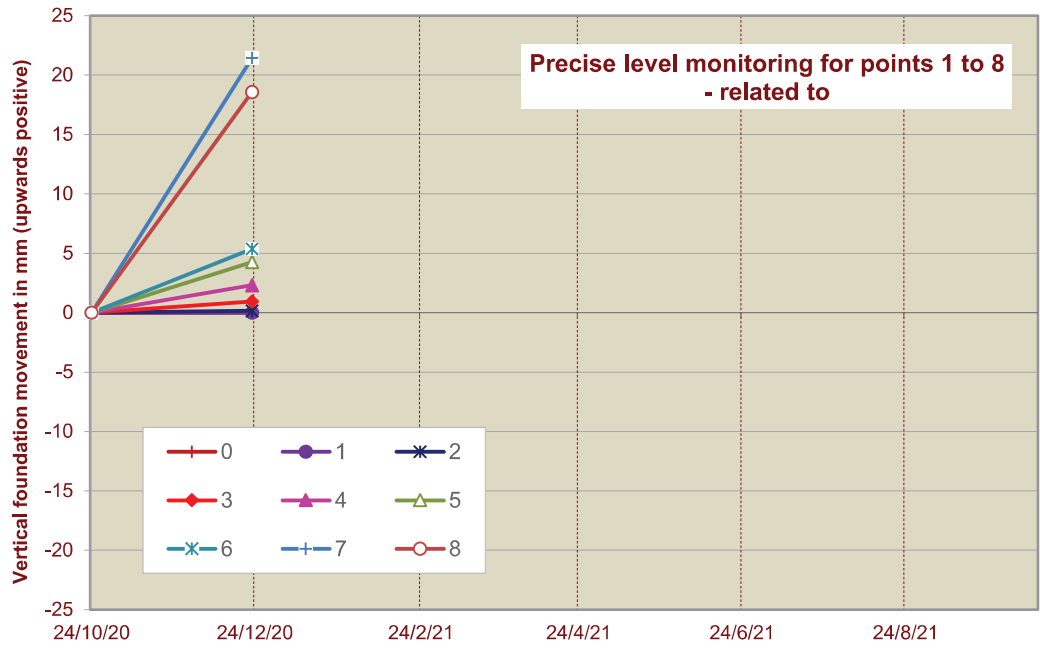
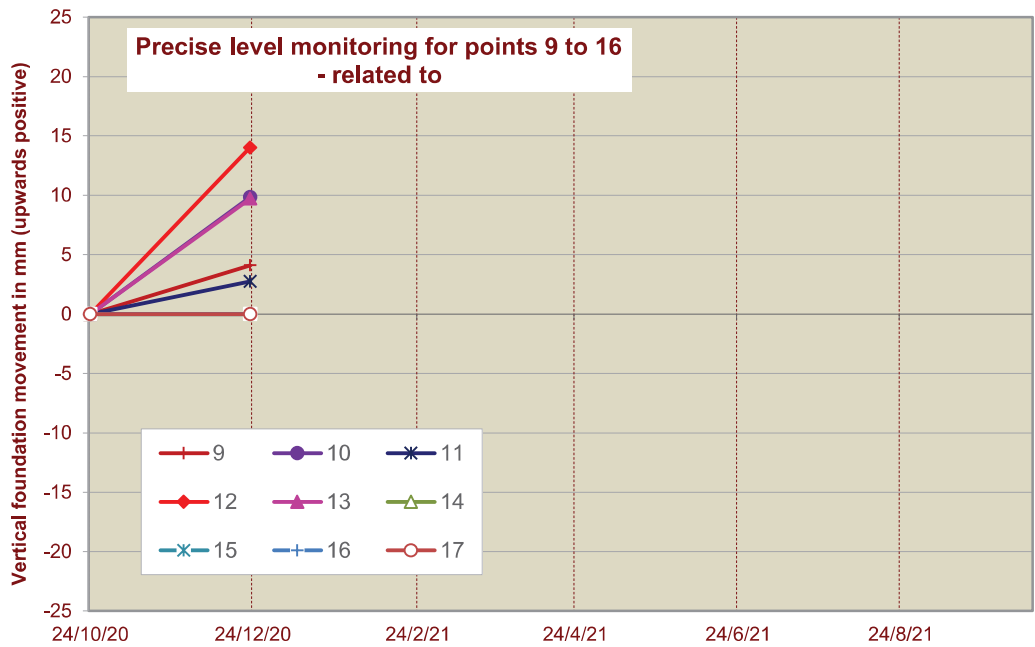
Level monitoring results

Survey: By: Date:	1 CV 24/10/2020		2 CV 23/12/2020		3		4		5	
Point ID	levels mm	<i>chngs</i> <i>mm</i>	levels mm	<i>chngs</i> <i>mm</i>	levels mm	<i>chngs</i> <i>mm</i>	levels mm	<i>chngs</i> <i>mm</i>	levels mm	<i>chngs</i> <i>mm</i>
1	1000.00	0.0	1000.00	0.0	1000.00	0.0	1000.00	0.0	1000.00	0.0
2	1007.17	0.0	1007.32	0.1						
3	1004.08	0.0	1005.02	0.9						
4	996.67	0.0	998.99	2.3						
5	990.52	0.0	994.79	4.3						
6	993.63	0.0	998.99	5.4						
7	963.16	0.0	984.60	21.4						
8	806.36	0.0	824.94	18.6						
9	738.12	0.0	742.22	4.1						
10	1093.81	0.0	1103.66	9.9						
11	1119.77	0.0	1122.52	2.8						
12	1085.02	0.0	1099.04	14.0						
13	1180.03	0.0	1189.74	9.7

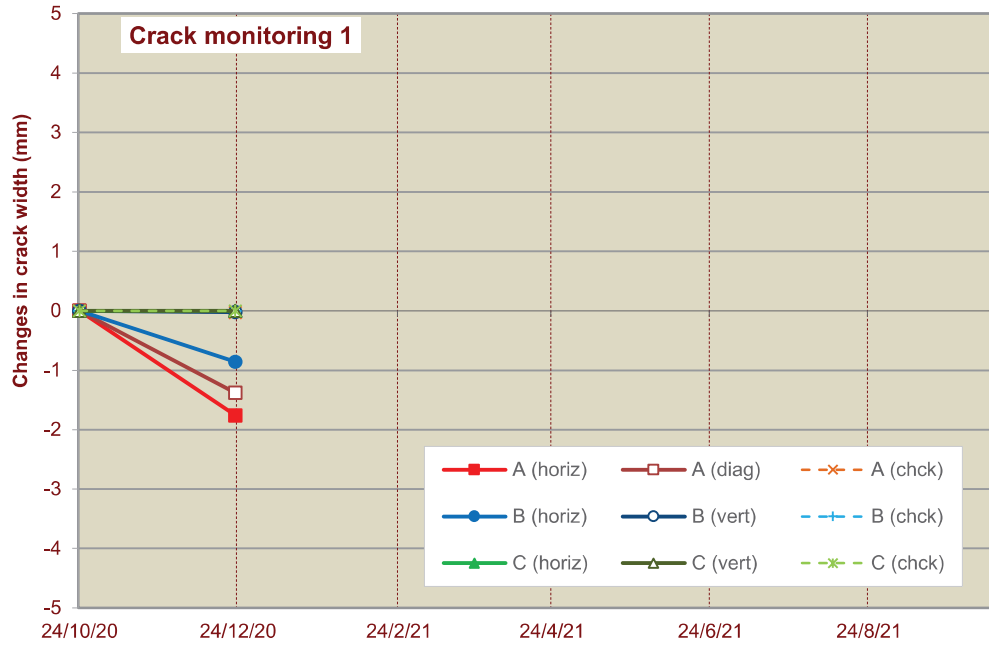
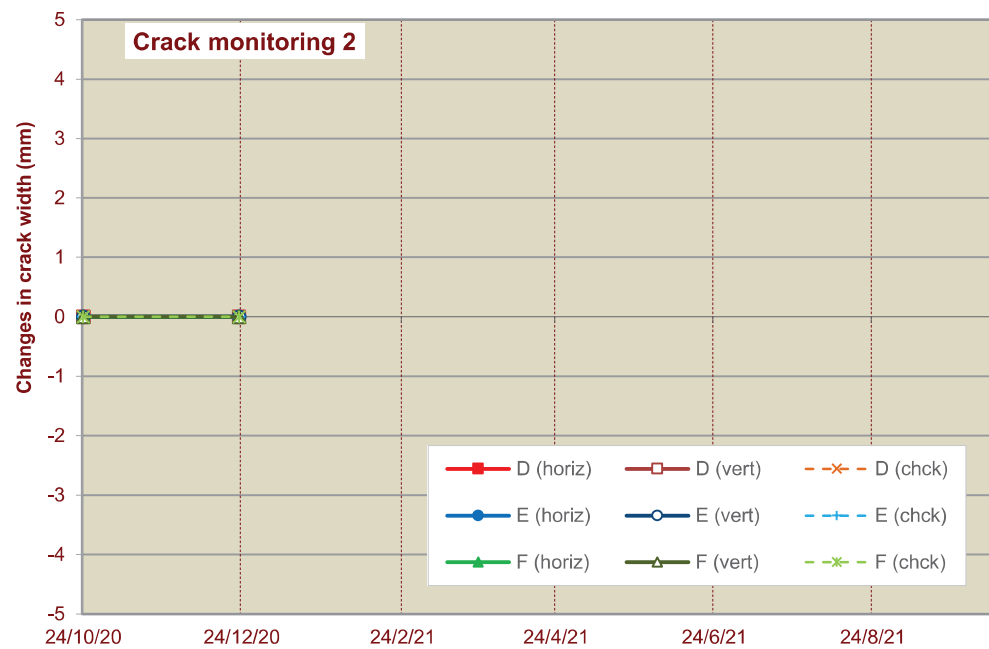
Crack monitoring results

Survey: By: Date:		1 CV 24/10/2020		2 CV 23/12/2020		3	4	5
Point ID	Initial widths mm		<i>chngs mm</i>		<i>chngs mm</i>	<i>chngs mm</i>	<i>chngs mm</i>	<i>chngs mm</i>
A (horiz)	4.5	100.91	0.0	99.15	-1.8			
A (diag)		129.80	0.0	128.42	-1.4			
A (chck)		77.13	0.0	77.10	0.0			
B (horiz)	2.8	78.66	0.0	77.80	-0.9			
B (vert)		73.68	0.0	73.66	0.0			
B (chck)		108.29	0.0	108.29	0.0

A (horiz)	Demec triplet, internal, crack below landing window
B (horiz)	Demec triplet, internal, crack above landing window
