Subsidence  
Monitoring  
Services

Monitoring Visit: 1 of 4

### Monitoring Plus Report

Owners name	Mrs. Julia Oakley	Suspected cause	To be advised	Monitoring type	Levels & Cracks
Address	9 Rudlands Ipswich Suffolk  IP8 3RQ	Principal area of damage	To be advised	Installed	24/10/2020
Home phone		Damage category	To be advised	No of visits / weeks	4 @ 8.7
Work phone		Surface geology	To be advised	Completion date	
Correspondence address		Feedback from last visit		Status	new
Comment	Max movement 0.0 Focal area	Sketch showing location of monitoring points			
		<p style="text-align: center;">Front Elevation</p>

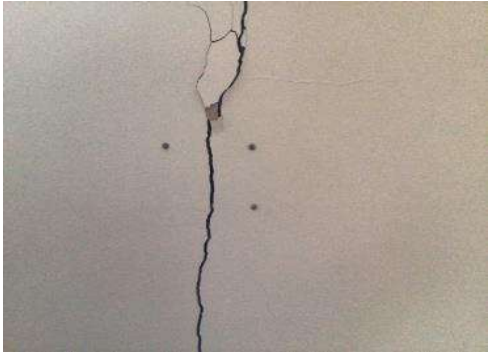
Crack A

A (horiz)	Demec triplet, internal, crack below landing window
B (horiz)	Demec triplet, internal, crack above landing window
