R & K NICE PROJECT N° NANSAWSAN COTTAGE ANNEXE DRAWING TITLE EXISTING BUILDING DRAWING N° 207-PL-02 CHECKED BY

SCALE 1:50 DATE NOV 2021

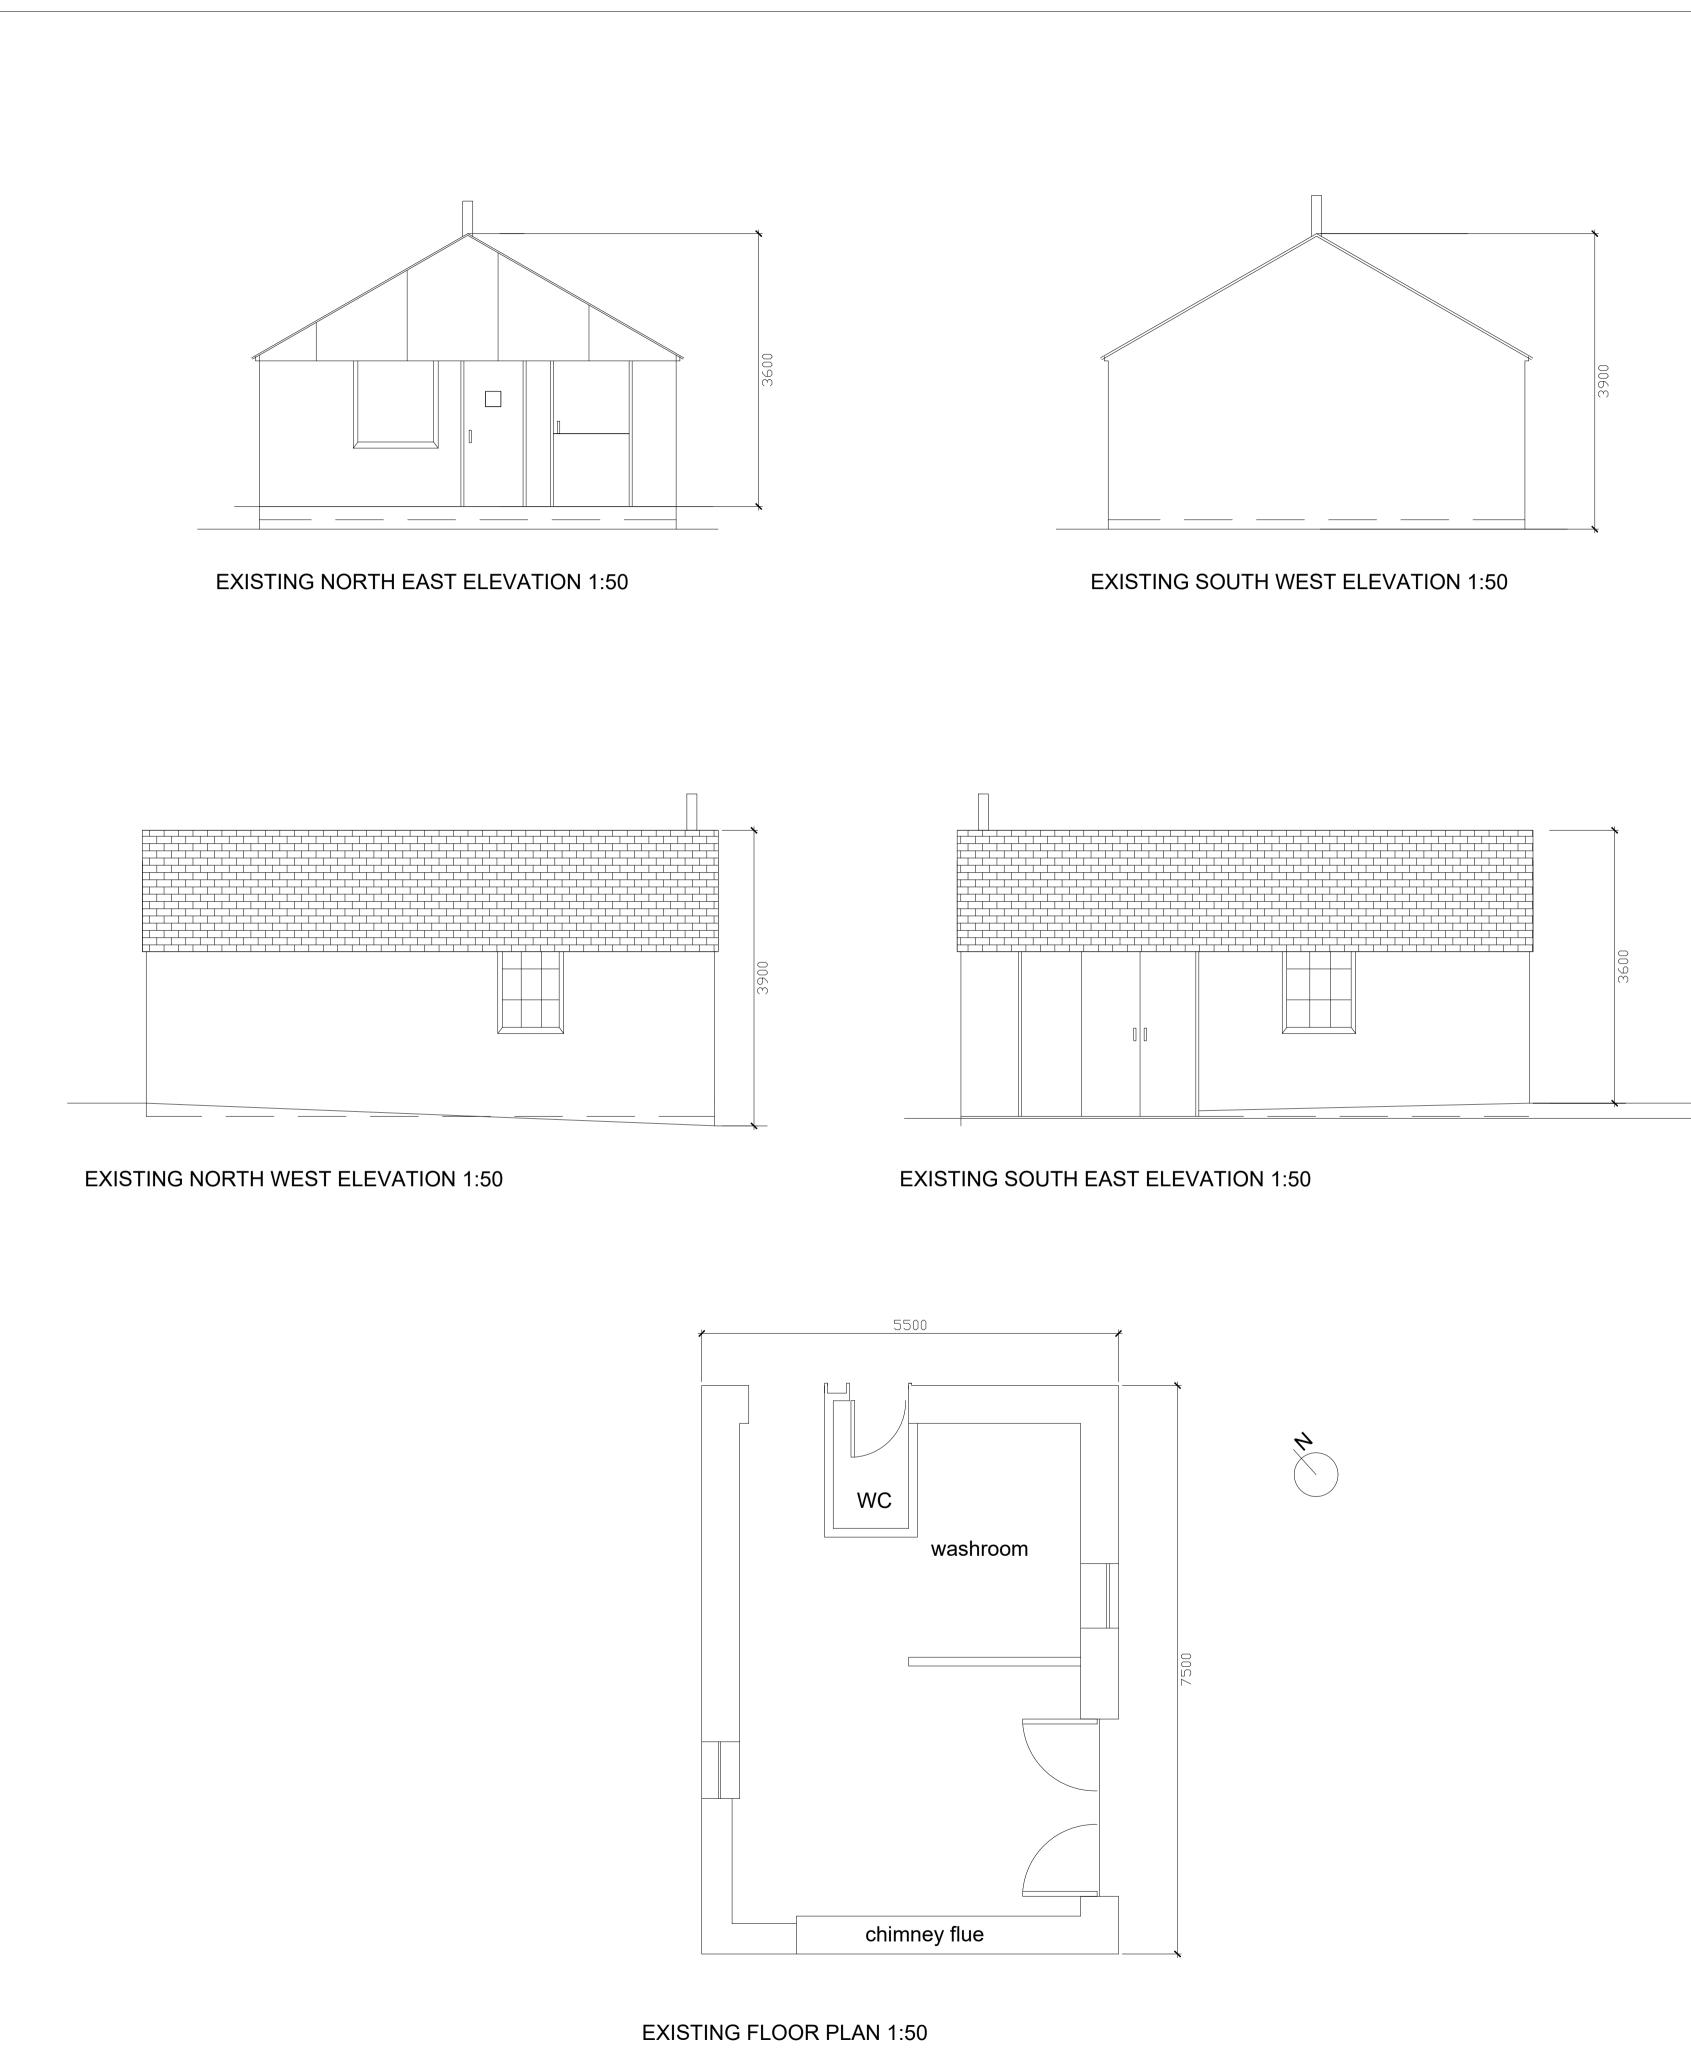
NORTH WEST ELEVATION

SOUTH WEST ELEVATION

NORTH EAST ELEVATION

SOUTH EAST ELEVATION

SOME AREAS OF SATURATED COB & STONE WALLS HAVE BEEN REPLACED WITH CONCRETE BLOCK AND BRICK (THE GABLE OF THE NORTH ELEVATION HAS BEEN REPLACED WITH A FLIMSY TIMBER FRAME & TIMBER SHEETING) . SLATE ROOFING IS NO LONGER FIT FOR PURPOSE SIMILARLY THE STRUCTURAL ROOF TIMBERS ARE ROTTEN.
