DESIGN, ACCESS AND HERITAGE IMPACT STATEMENT
EXTENSION AND ALTERATION WORKS AT
WILLOW COTTAGE, LITTLE BARRINGTON, BURFORD,
OXFORDSHIRE, OX18 4TE

Mr and Mrs Dickens

December 2021

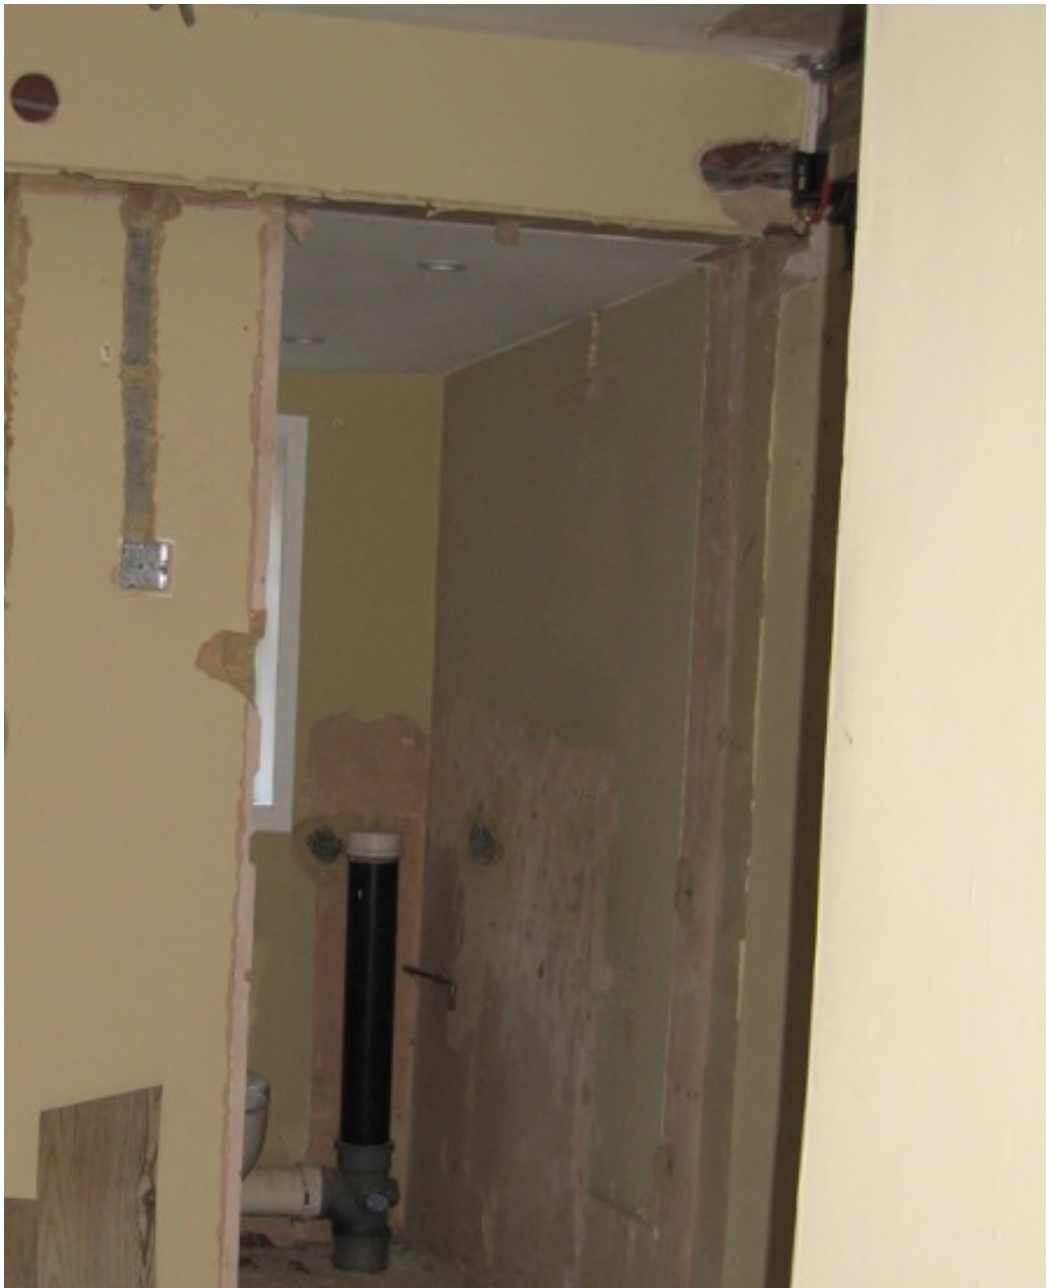
Photograph 1 Existing WC

See photograph (1) below of existing WC in partly plastered state. This was likely to have been reconstructed in the 1980s under former ownership. Note use of block work on internal wall and as lining to external walls. Steel RSJ boxed in above the internal door opening and of course gypsum plaster.

- Demolish existing, modern single storey flat roofed extension.
- Demolish two walls of the single storey WC off-shot – first suspected to have been of an earlier date but we have photographic evidence of the structure in partly plastered state which tells us that the structure, which may have earlier origins, is constructed with a block work core and may have been reconstructed (possibly circa 1980s).

- Two affected walls of the WC off-shot are of later construction or reconstruction with block work linings.
- The ground floor part of the extension is not more or less impactful on the Victorian rear range than the current extension.
