**RAMBLERS
BURLEY STREET
BURLEY
HAMPSHIRE
BH24 4DD**

**DESIGN & HERITAGE STATEMENT FOR
NEW GARAGE AND STORE**

**JOB NO: 8144
NOV 2021**

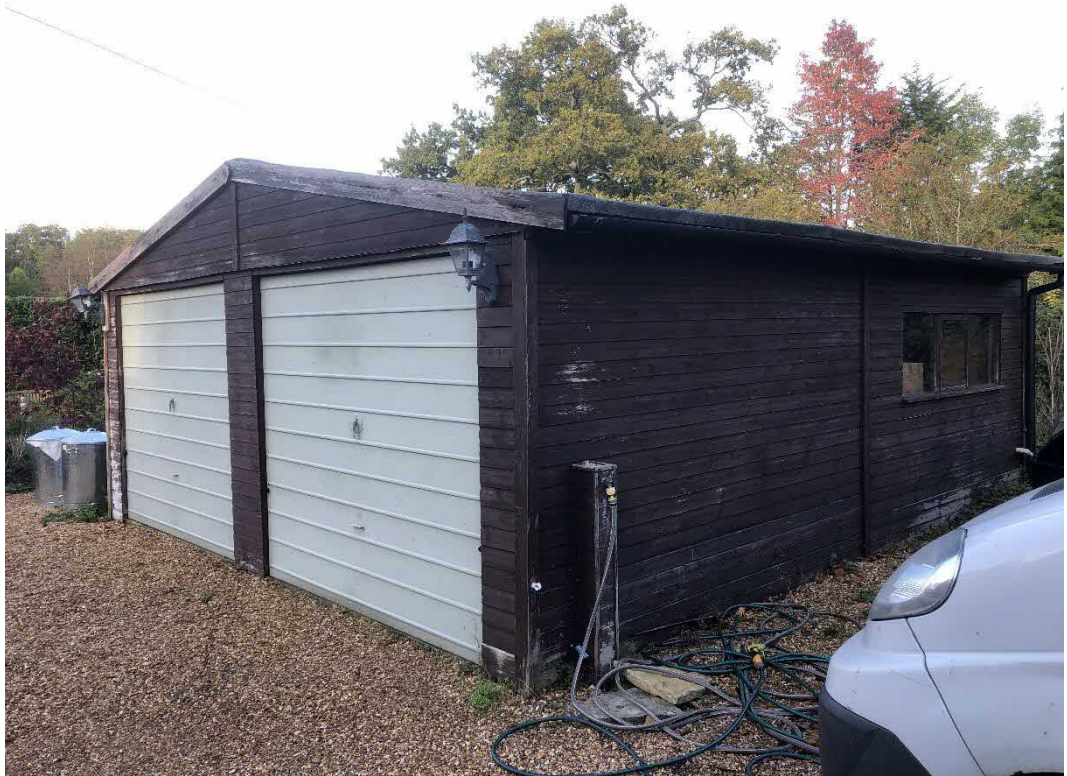
Existing timber clad garage to be replaced

Within the curtilage of the existing cottage, a double garage and workshop have been constructed with timber-clad elevations and a shallow sloping felted roof. Two garage doors face west which makes access for vehicles impossible and was no doubt affected by the construction of the north-facing kitchen extension. The design of the garage does little to enhance the setting of the listed cottage.

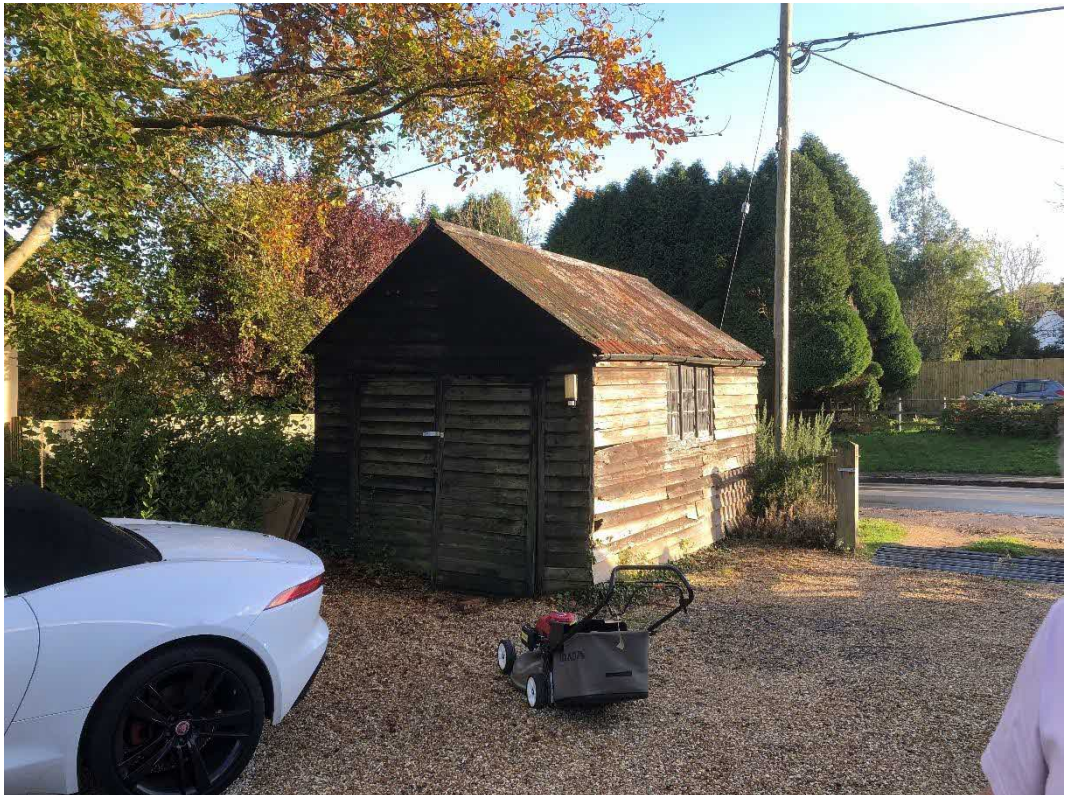
Existing shed alongside main road, to be replaced

A timber shed is located on the south boundary and formed part of a garage building dating back to circa 1850. This building was clad in timber and has a corrugated metal roof. The building is in a poor state of repair with wall timbers rotting and decaying and extensive areas of damp. The corrugated metal roof needs replacing.

- 4.2 The small timber shed facing onto the main road is not economically repairable and the applicants wish to replace this with a similar scaled timber clad structure in the same location which retains the presence of the original garage. The replacement building would have a new concrete floor with a timber framed structure with timber cladding. The corrugated roof is to be removed and replaced with a new structure with a slate roof finish. External doors and windows would be timber to compliment the cottage. The building would be used for garden storage.
