DESIGN & ACCESS STATEMENT REPLACEMENT OF CEILING – NORTH SECTION

ROBERT ADAM'S SCREEN

26 WHITEHALL, LONDON SW1A 2DY

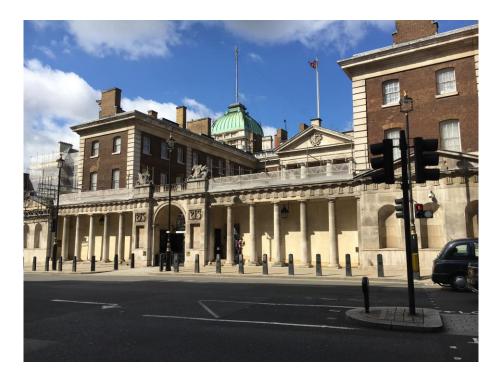
This application is for replacement of ceiling to the north section of the ceiling to the screen beneath the portico which has suffered from water ingress and was found to have previously been repaired with gypsum plaster.

The ceiling in the northern section has become water saturated beneath the hopper and this section needs to be replaced but it is proposed to replace the entire north section, removing the incorrect gypsum plaster and replacing it with lime plaster.

In addition, the Application is for the repairs to the lead hopper and outlet where the north section of the screen discharges through the existing stonework into the lead hopper which was found to have splits in it and is intended to be replaced on a like for like basis.

The replacement of the ceiling will be carried out in three coat lime plaster on EML retaining existing cornice and carrying out localised repairs accordingly. There is an allowance for replacing the cornice if this cannot be salvaged by taking a mould and reinstatement.
