## BS5837 2012 Tree Information Bryn Celyn Primary

Bryn Celyn Primary  
Caretakers House  
Pentwyn  
Cardiff

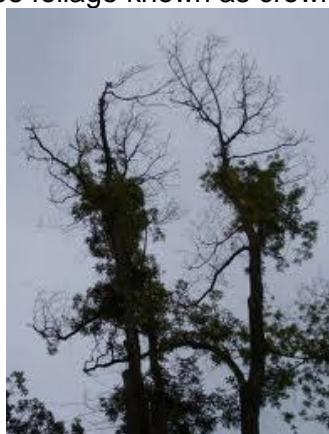
The picture to the right shows the years after the completion of a development site. Machine operators will often mention how driven over them. This is what site.

die back of foliage several years after the completion of a development site. Machine operators will often mention how driven over them or happens once they leave

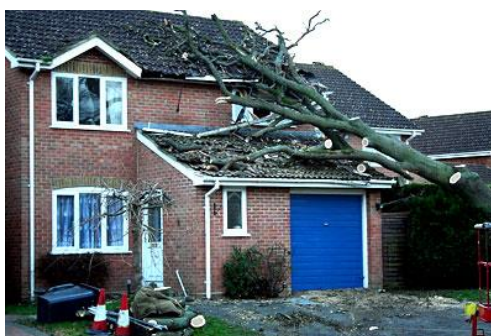
If adequate protection is not given the disaster below is not far behind!

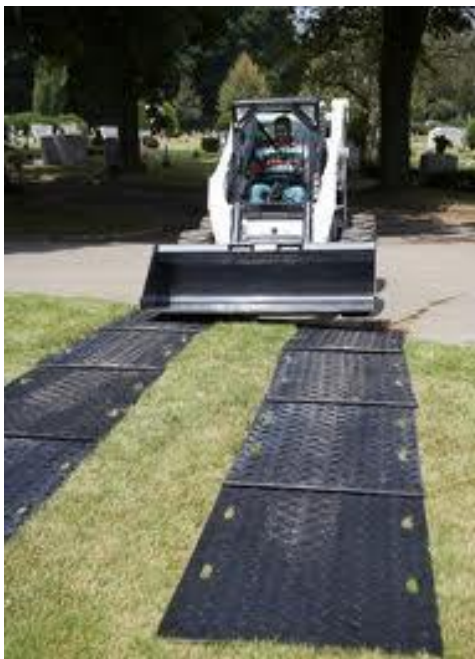
The use of ground protecting boards such as these seen in the adjacent picture should be used. Geo textile and felt may be required beneath these routes to minimize puddling of the soil surface. Should puddling occur, a capped layer may well be formed which will reduce the lateral diffusion of soil gasses and cause significant problems for retained trees.

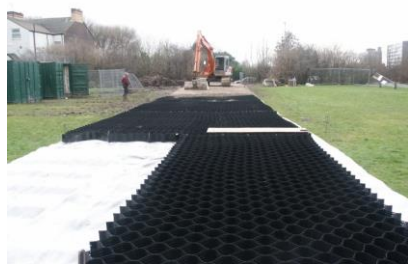
## Methods and specifications of paths using cellular confinement systems

When considering possible damage to tree roots during the applications of vehicular access and parking, the risk to trees is from oxygen depletion caused by compaction of subsoils and site clearance work damaging the soil structure and roots below ground.

1. Lay second layer of Fibretex F4M Geo textile separation fabric over the filled confinement sections.
2. Lay sharp sand bedding layer compacted with a compaction plate to recommended depth to consolidate but not compact.
3. Lay block pavers as per manufacturer's instructions.

Place 25mm layer of the granular material above the confinement system and lay the bitumen base and wearing courses.

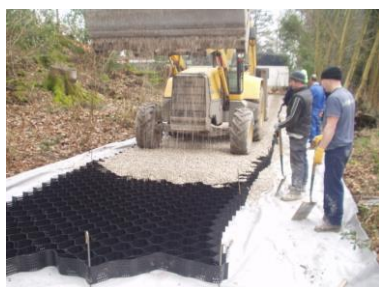
## **Cellular Confinement and Backfill Material.**

Expand the confinement systems 2.56m wide panels to the full 8.1m length. Pin the panels with staking pins to anchor open the cells and staple adjacent panels together to create a continuous mattress. Infill the cells with a no fines angular granular fill (typically 40-20mm) within each open cell. The use of cellular confinement reduces the bearing pressure on the subsoil by stabilizing aggregate surfaces against rutting under wheel loads. Comparisons between cellular confinement and traditional aggregate and geo grid-reinforced structures

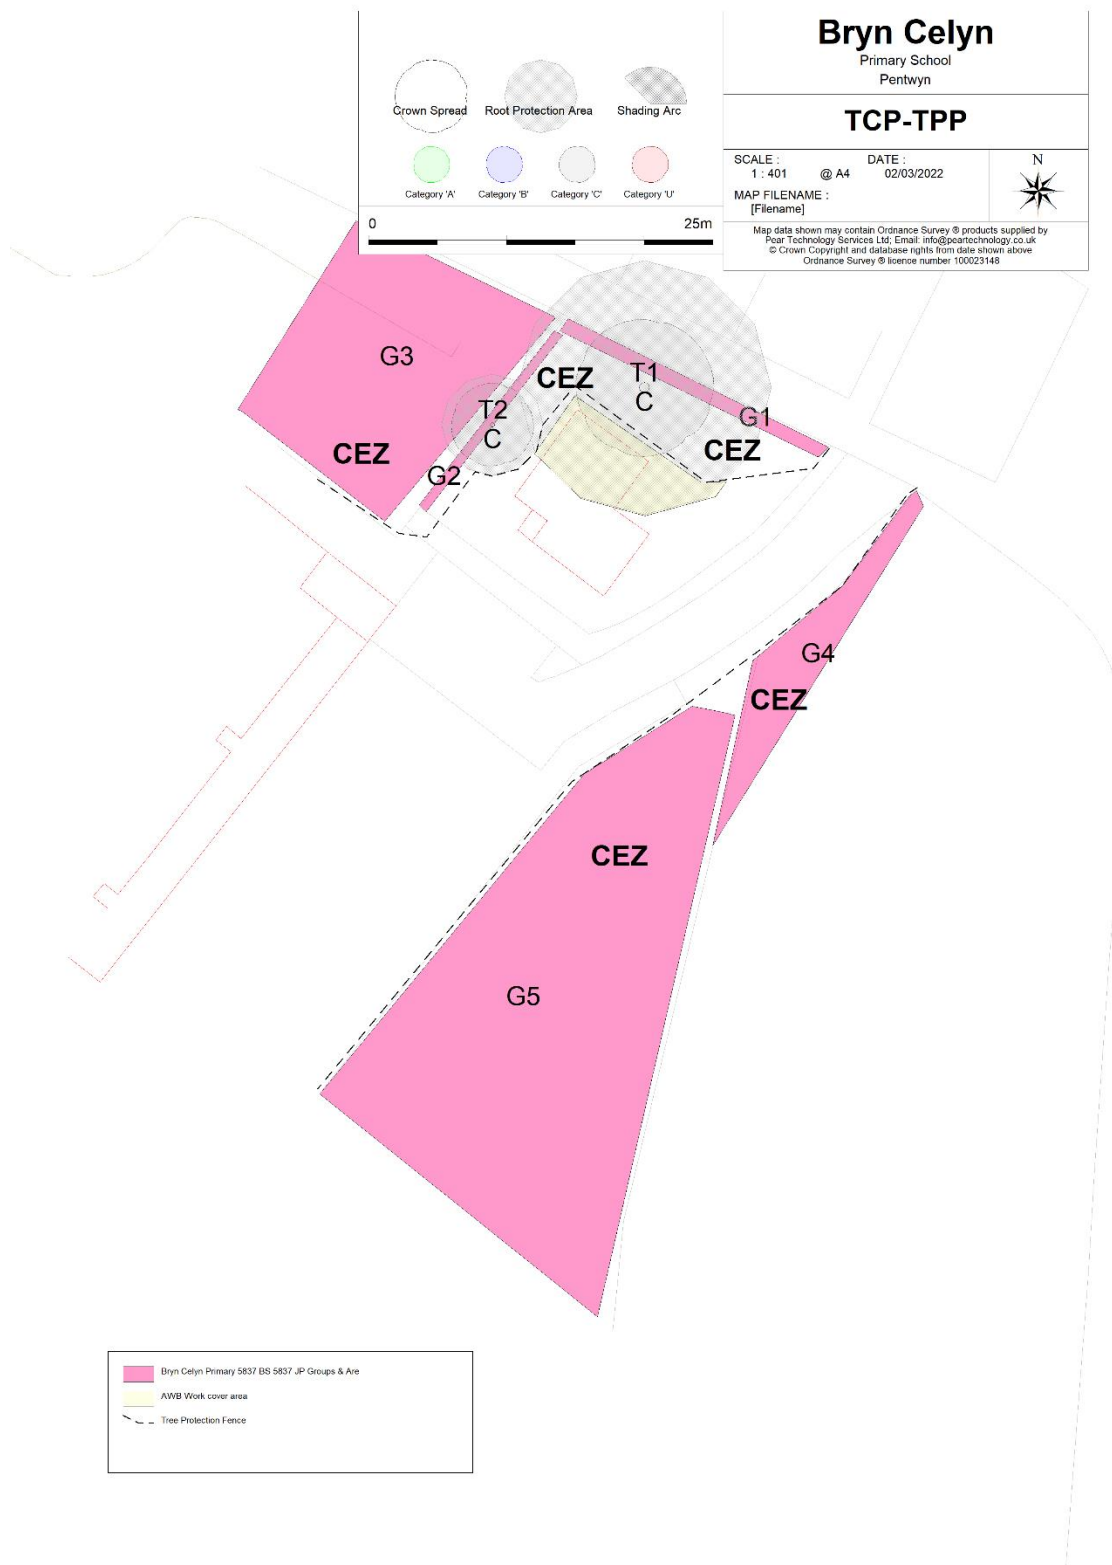
Site Plan screen grab – please see scale pdf plan also

The theoretical rooting area of T1 extends under the existing house. This means that an arboricultural watching brief should be present when the footings/slab are removed. This is to ensure that T1 does not suffer any adverse root damage. This caution zone is shown in yellow on the site TCP-TPP plan.

Scale plans can be sent as PDF files if required. The plans are to indicate locations of trees, locations of main objects on site and the location of tree protection fencing. Stem diameters found in tree and tree group data tables should be used to mark out the location of root protection fencing on site.
