GROUND FLOOR

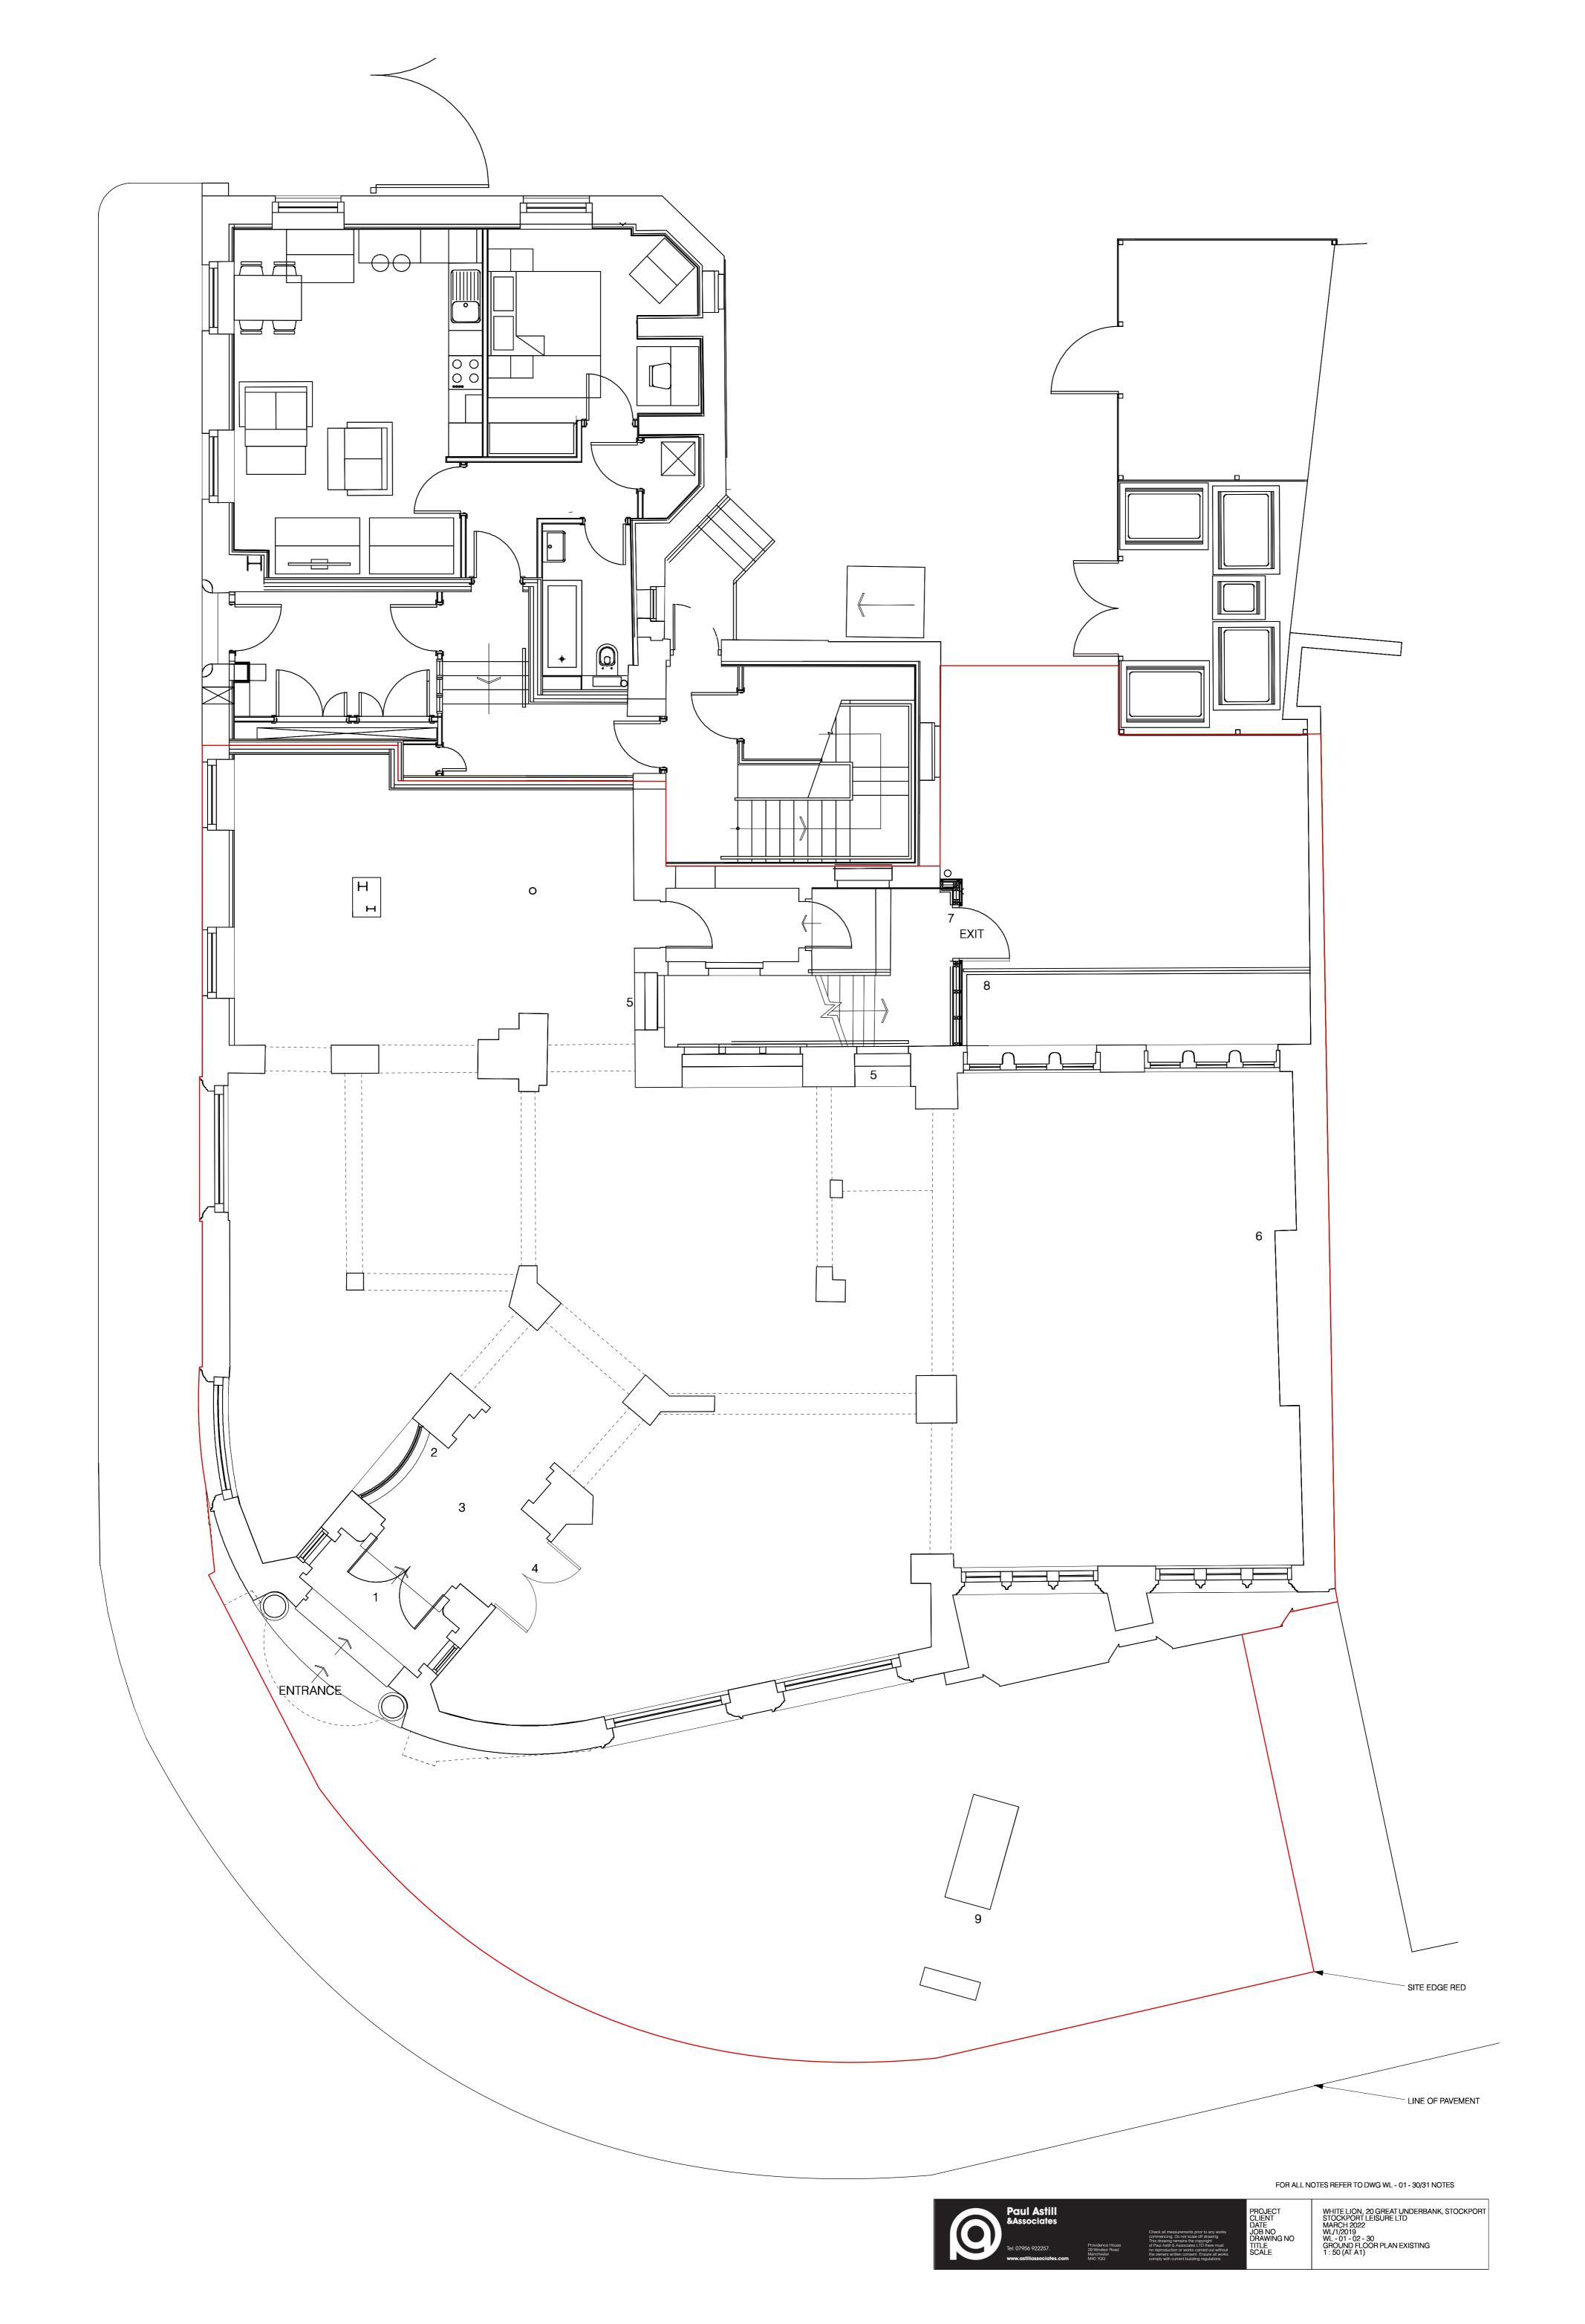
- 1. ORIGINAL ENTRANCE DOORS
- 2. ORIGINAL TIMBER PANELS AND WINDOW TO ENTRANCE
- 3. FLOOR OF ENTRANCE AREA WITH PROTECTIVE BOARDING
- 4. NONE ORIGINAL PLAIN DOORS
- 5. EXISTING BRICKED UP WINDOW.
- 6. BRICKWORK FIREPLACE WITH FIREPLACE REMOVED BROUGHT BRICKWORK AND SVP PIPE RUNNING DOWN SIDE.,
- 7. NON ORIGINAL REAR DOOR WITH GLAZED PANEL.
- 8. LIGHT WELL WITH GLAZED BRICKS TO WALLS, STONE PLINTH TO RAILINGS AT GROUND FLOOR AND NON ORIGINAL STEEL RAILINGS BLACK PAINTED FINISH.
- 9. TRADITIONAL PHONE BOXES RED PAINTED FINISH (LISTED) BT TELEPHONE EXCHANGE FREESTANDING GREEN FINISH

- ALL WINDOWS NON ORIGINAL TIMBER FRAMES WITH ORIGINAL STAINED GLASS PANELS RE-USED BUILT INTO DOUBLE GLAZED UNITS. PAINT FINISH IN WHITE.
- CEILING NON ORIGINAL OVERBOARD WITH FIRE LINE BOARD THROUGHOUT NOT DRYLINED OR PAINTED.

FLOOR WITH SECTION OF MOSAIC TILES TO ENTRANCE, SOFTWOOD TIMBER IN POOR CONDITION AND POT AND BEAM.
- INTERNAL WALLS BOARDED WITH FIRELINE BOARD NOT DRYLINED OR PAINTED.
- EXTERNAL WALLS UNFINISHED EXPOSED BRICK.

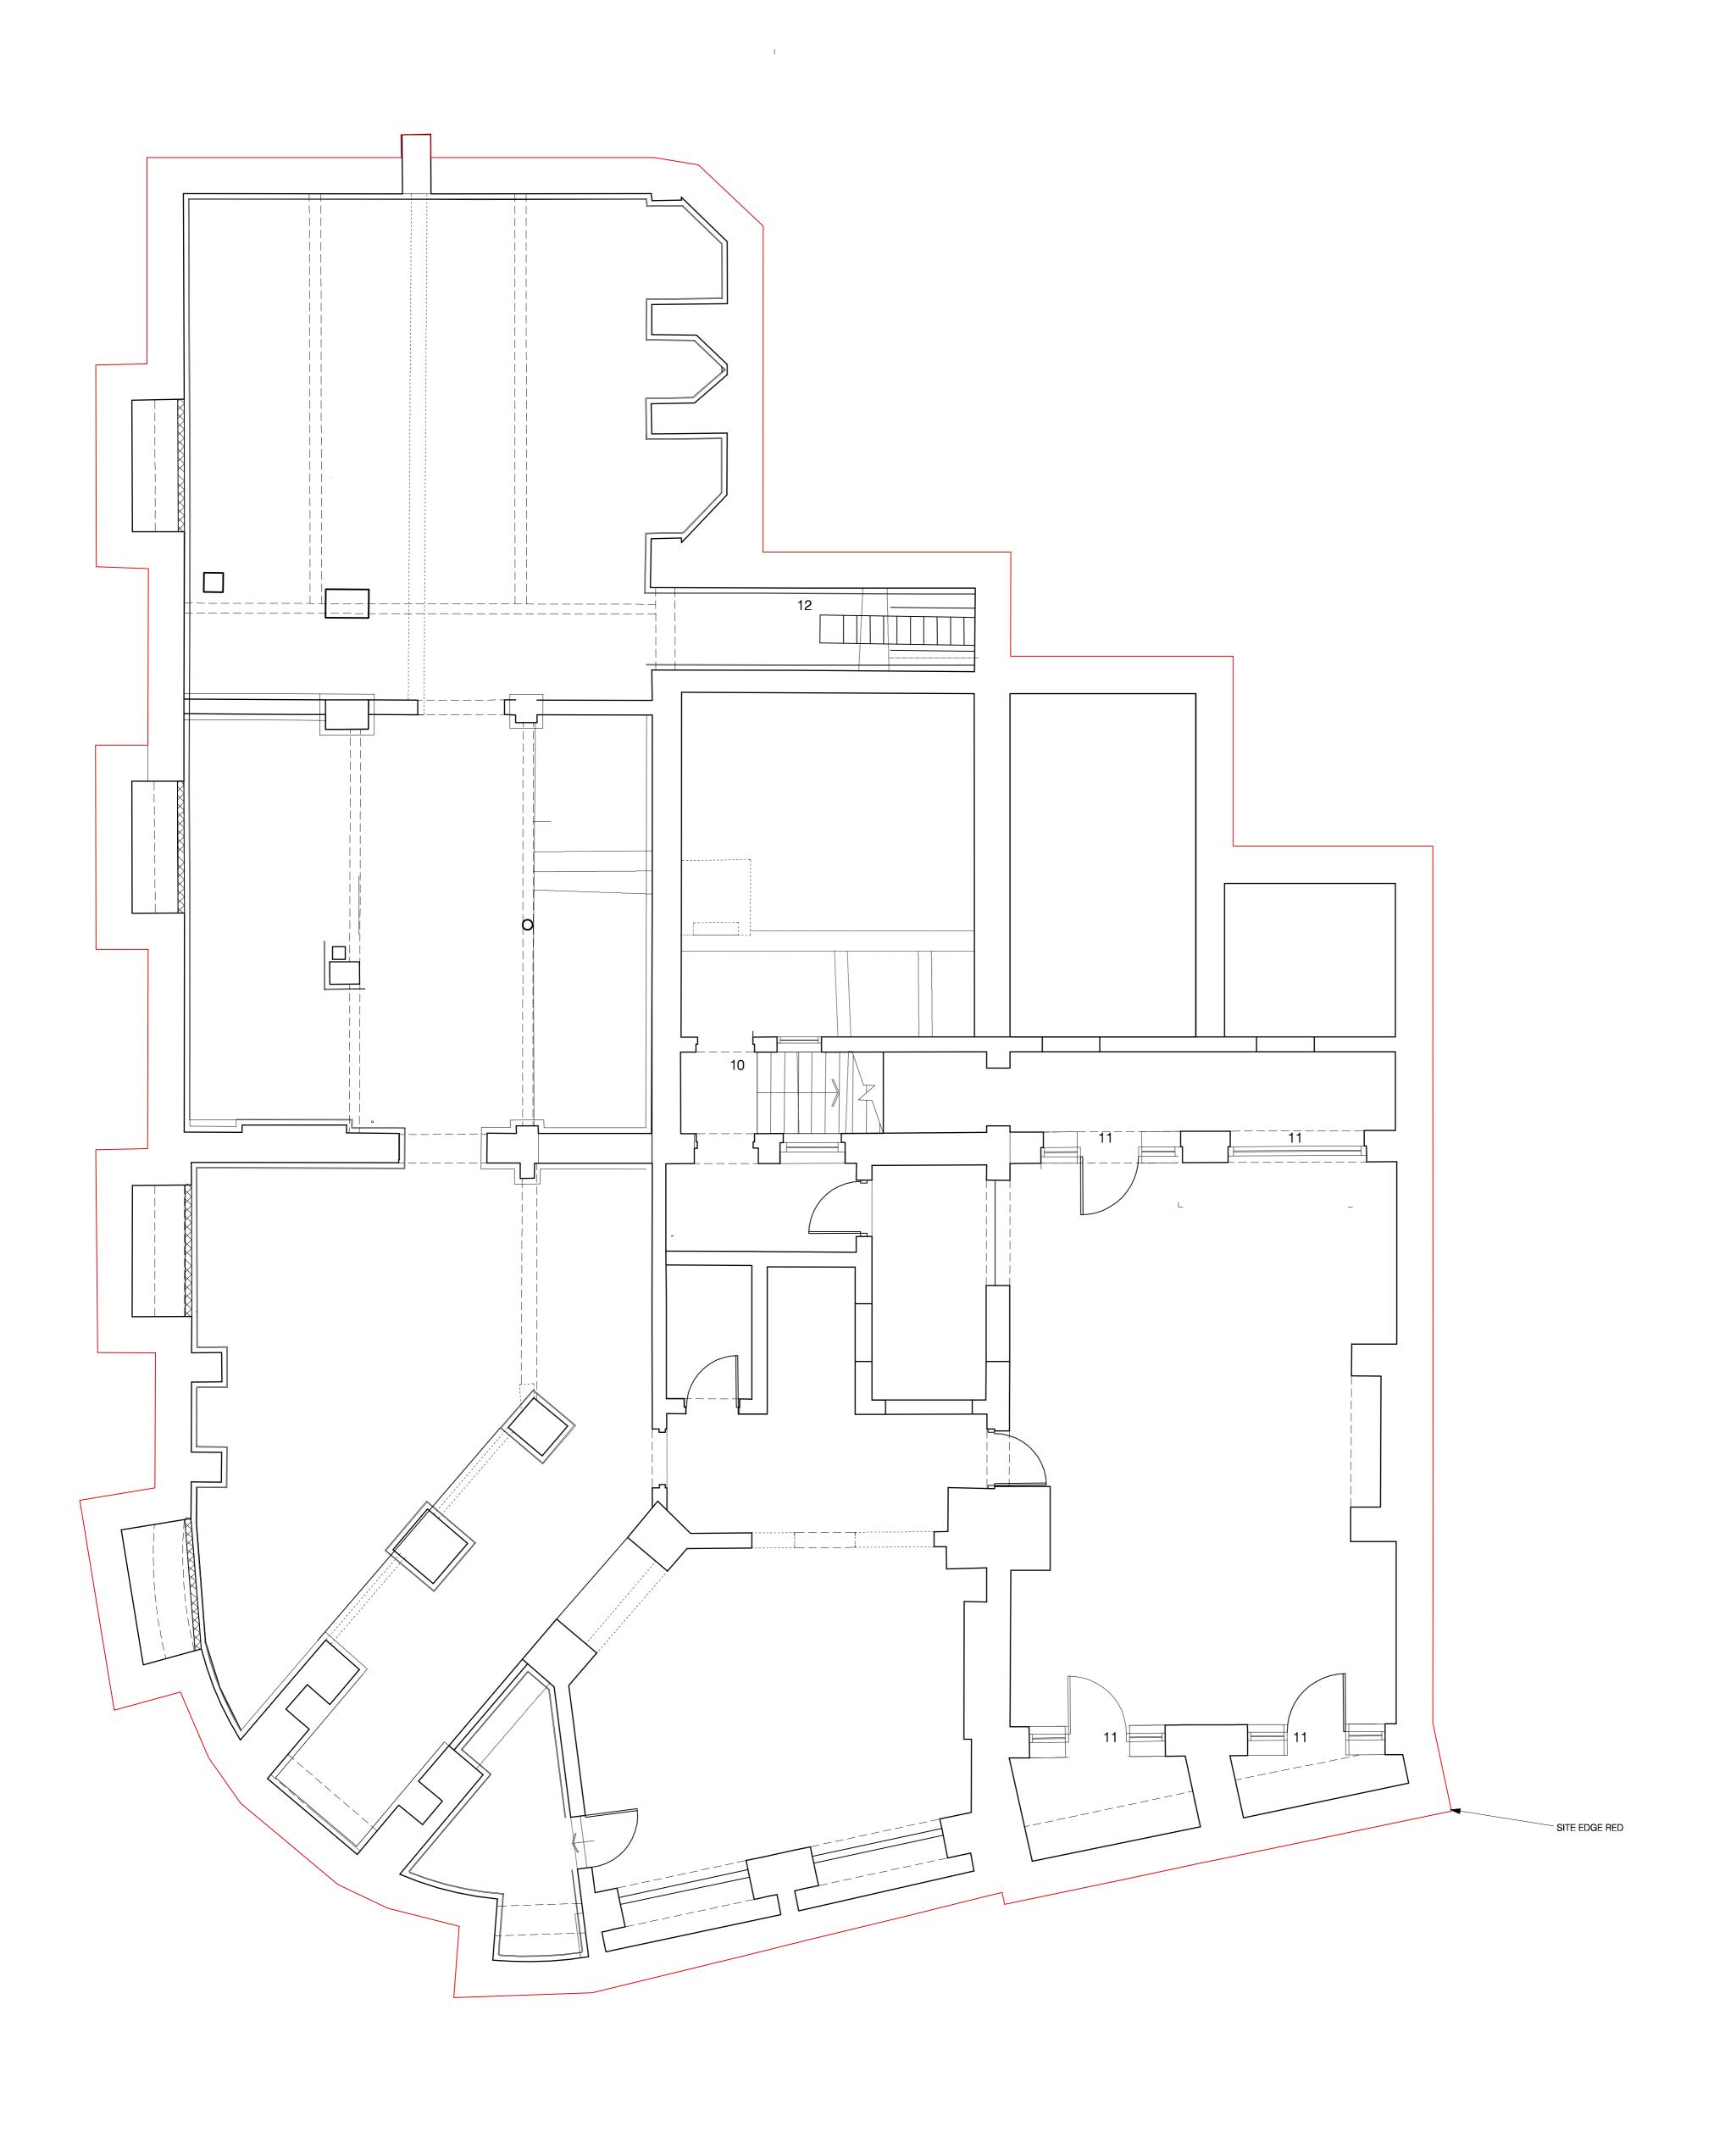
NOTES TO BASEMENT FLOOR

- 10. EXISTING STONE STAIR TO BASEMENT 200MM GOING TO 200MM RISE DANGEROUS FOR PUBLIC USE.
- 11. NON ORIGINAL TIMBER WINDOWS AND DOORS WITH WHITE PAINTED FINISH AND DOUBLE GLAZED UNITS.
- 12. ORIGINAL CONCRETE BARREL DROP WITH NON ORIGINAL STEEL DROP DOORS TO GROUND FLOOR

MOST EXTERNAL GLAZED BRICK WALLS TANKED AS PART OF PREVIOUS APPLICATION AND BUILD.

BASEMENT FLOOR CONCRETE

BASEMENT CEILING ORIGINAL WITH EITHER CONCRETE FINISH OR EXPOSED BEAMS WITH VISIBLE FLOORBOARDS ABOVE.
