## Method Statement for Ashlar Indent Repairs

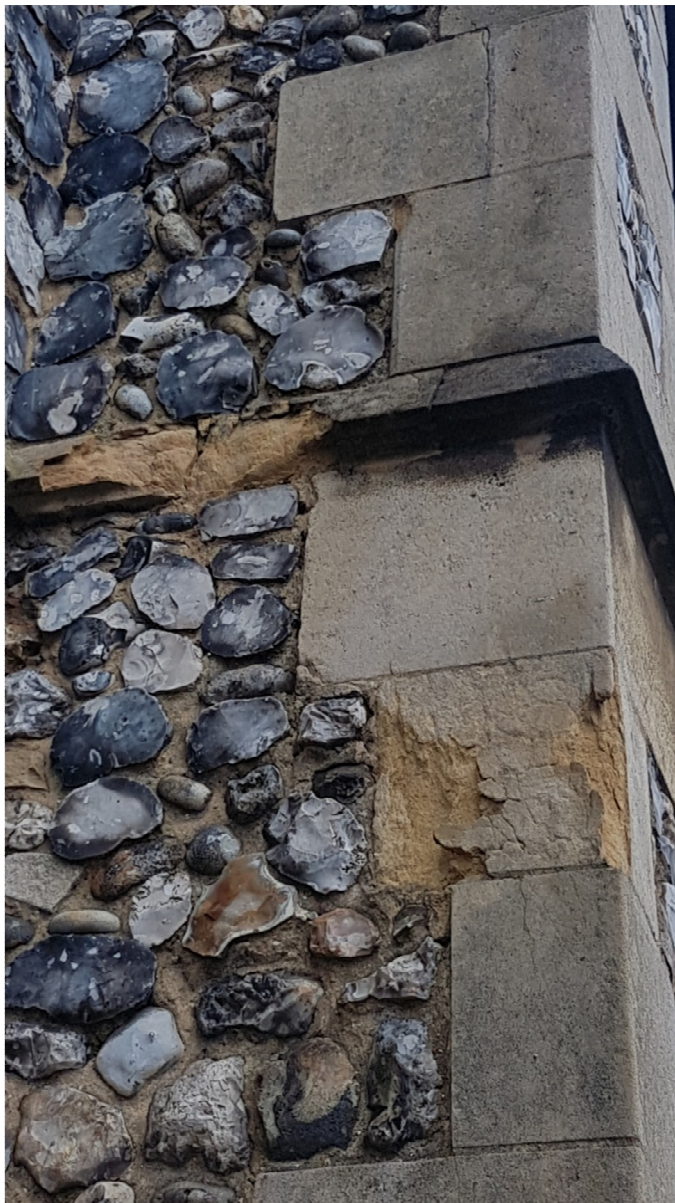
It is quite possible that stone b) has been laid end-bedded so that the exposed side face has become face-bedded allowing most of the face to be worn back nearly an inch.

For indents the damaged surface must be carefully prepared. Lack of surface preparation and lack of adequate reinforcement or armature are two of the most common causes of failure of past repairs. The stone surface should be cut back to sufficient depth that the indent will remain safely in place and the edges of the repair cavity undercut to hold the repair.

Although it is often possible in the case of larger indent repairs to use mechanical (disc) cutters to remove the bulk of the damaged stone, the final dressing of the repair cavity, the back and sides, should be done by hand with sharp masonry chisels to form well-cut, neat edges to the repair. The interface between a stone indent and repaired stone should be very fine, not a masonry joint, for maximum durability. Good indent repairs require a high level of masonry skill.

Stone indents to exposed edges, for example on the nosings of cornices, steps, and copings, should be dovetailed in place to secure them. In general, indent repairs should be anchored by dowels (normally corrosion resistant stainless steel or phosphor bronze) inserted into fine drillings into the indent and the back of the repair cavity, and bonded with resin designed for this application. Resin should be used in the drilling only and not smeared across the stone surfaces at the interface.

Lime grout is the appropriate material for bonding the stone interface, which must be completely filled to avoid rainwater penetration using grout specifically designed to suit the exposure, stone type and colour.
