Method Statement for Flintwork Repairs

Description of existing 1906 Wall

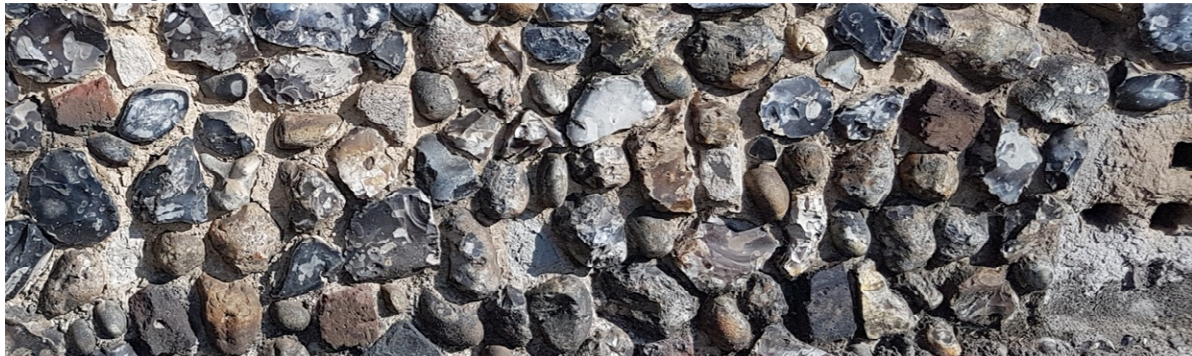
Red-brick backing wall of solid construction with projecting bath stone dressings as ashlar forming plinth, cill, lintel and jambs as well as ledger stones to break up deep sections of the flint. Stone joints are fine e.g. from 3mm to 5mm. Between these stone dressings the flint work is laid in a random 'artistic' style, that is it is not coursed and is very irregular with pebbles, un-knapped flints, knapped flints (of different colour) and flints knapped to square or oval shapes as a mix of large and small with small fragments of brick and stone in the mix. The joints are not especially tight.

The existing mortar is of rather fine aggregate, becoming loose and dusty. Where flints have come away it is clear that the depth of the flint facing is quite shallow with tails from the flints sometimes touching the brick backing and poorly bonded allowing trapped moisture to settle in pockets against the inner wall.

It has been noted that in character, the plinth section contains many rounded pebbles and there are very few in the upper levels. Also the pointing has been taken close to the face of the flints at the top of the building under the protective eaves overhang and gives a helpful model for the depth for new pointing to aim for.
