Carrycoats Hall Garden Room & Terrace 2032

HERITAGE STATEMENT

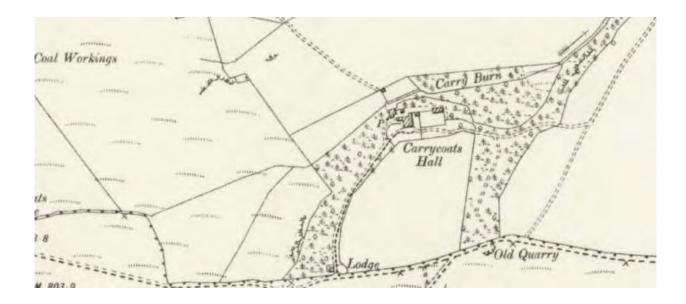
Apart from minor changes to the interior of the buildings these are currently similar to how they were constructed. Various C19 outbuildings and walls were added to the north and east which are curtilage listed, and the layout as shown on the 1888 – 1913 6" to 1 mile map below is unchanged.

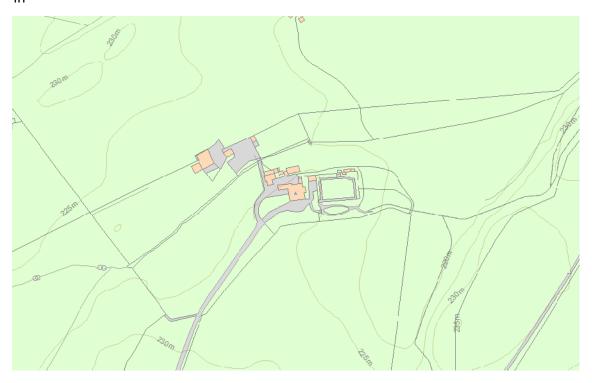
House. C16/C17, early C18 and 1830's. Oldest parts are random rubble, the rest ashlar. Welsh slate roofs. 2 storeys. 3-bay front of 1830's with rusticated quoins. Gabled and recessed centre bay has 6-panelled door with overlight in possibly re-used C18 architrave. Moulded continuous cornice above and panel with crest of Shafto family. Narrow flanking windows in architraves. Outer bays have shallow square bay windows with 2-light windows in

HERITAGE STATEMENT: CARRYCOATS HALL GARDEN ROOM & TERRACE architraves. 12-pane sash to each light. First floor has 12-pane sashes with cornice and architrave. 2-light window above door. Similar decoration on returns but rear bay has C18 masonry and the remains of ground and 1st floor sill bands.

Older building incorporated in house to rear, possibly a bastle house, has walls c3ft. to 3ft.6 inches. Also further C17 and C18 masonry. Various windows C18 and early C19. Gabled roof with ridged coping,kneelers, ball finials and stone corniced ridge stacks.

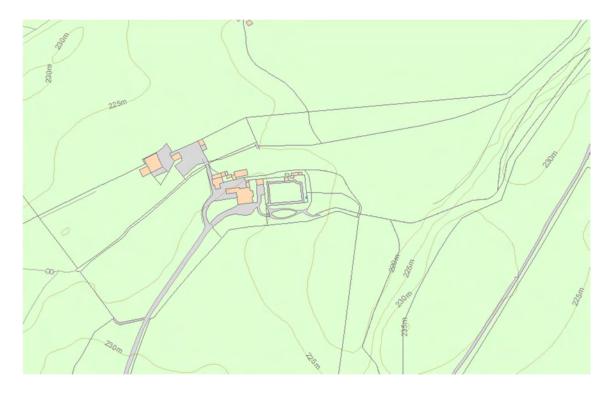
GARDEN WALL EAST OF CARRYCOATS HALL

Garden wall. C18. Random rubble and brick. Round 2 sides of garden. c12 ft. high, but ramped to lower section on east side. Flat coping. South face lined with brick in English garden wall bond and pierced by plank door with brick segmental-arched doorway. Lower east wall is brick only.

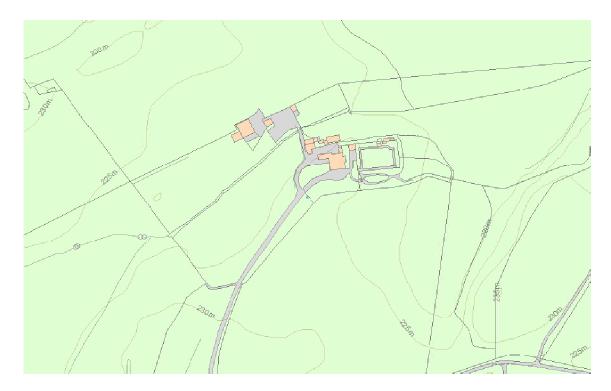
GARDEN WALL AND GATE PIERS SOUTH-WEST OF CARRYCOATS HALL

Garden wall and gate piers. Early C19. Dressed stone. c5 ft. high with flat coping. Ends on left with quadrant walls leading to square gate piers with shallow pyramidal caps.

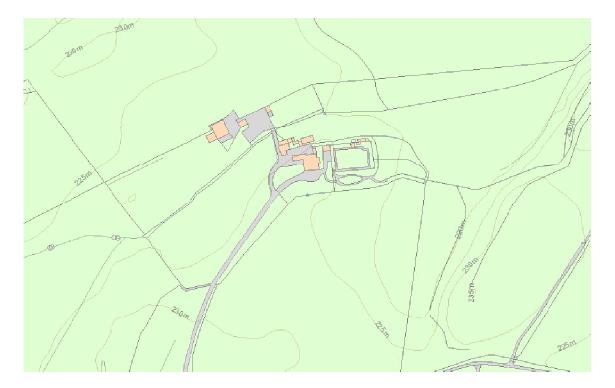
BELVEDERE RETAINING WALL C30 YARDS SOUTH AND EAST OF CARRYCOATS HALL

Belvedere wall, acting as ha-ha wall on south. Early C19. Dressed stone with steeply-chamfered coping. Broken on east side by steps flanked by square piers with ball finials.

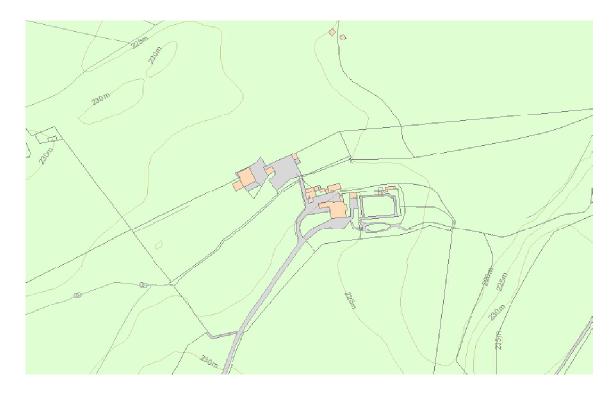
STABLES AND GROOM'S COTTAGE C20 YARDS NORTH-WEST OF CARRYCOATS HALL

Stables with carriage house and groom's cottage. 1830's. Ashlar with Welsh slate roof. 2-storey carriage house with single-storey cottage to right and lean-to stables to rear. L-shaped. Projecting carriage house has double plank doors in segmental-arched chamfered surround. Pitching door with chamfered surround above. 12-pane sash with similar surround on right return.

2-bay cottage to right has plank door and 6-pane sash, both in similar surrounds.

Gabled roof with ridged coping and kneelers. Stone corniced end stacks.

Stables to rear have 2 stable doors and 2 windows with similar surrounds.

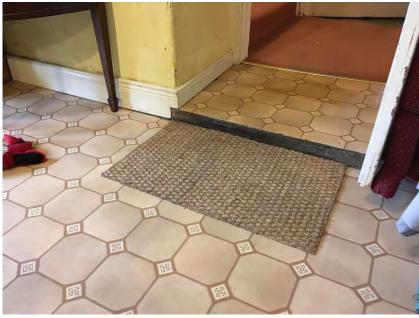
Photo 11 Vinyl flooring to kitchen over cement screed with 90mm step up.

- 12. Removal of approximately 90mm of C20 concrete in kitchen will return the floor to its original level, leaving a full 160mm step up to the north wing.

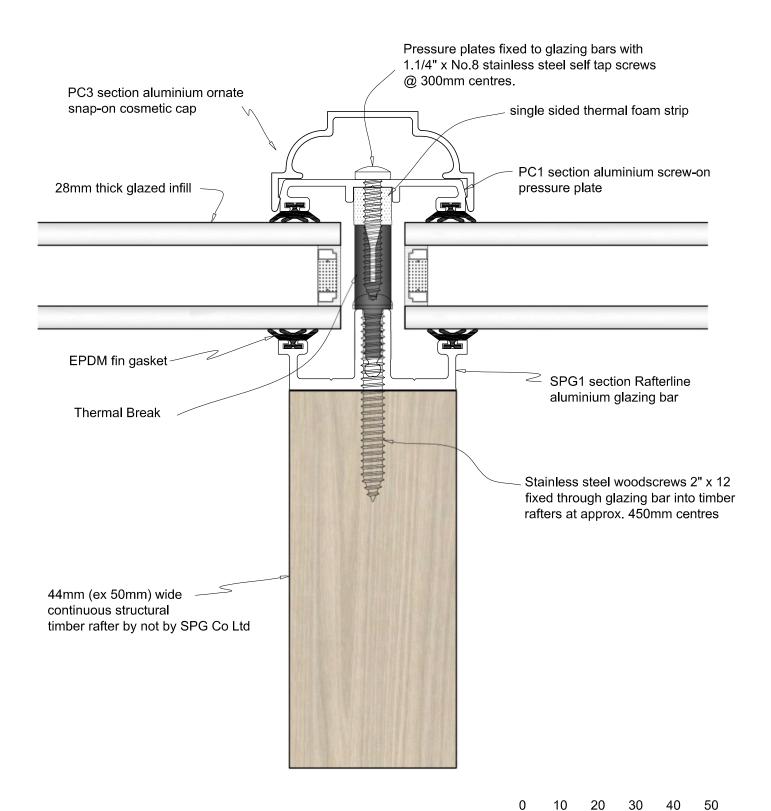
$Drg\ No.\ RD-1021$ < use this ref for downloading from our website

Title : Rafterline Glazing details Section through Double Glazing bar Scale: 1:1

- 6. The new roof will be finished in Welsh slate to match that on the Hall. The double glazed ridge light will be low profile and finished with lead flashings by The standard Patent Glazing Company (see Appendix 7.3). The roof will be supported on 4No. 100 x 75mm rectangular hollow steel portal frames which are to be built into the new stone piers on the south elevation and support the new roof structure (see section 2032 L15). These will be fixed through plates with removable anchor bolts into the south elevation of the north wing adjacent the walk-in lead gutter. (There will be no fixings required into the Hall west gable as the roof will be supported on the easternmost truss). This gutter will be laid to fall to west, have 2No. drips and be lined in Code 7 lead (see roof plan 2032 L16). This will provide access to maintain the wall, windows and gutter above.

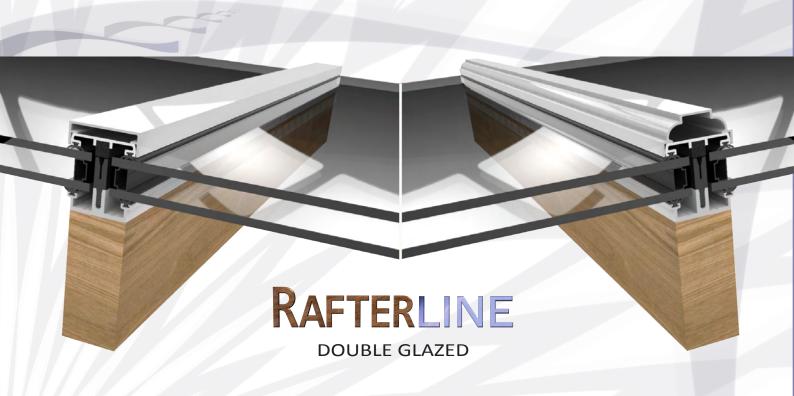
Rafterline SPG1 type thermally broken extruded aluminium Glazing Bar with screw-on PC1 capping and snap-on cosmetic square topped PC2 capping section - double glazed with 28mm thick double glazed units

Rafterline SPG1 type thermally broken extruded aluminium Glazing Bar with screw-on PC1 capping and snap-on cosmetic ornate topped PC3 capping section - double glazed with 28mm thick double glazed units

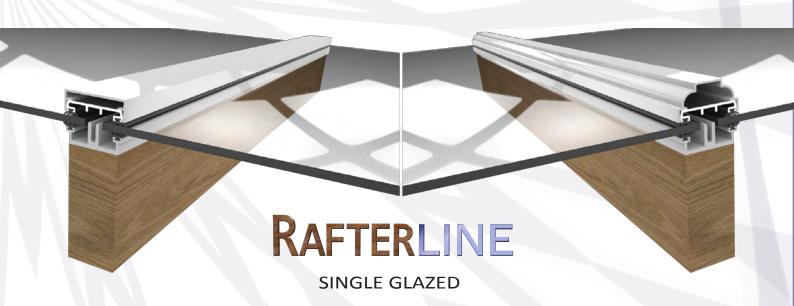
Rafterline SPG1 type extruded aluminium Glazing Bar with screw-on PC1 capping and snap-on cosmetic square topped PC2 capping section - single glazed with 6mm thick glass

Rafterline SPG1 type extruded aluminium Glazing Bar with screwon PC1 capping and snap-on cosmetic ornate topped PC3 capping section - single glazed with 6mm thick glass

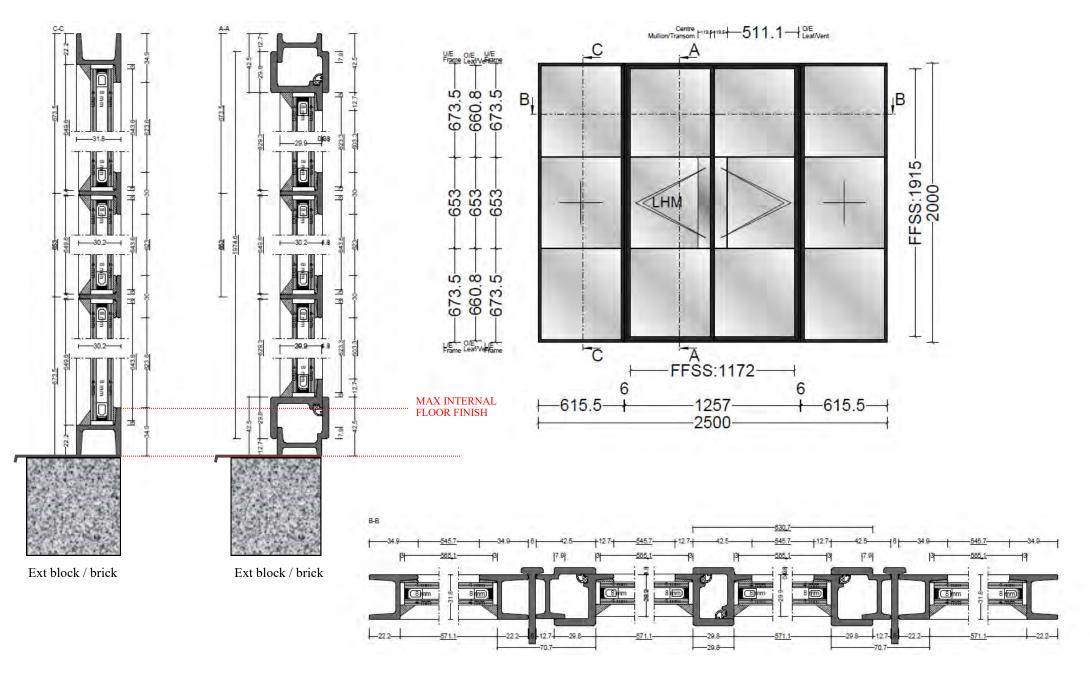
Illustration of glazed door type.

- 7. Proposed Crittal type W20 double glazed doors (see appendix 7.4) are to be powder coated off white and putty finished, in similar size and proportion to the existing 6 over 6 sash windows. These have fine lines and complement the windows on the Hall south, east and west elevations.
