## **Supporting Statement**

White Horse Architecture were appointed by Chris and Sarah Keelty to design and coordinate the renovation of Church Farm, recently purchased at auction.

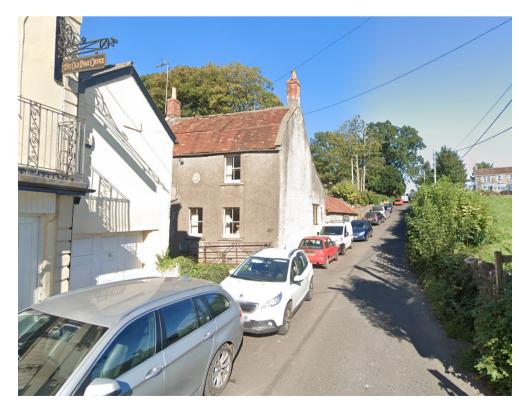
1. View from Church Street looking north.

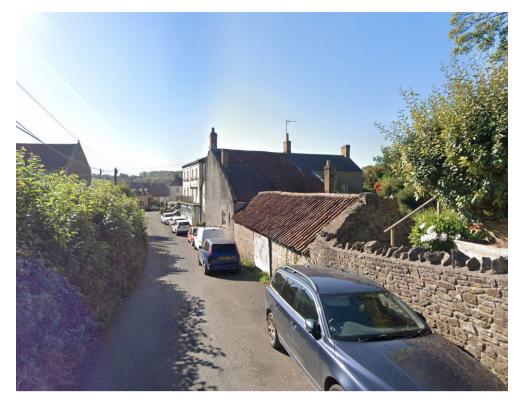
2. View from Church Street looking south

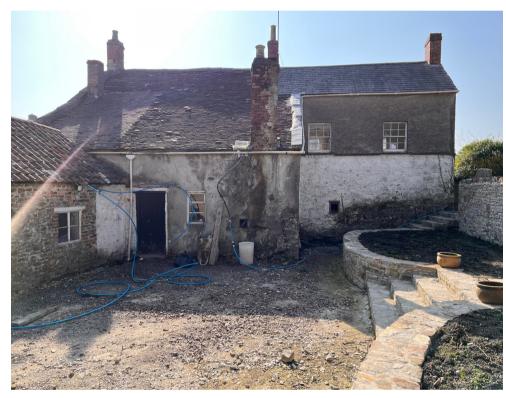
3. North elevation of the main farm house

Church Farm comprises of the main farm house, a barn, a store building and a ruin at the top of the plot. The main farm is arranged perpendicular to the Church Street presenting a gable end characterised by a catslide roof to the rear. An attached garage / store runs along the length of the street frontage. The building is currently in a severely delapidated state requiring major renovation and reordering in order to turn it into a family home.

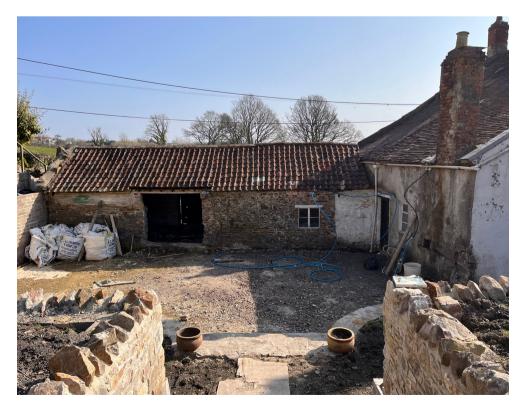
4. West elevation of the barn
