DESIGN, ACCESS AND HERITAGE STATEMENT
In connection with
APPLICATION FOR FIRST FLOOR ROOF UPSTAND
At
22 MILL STREET
WARWICK
CV34 4HB

1.0 BACKGROUND

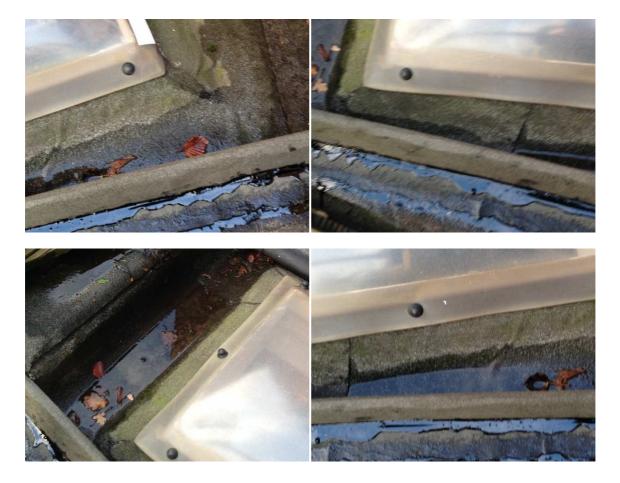
2018

The current 130mm tall upstand extends along a length of 2.5 metres of the rear first floor boundary, adjacent to both buildings.

Photographs of the position, characteristics, extent and purpose of the existing upstand are shown below.

- 1. 1Nr softwood timber treated deck board;
- 2. 128mm H x 118mm D x 2.545m L;
- 3. Covered with green mineral felt to match flat roof felt, taking height to 130mm;
- 4. Affixed to flat roof and at both ends (wall and step) using specialist roof resin coating.
