Client:	Project:
W. J. & M. Mash Limited	Bovingdon Airfield WW2 Control Tower
	Bovingdon Airfield
	Chesham Rd, Bovingdon
	Hemel Hempstead, HP3 0NP

Job Number:	Drawing No.:
2114	P_1000
Title:	Revision:
Plans As Existing & Original	-

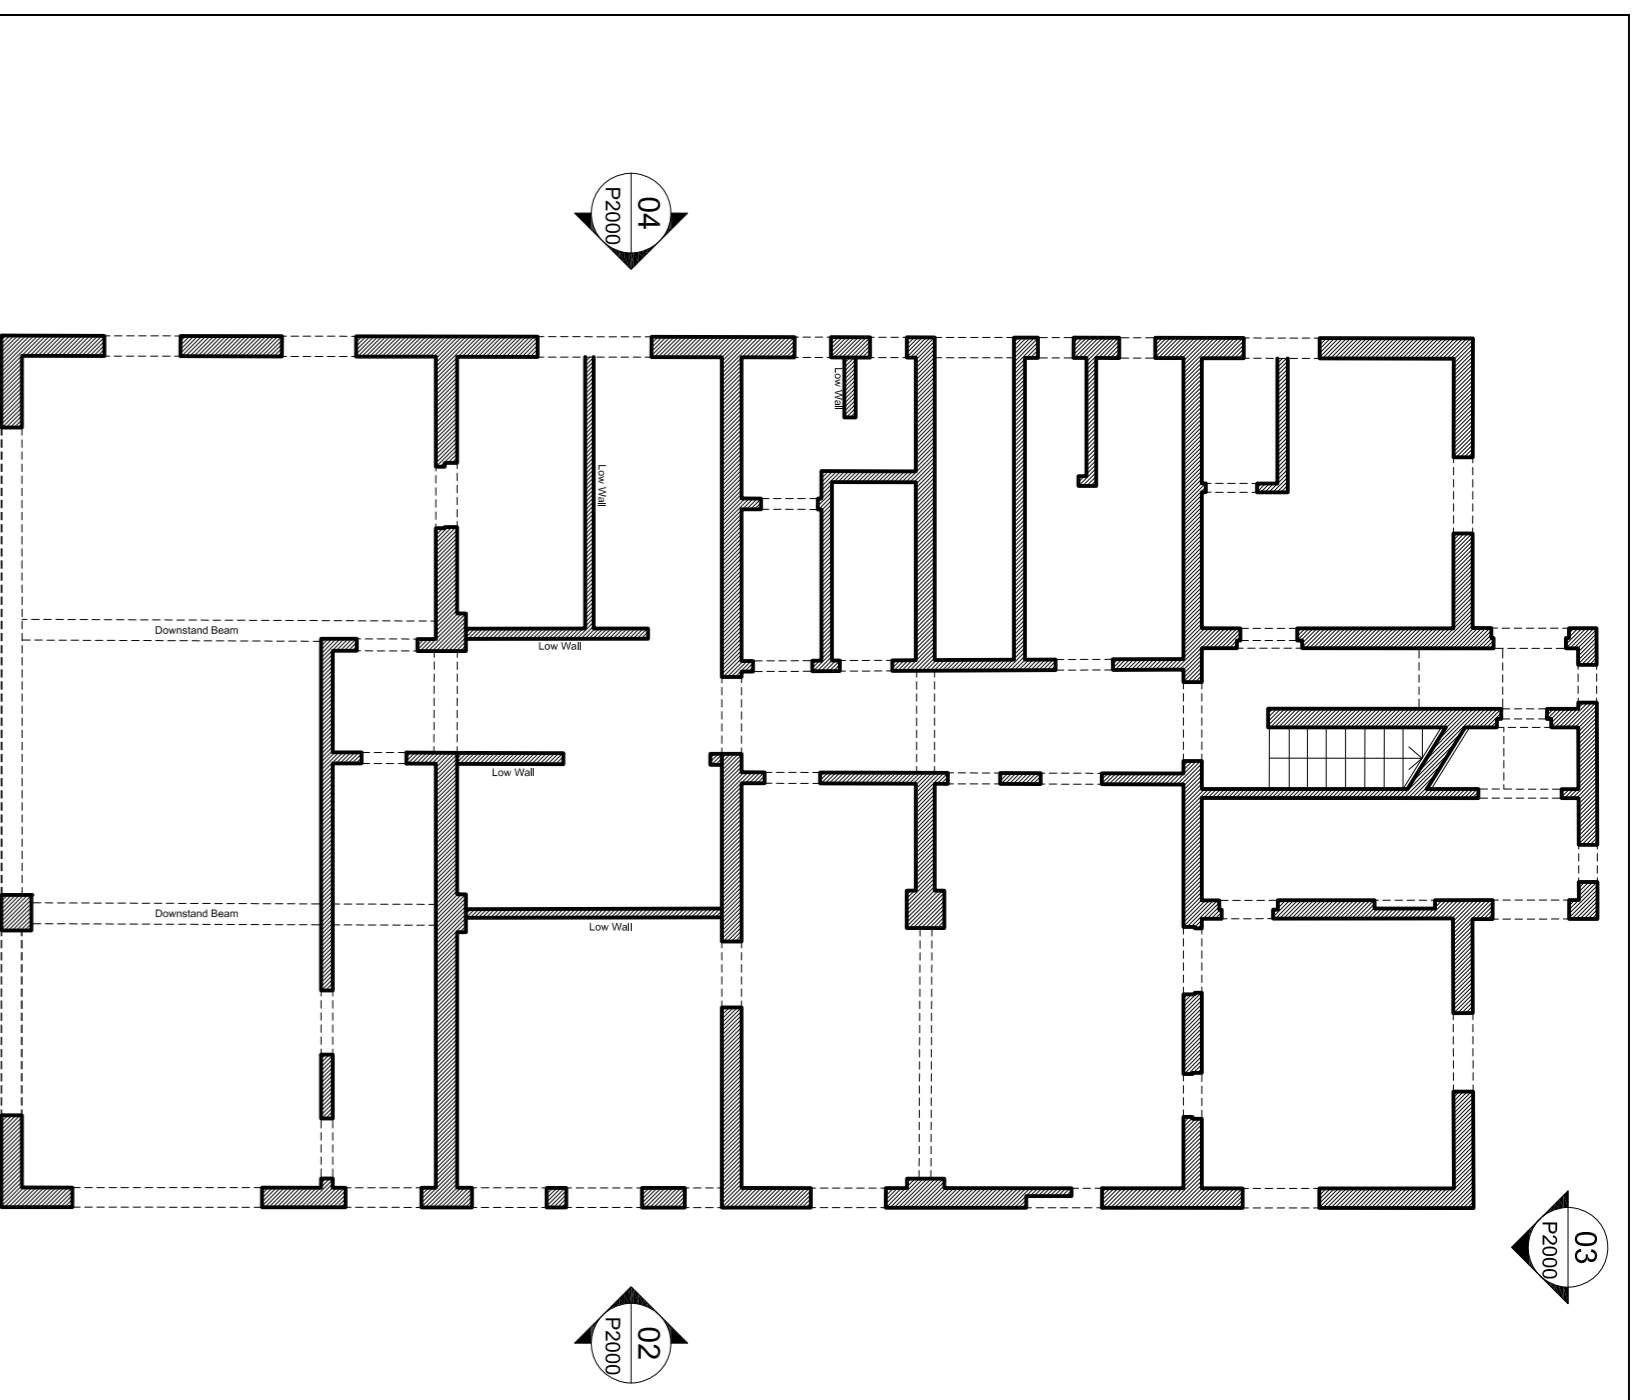
01 Ground Floor Plan As Existing
 Note: The existing building is derelict and is in an extremely poor state of repair - no doors or windows exist with the exception of a few odd broken frames. The building has been severely damaged by water ingress and possibly fire in the past and much of it is unsafe to enter

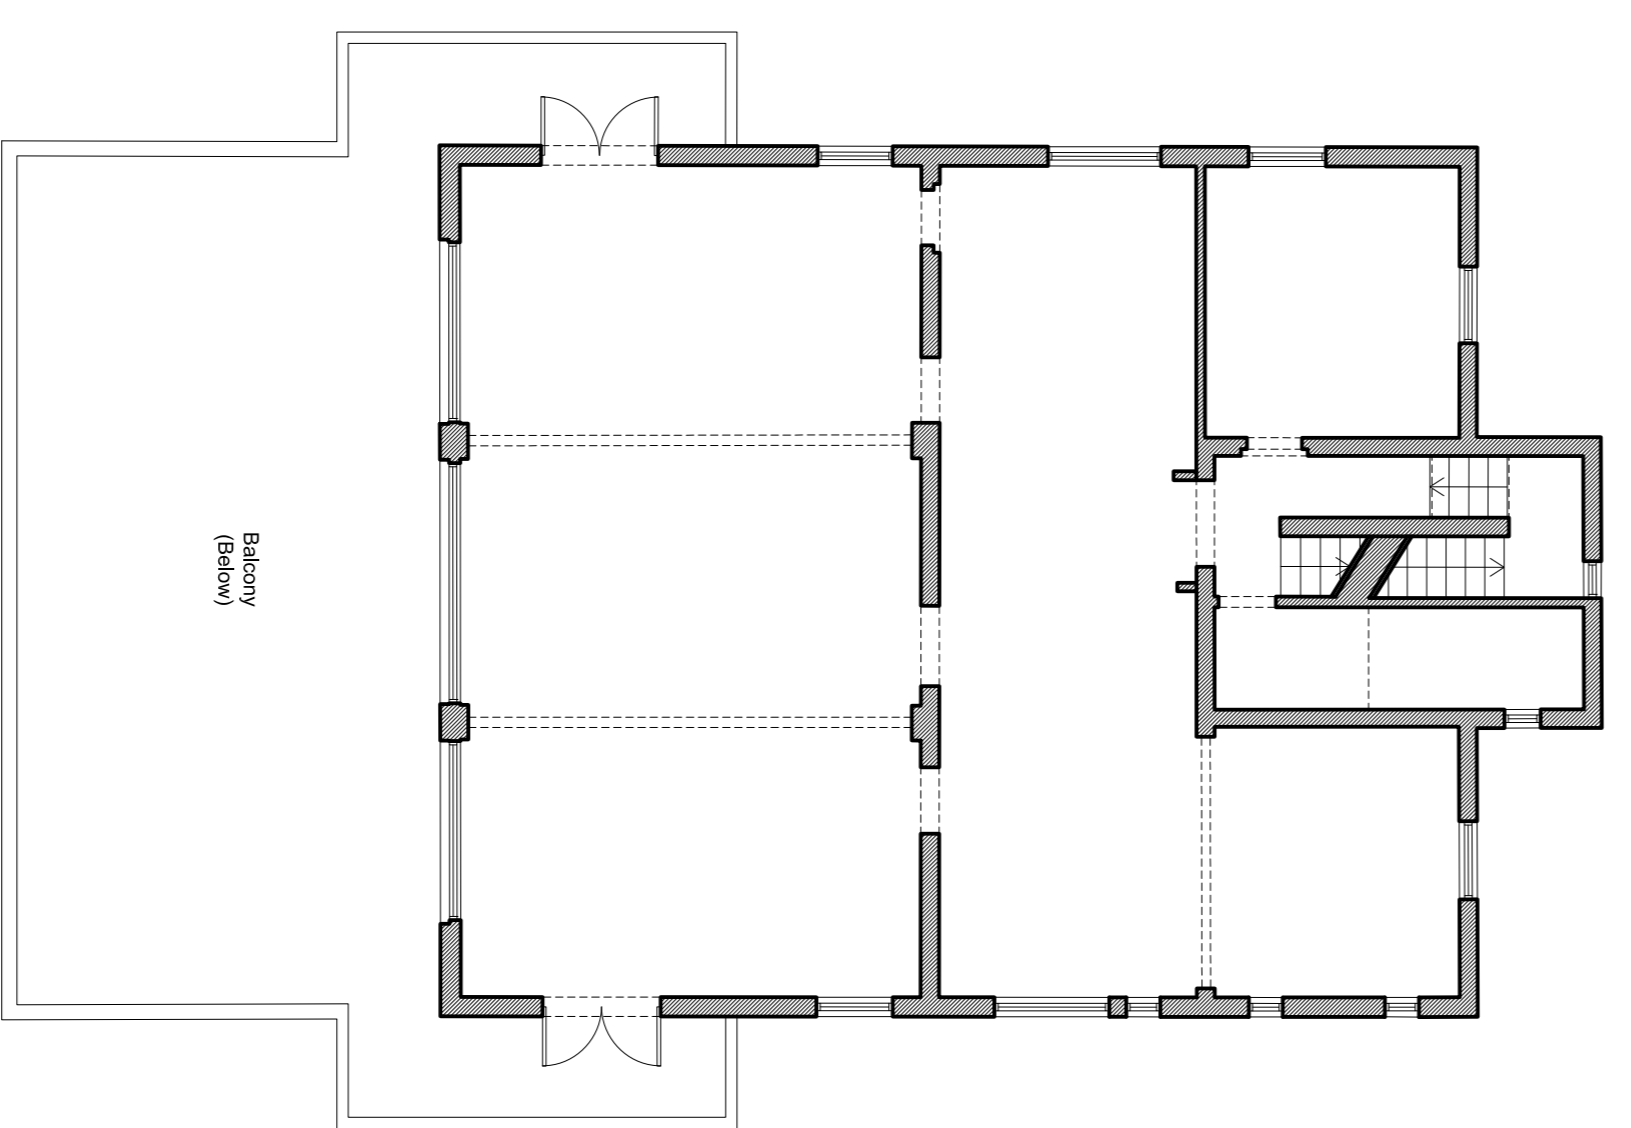
05 Ground Floor Plan As Original (assumed)
 Note: All doors and windows have been drawn in assumed locations following site analysis and from reviewing old photographs. Complete original internal layout unknown
