ORCHARD ASSOCIATES  
29 WEST STREET  
HARROW ON THE HILL  
MIDDLESEX 020 8423 4866

client  
MR D. PICKSTONE

MYRTLE HOUSE  
NOTTINGHAM ROAD NORTH  
HERONSGATE  
HERTFORDSHIRE ENTRANCE DETAILS

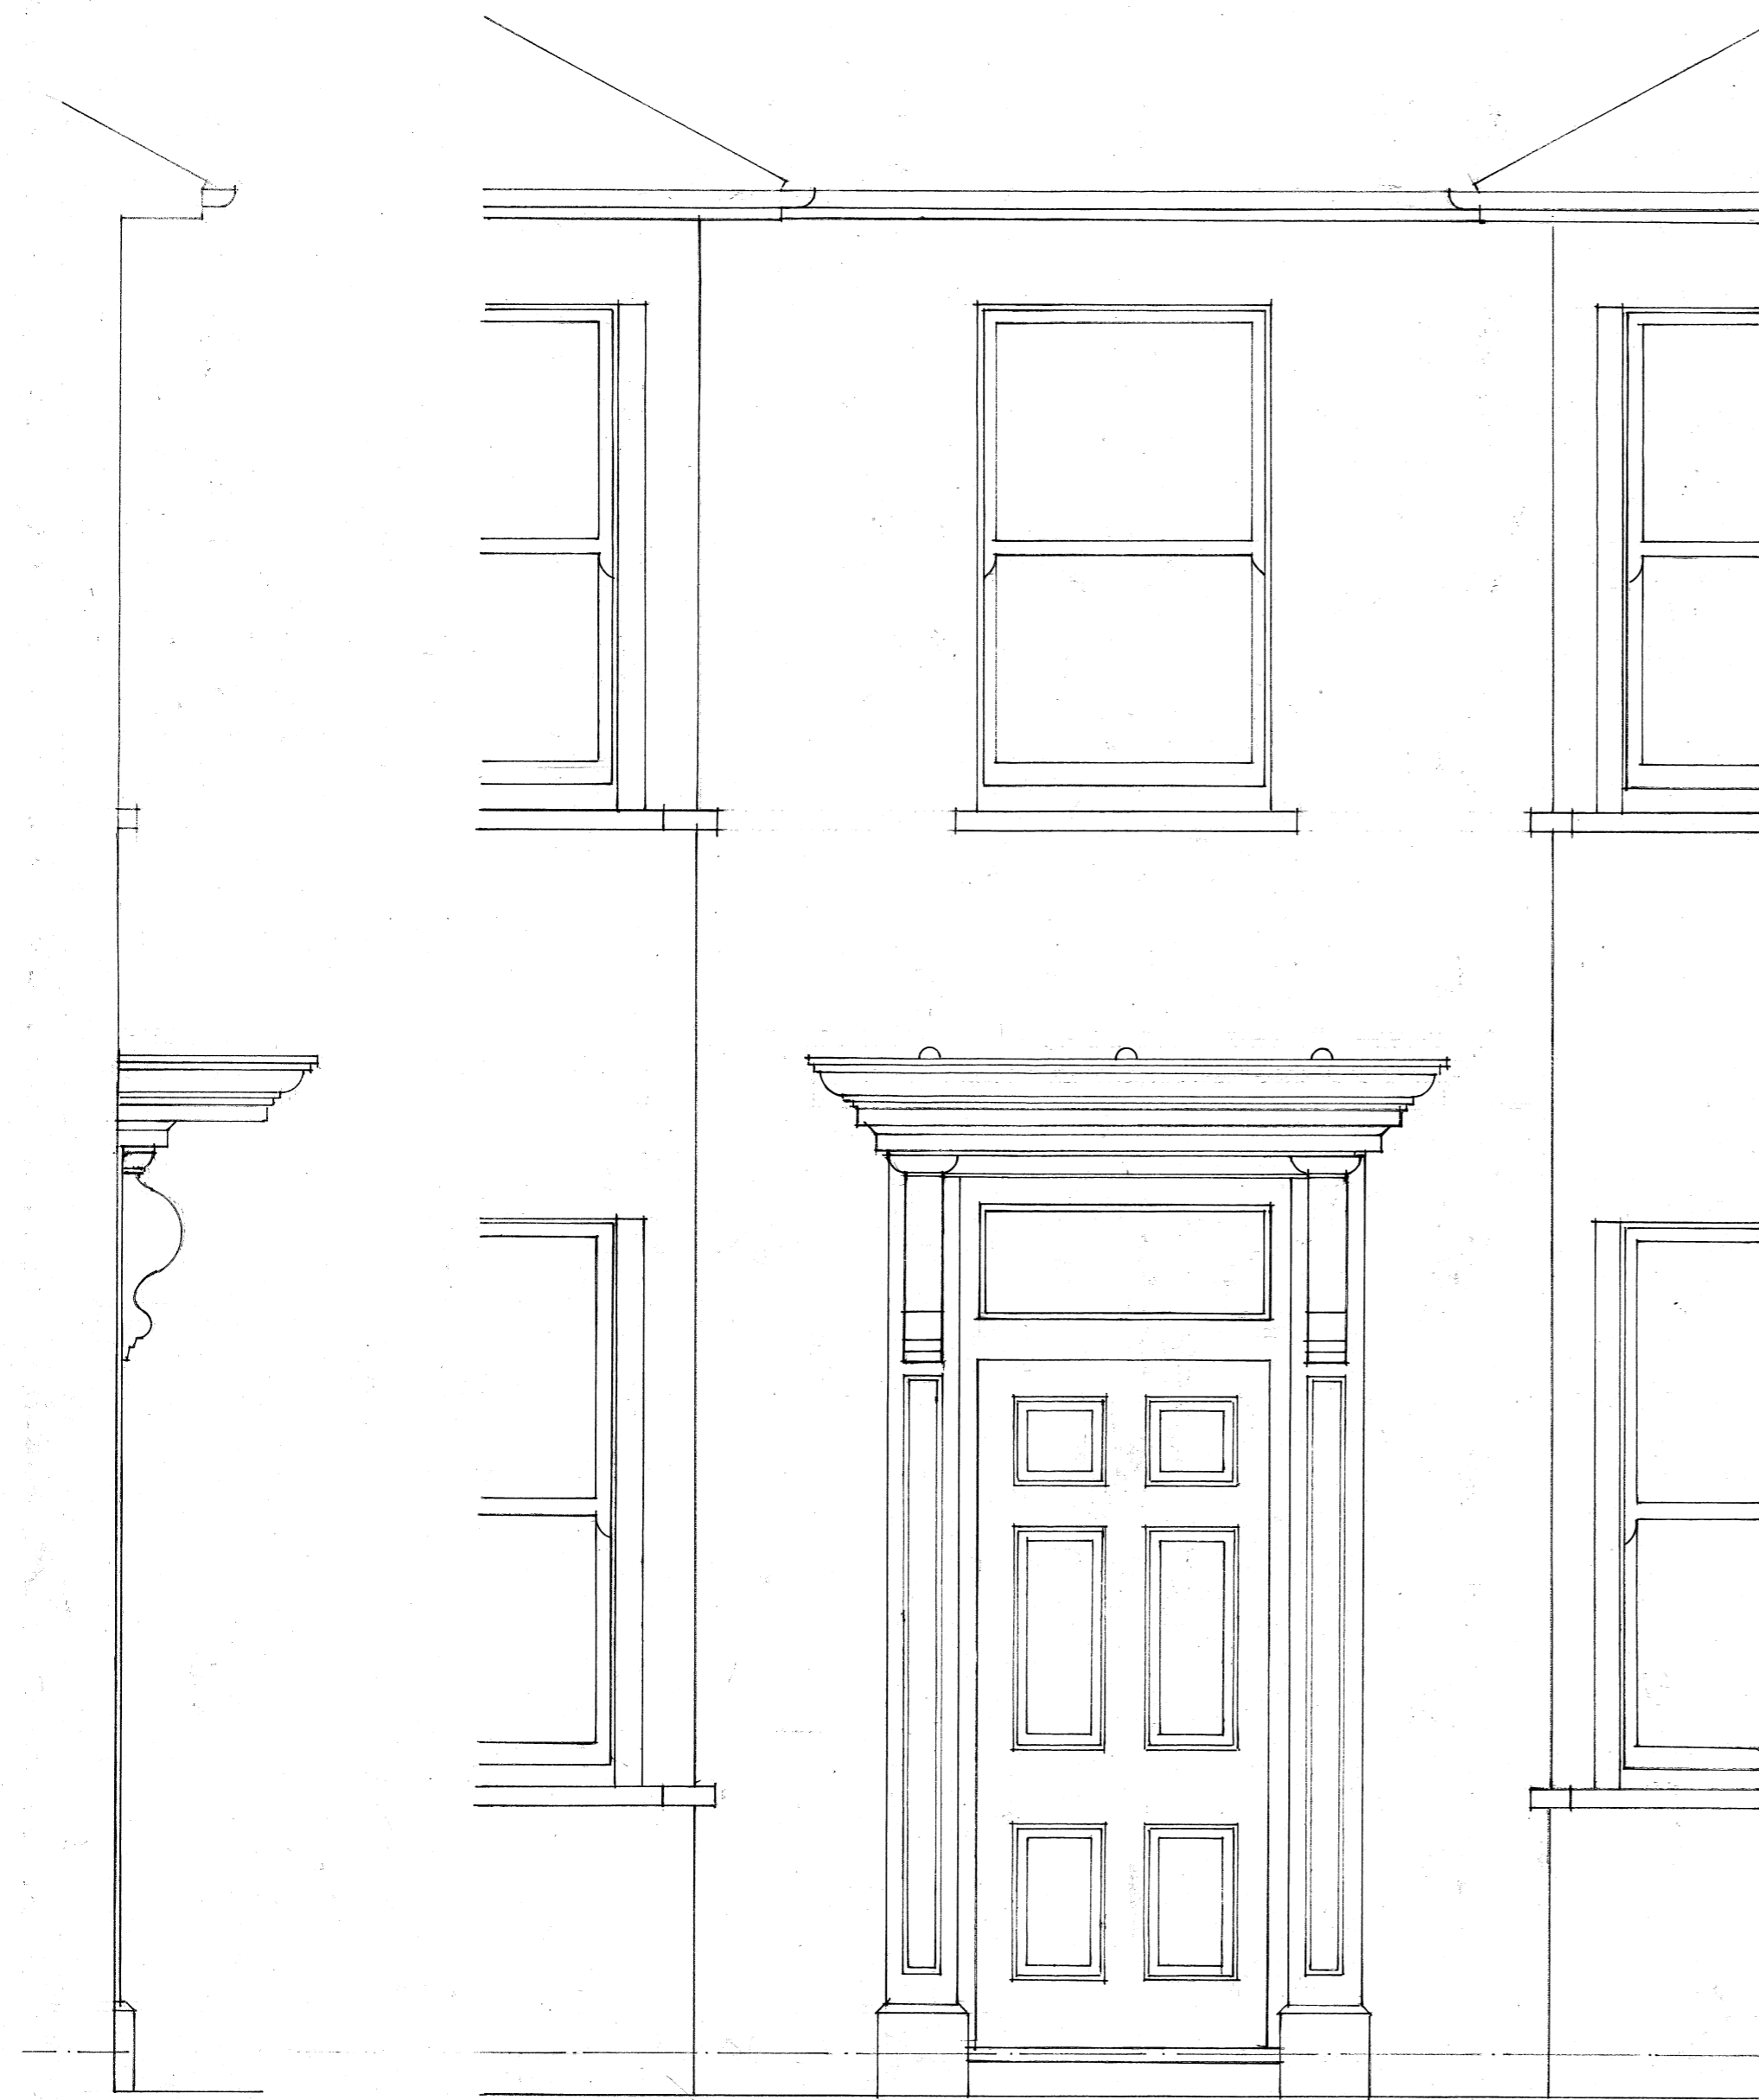
SIDE ELEVATION

FRONT ELEVATION

Painted timber sash windows

Stone window sill

Existing varied render replaced with smooth finished painted lime render

Leaded canopy flat roof

Painted timber moulded canopy and brackets

Glass fanlight

Six panel painted timber door with raised and fielded panels in timber frame

Painted timber moulded pilasters and reveal linings

Stone threshold
