Repair, Restore and Replacement of materials on
The open cart garage, stables, front flint wall and the
new works to the rear garden.

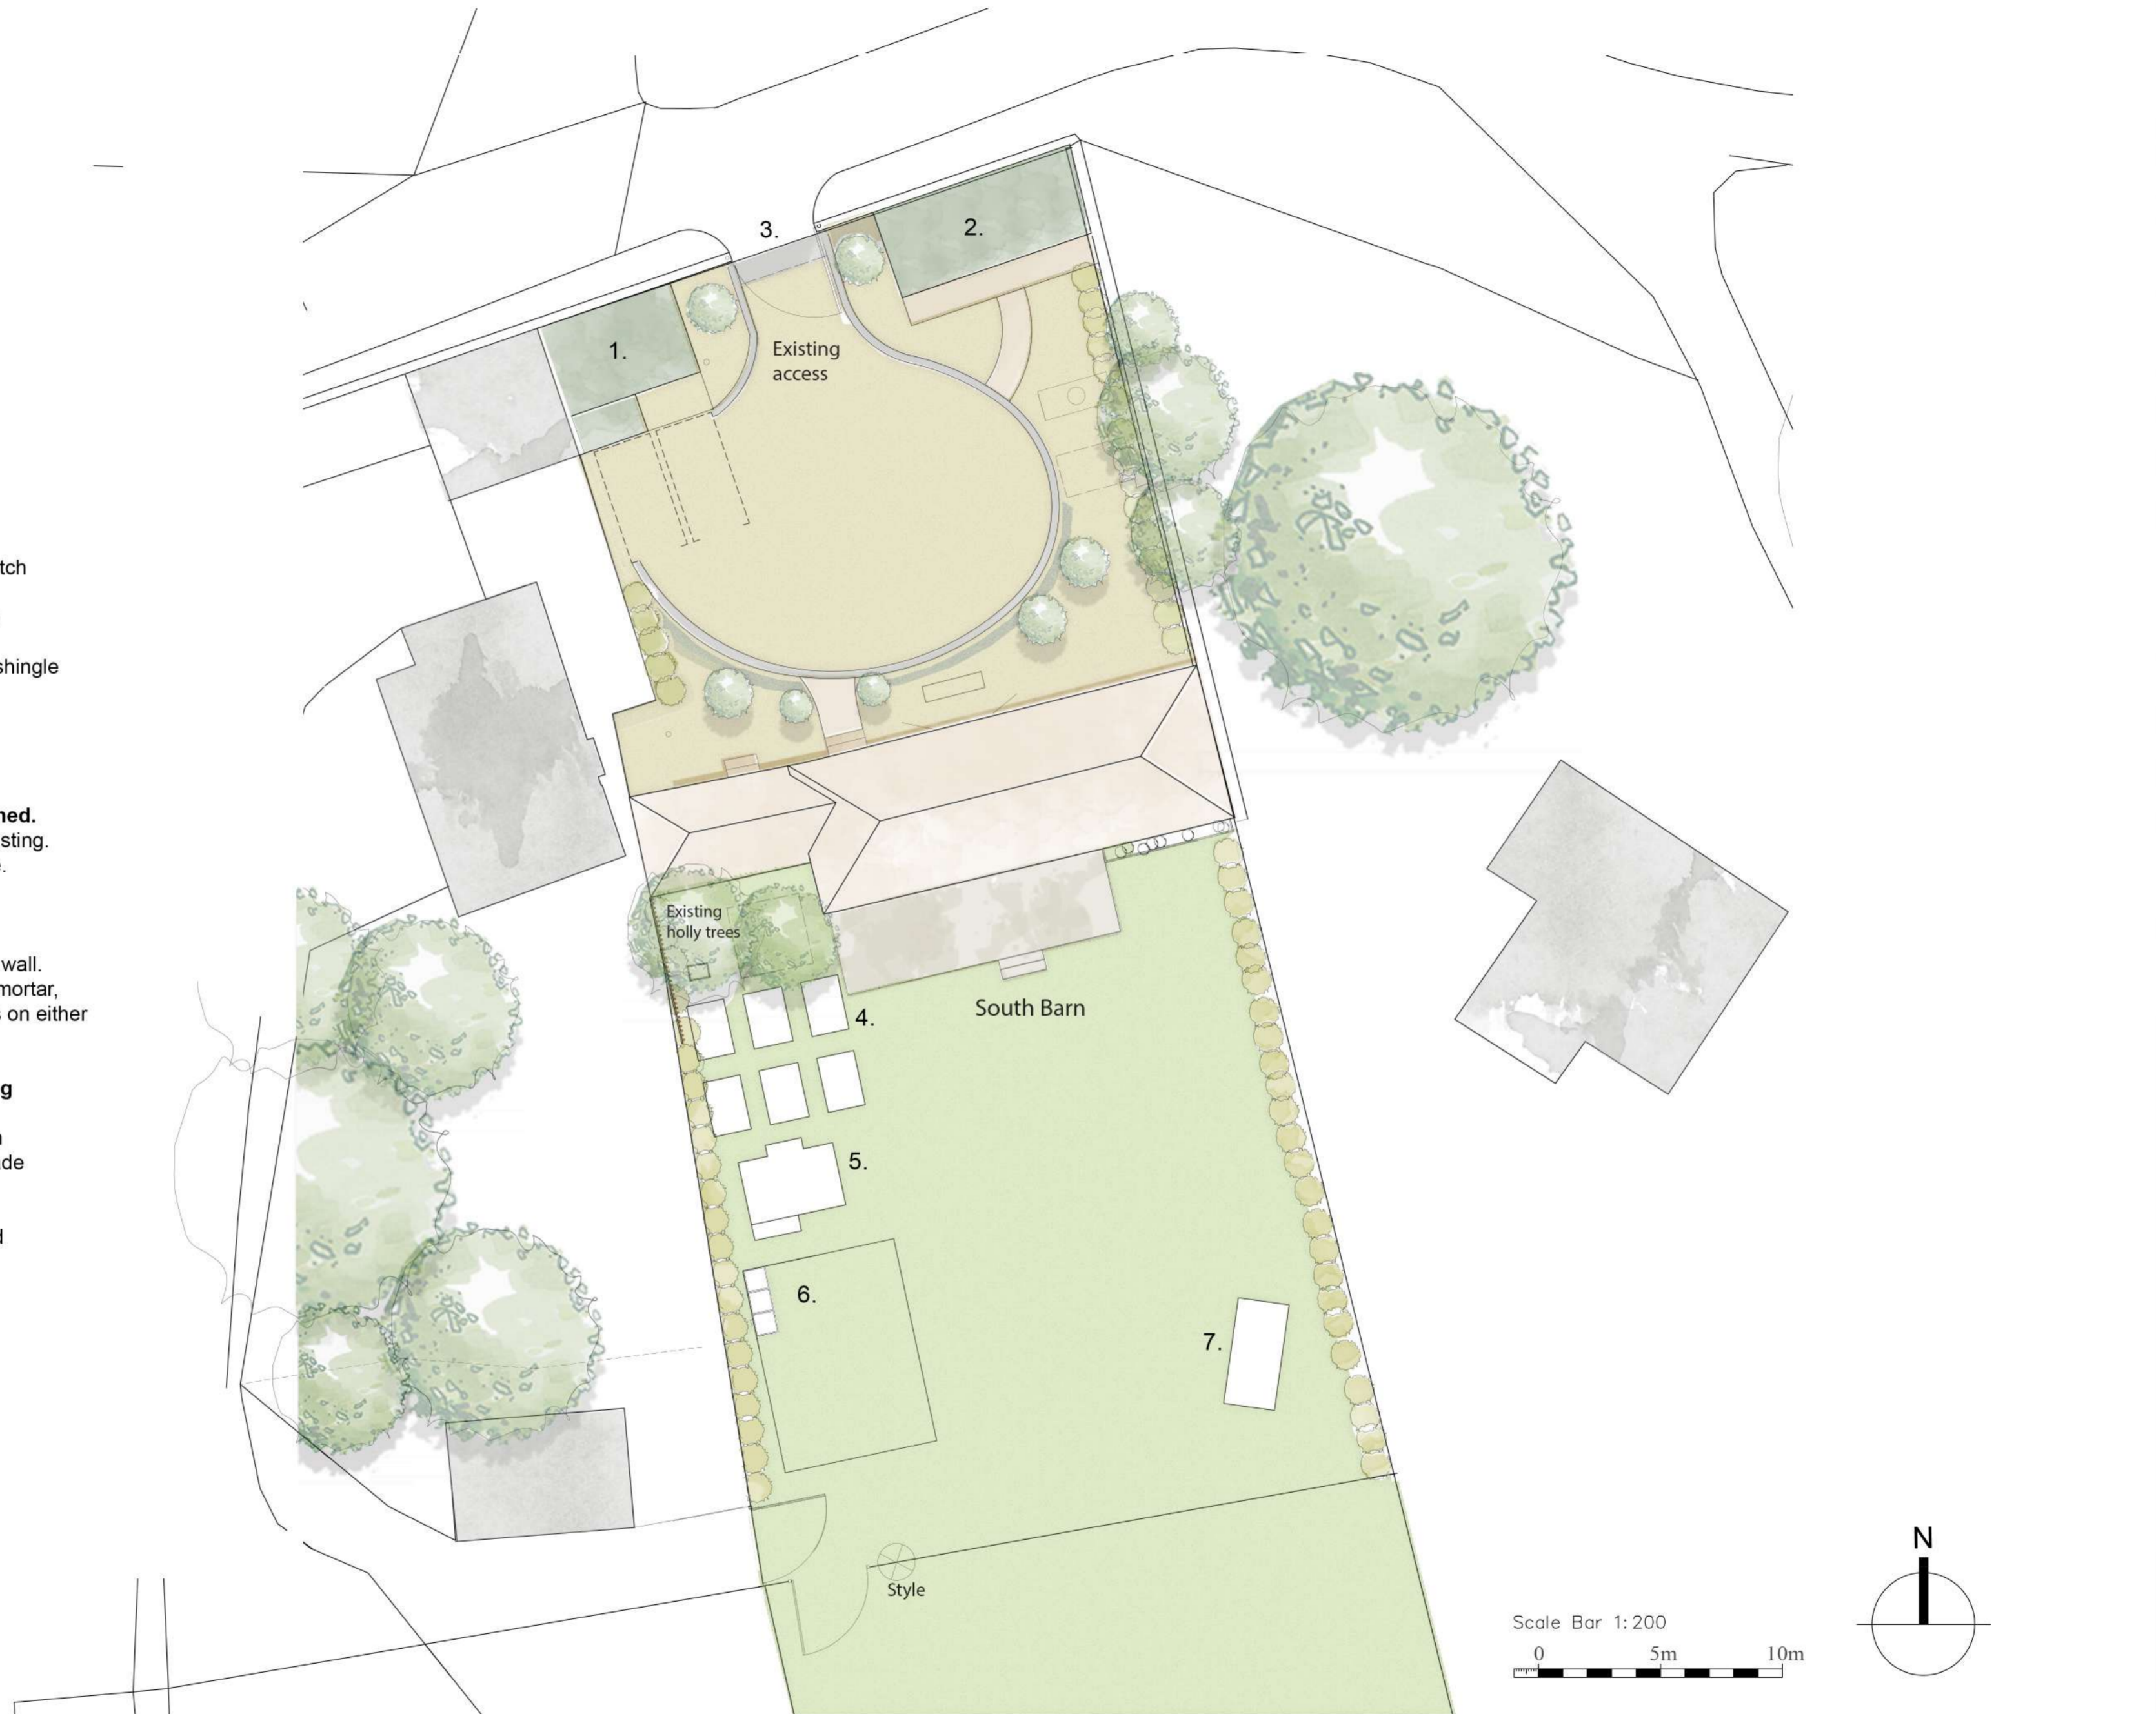
1. Proposed new metal corrugated roof sheeting
New saddle stone and removal of metal side wall
New timber plate, removal of metal fascia and new
weatherboarding fitted vertically and stained black to match
other right hand side cart barn.
Replacement of weatherboarding and painted black to
match the main barn.
Replacement guttering and new downpipe. New pea shingle
trench to allow for rain water drainage.

2. Proposed new metal corrugated roof sheeting
New repair and replacement of internal timbers
Timber cladding on the north elevations to be retained.
Replacement guttering and new downpipe to match existing.
New pea shingle trench to allow for rain water drainage.

3. The repair and restoration of the front flint wall. New
metal posts to strengthen weak corners inside the flint wall.
with existing farm gate to be hung/ refurbished. Lime mortar,
existing/ salvaged handmade red stock brickwork coins on either
end and brick capping on the top of flint work wall.

4. New raised vegetable beds
5. New Victorian Terrace Greenhouse and cold frame with
brick plinth (brickwork to match main barn with handmade
red stock bricks and lime mortar.
6. Vegetable patch with compost bins
7. New Shepherd's Hut 14' Snug. In clad tin to be painted
in a shade of green, roof clad in black.
