DESIGN AND ACCESS HERITAGE STATEMENT

RESTORATION WORK

NUTTERCOTE COTTAGE THORNTON-IN-CRAVEN, NORTH YORKSHIRE BD23 3TT

Our Ref: 211436

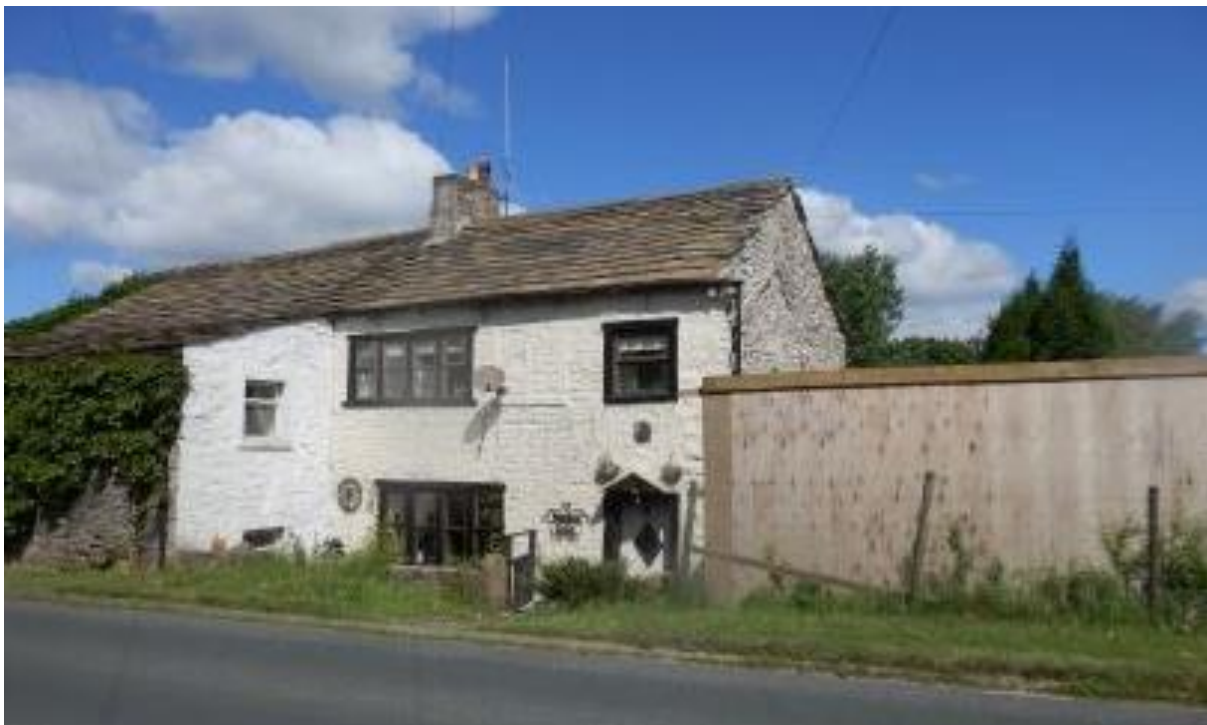
Image 1 Nuttercote Cottage as at June 2018. Nuttercote Farm was to the right of the property before its demolition.

8.1 The Cottage has been significantly impacted upon by the demolition of the neighbouring property and the proposals for this application intend to restore the building to its original arrangement whilst also improving the thermal performance and ensuring it is watertight.

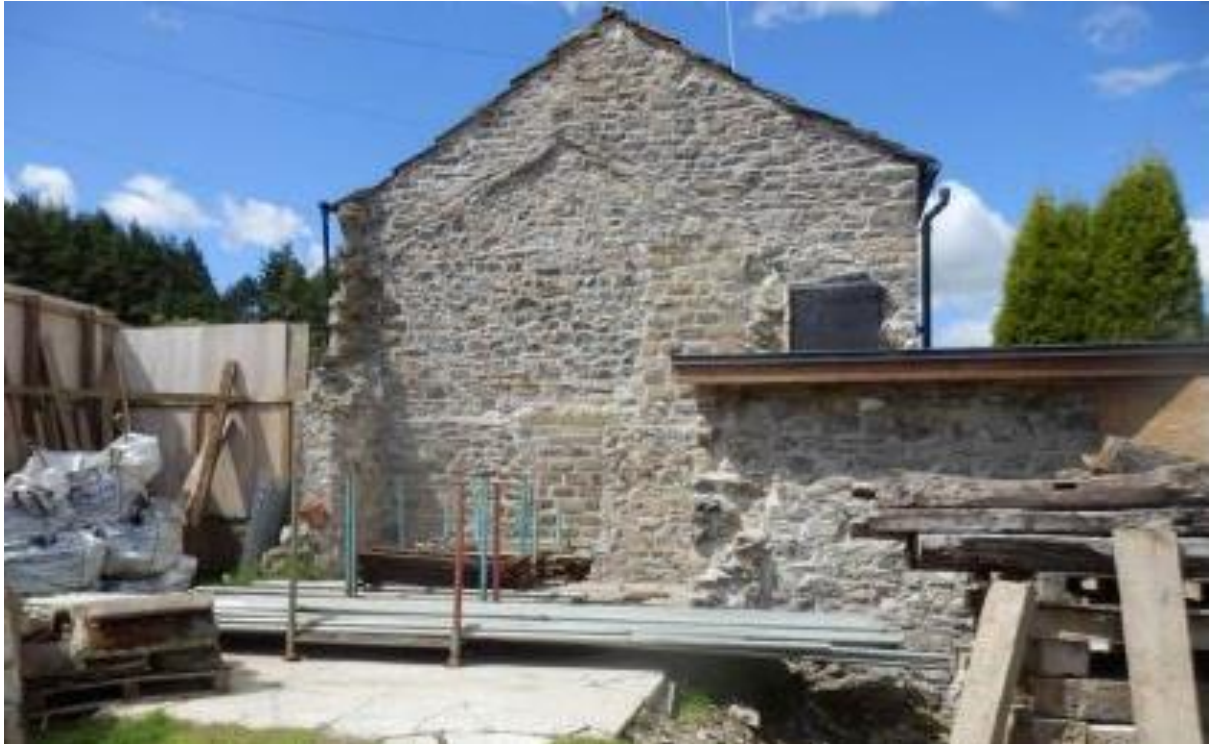
Image 2 Exposed party wall as at 21 June 2018. Dining Room to the property is in the single storey addition to the right of this photograph.

- Tanking to walls and floor in the Ground Floor Dining Room
- Remedial works to the internal face of party walls
- New pitched roof to Dining Room with associated rainwater goods
- Remedial works to the main house pitched roof
- Associated work to stonework to party walls
- Construction of a new outer leaf of stonework to the south and east elevations to the dining room.

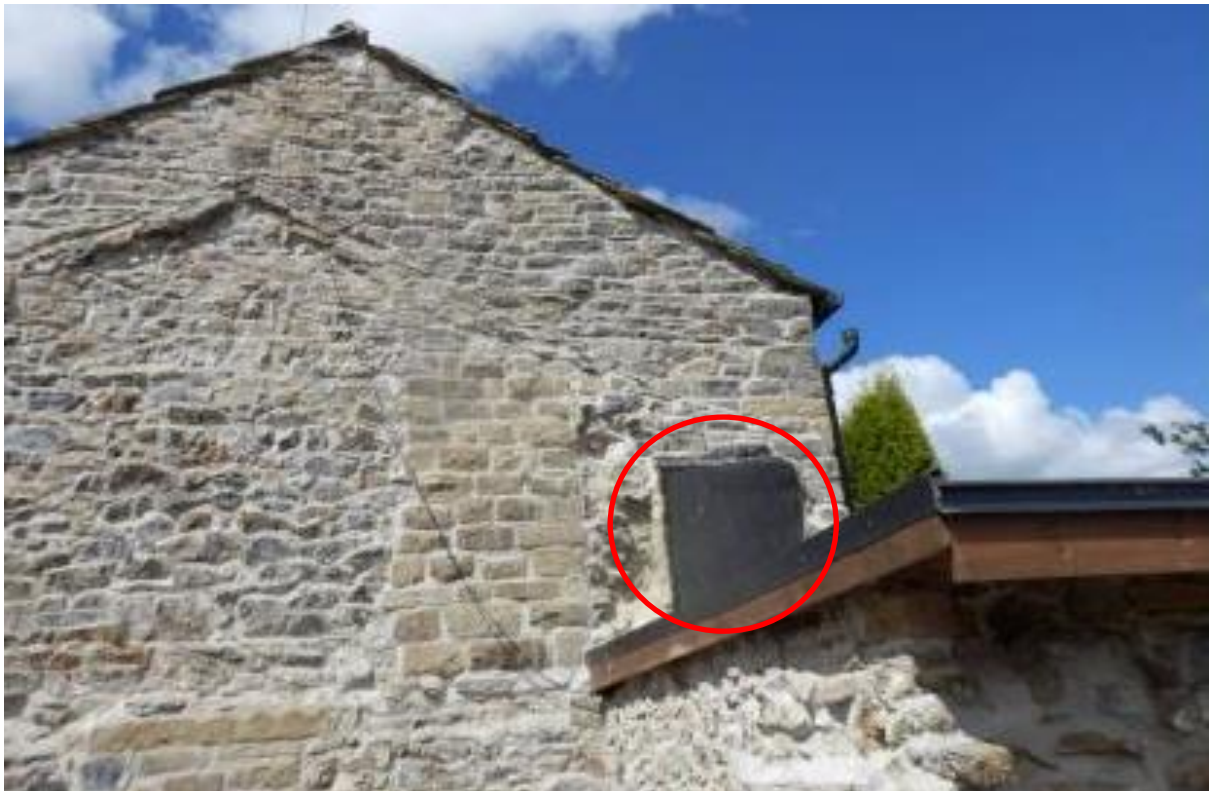
Image 3 View of infilled hole in the party wall when exposed following demolition of Nuttercote Farm.

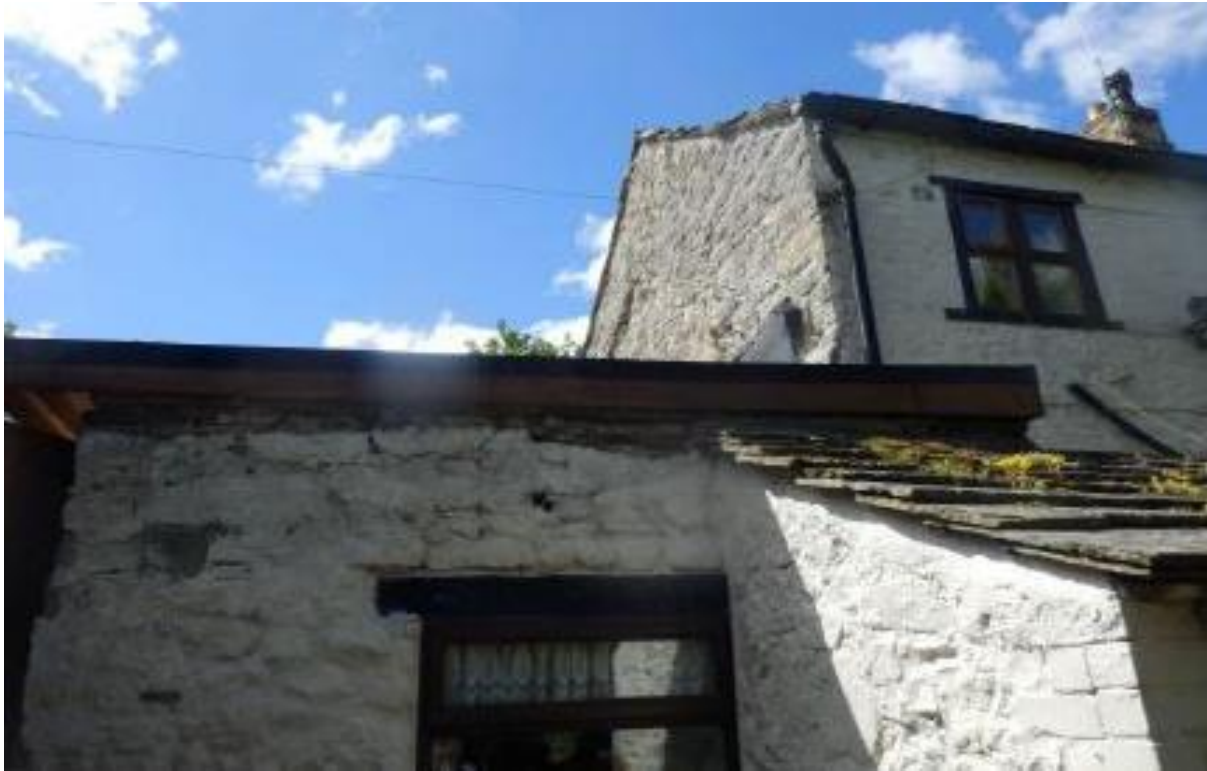
Image 4 Lean to and rear of the Dining Room with temporary roof over above.
