Windermere Warningcamp Arundel West Sussex BN18 9QL

Ref: 21223

Biodiversity and Habitat Survey and Report Justification Statement

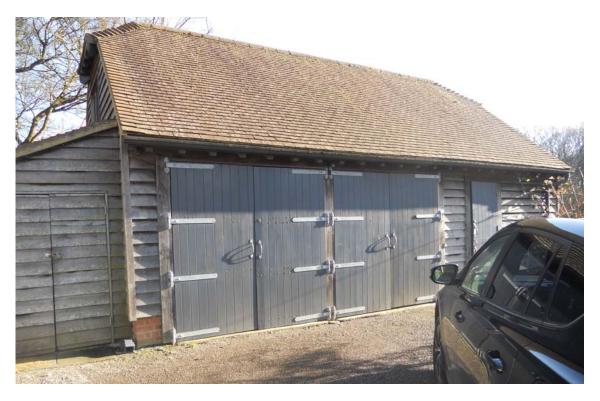
Figure 01

The existing roof is relatively new, constructed in 2015. The exiting roof tiles are in good order and close fitting and there are no gaps available for bat hibernation or roost. See figure 01.

The roof tiles, eaves and verges within the areas or the proposed works are in very good condition, with no gaps or crevice's suitable for bat roosts or hibernation.
