PROPOSED WORKS

Client: Mr and Mrs Greening	
Project Title: Bellister Castle, Haltwhistle, Northumberland, NE49 0HZ	
Drawing Title: Window Overhaul	
Drawn By: C Wallace	Date Drawn: 11-05-2022
Scale: Not To Scale	Page Size: A3
Drawing Number: 005	Revision: -

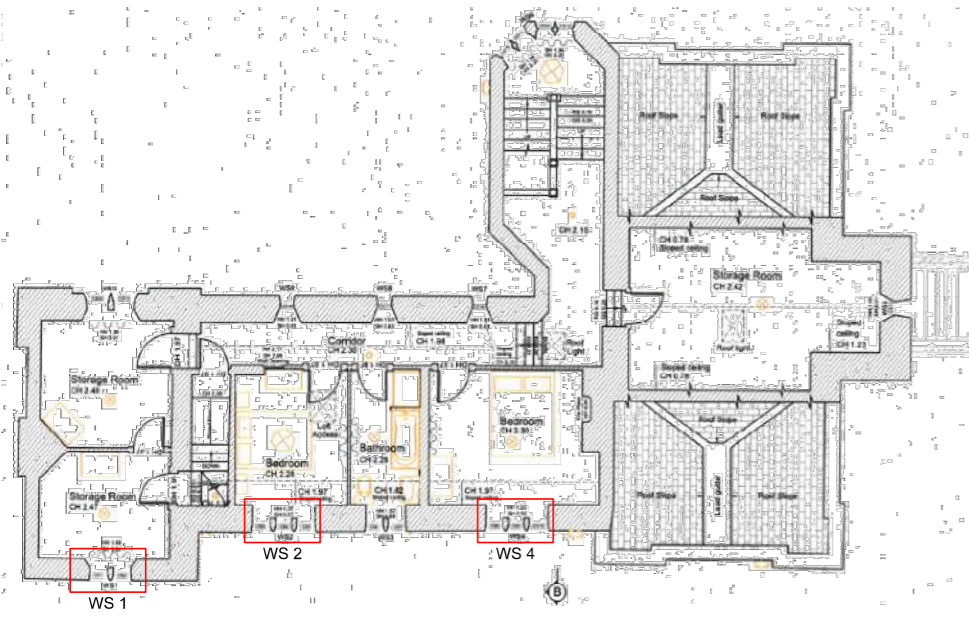
**SECOND FLOOR
NOT TO SCALE**

Windows WS 1, WS 2 and WS 3:
Casements to be removed and renewed, on a like-for-like basis. Surrounds to be retained.

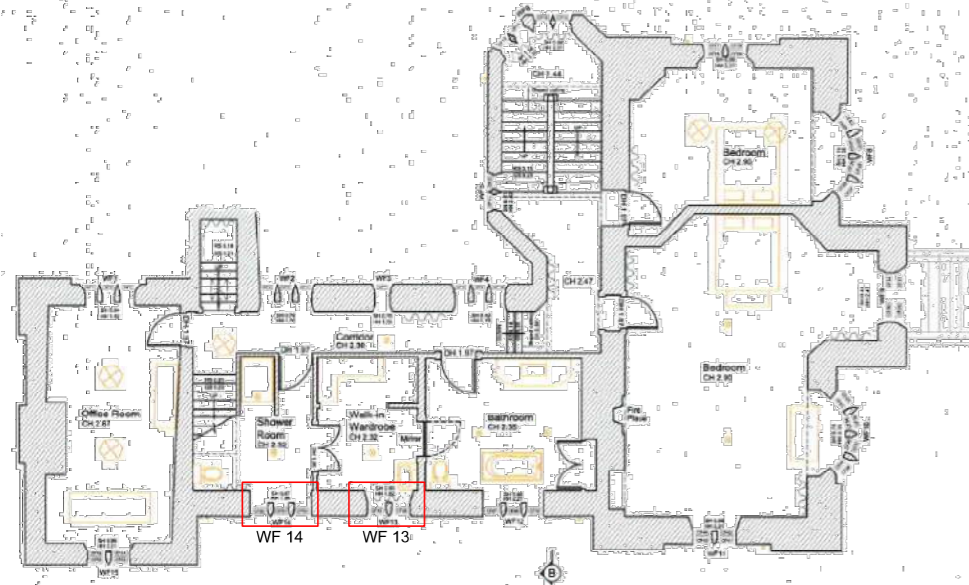
**FIRST FLOOR
NOT TO SCALE**

Windows WF 14, WF 13 and WG 3:
Casements and surrounds to be removed and renewed, on a like-for-like basis.

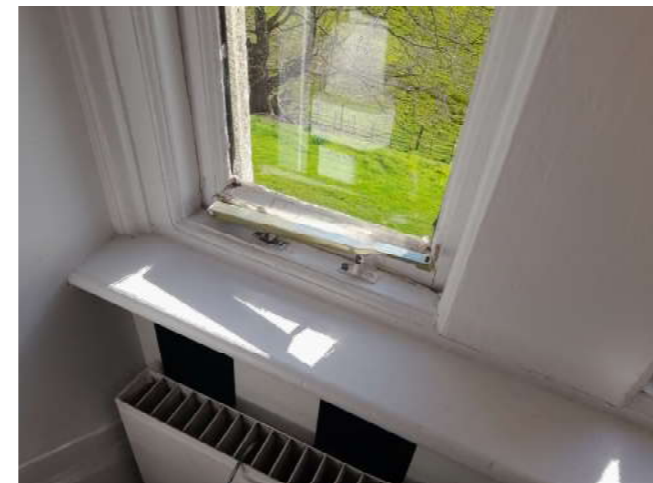
**PHOTOGRAPH A
NOT TO SCALE**

Generally:
Where conventional latches (Photograph A) have been installed (prior to Mr and Mrs Greenings tenure) these are to be removed and replaced with traditional latches (Photograph B).

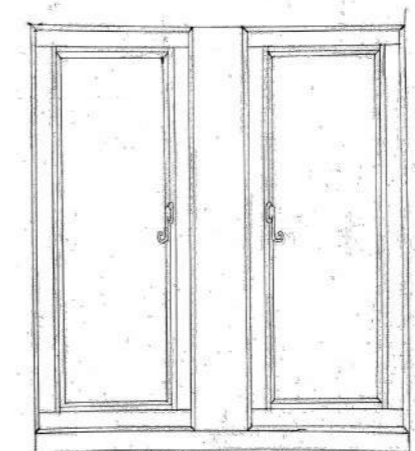
TYPICAL ELEVATION (supplied by Martin Johnson & Co (York) Limited)
NOT TO SCALE

To undertake any splice repair or adjustment, on a like-for-like basis, that may become necessary during the proposed refurbishment of the windows.
