PROPOSED REPAIRS to WHITE HOLE PECKET WELL HEBDEN BRIDGE on behalf of The Savile Trust 1965

EXISTING

Drawing no.		Revision
2522:	10	
Scale	Drawn	Date
1·100 @ A1	mfn	July 20

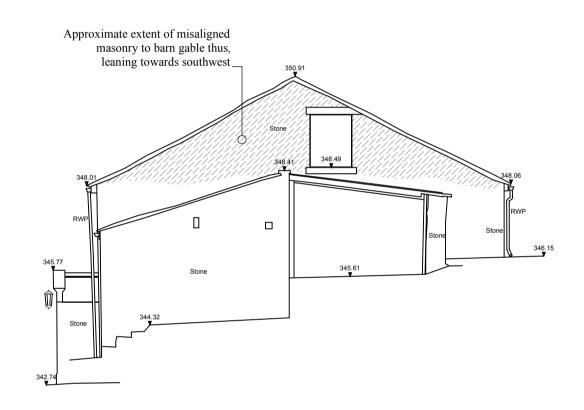
▼ 340.00m above OS Datum GABLE ELEVATION

Longstanding water ingress into historic fabric due to substandard junction between roof and barn gable along front and rear slopes Extent of misaligned masonry to barn gable thus, leaning towards southwest_ Displaced quoins induced by structural movement of gable wall towards southwest 343.82
