Wentworth

Loft Door Details

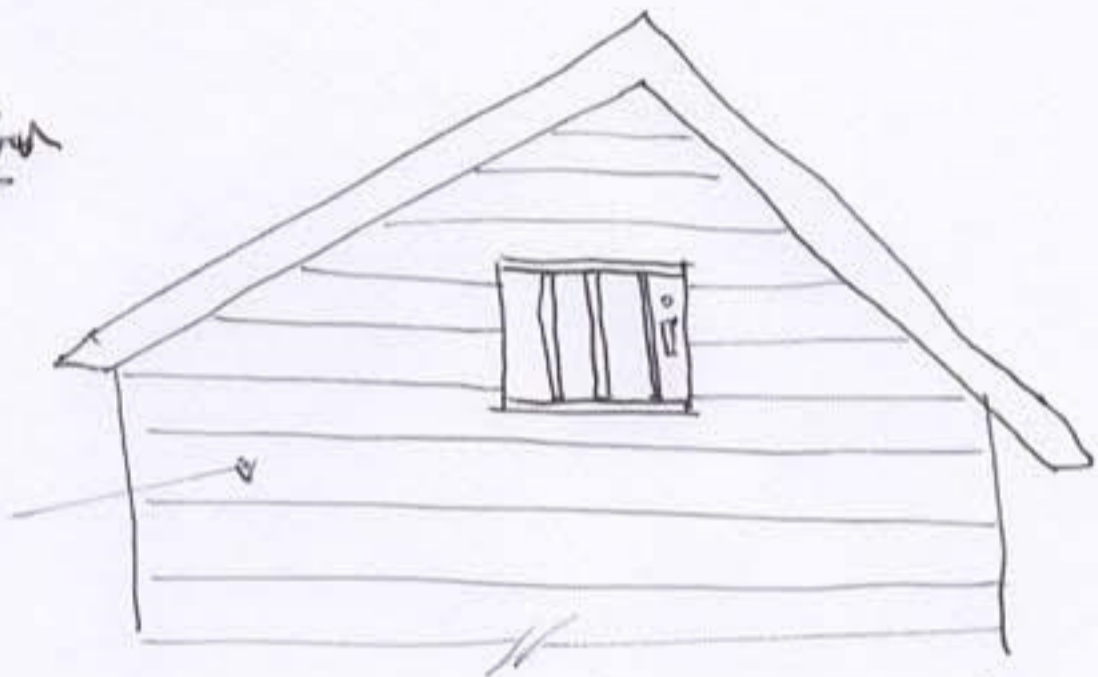
Gable Elevation
(South)

Douglas fir
cladding

Loft door, size as existing.
Douglas fir, hedged and braced. Full spec as per stable door.

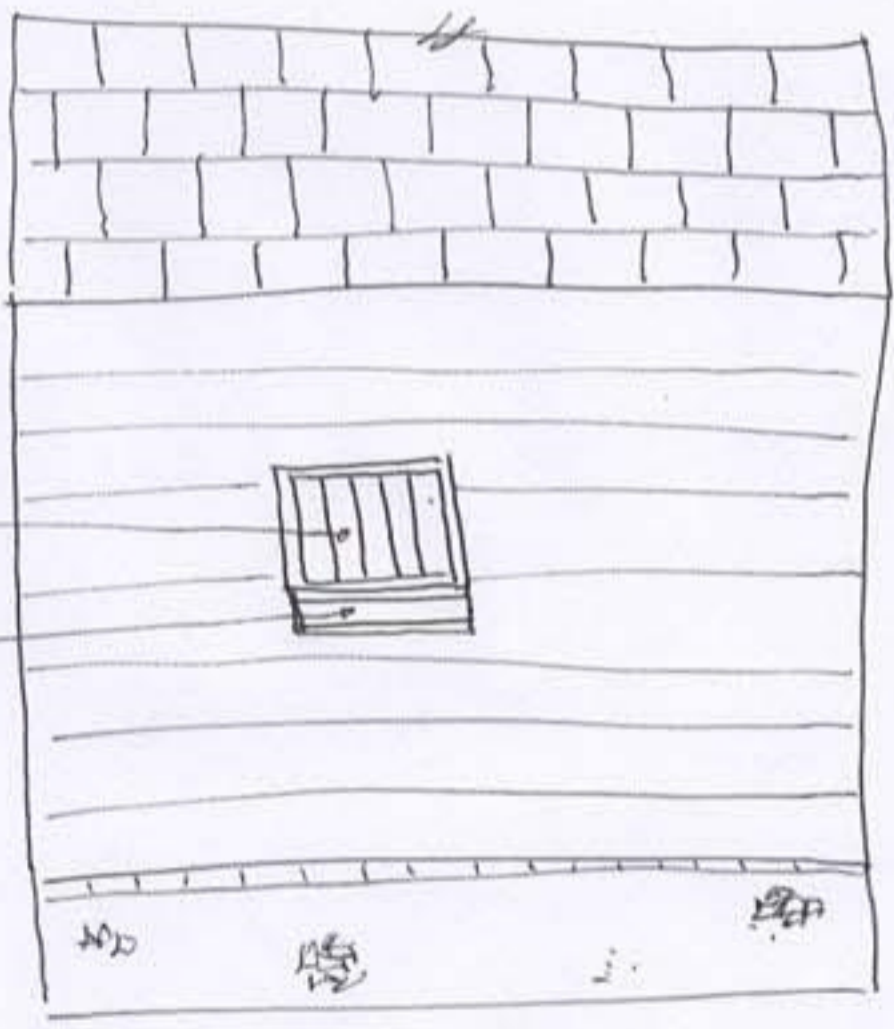
Window Detail

Window
Bat access in accordance with Bat Mitigation Plan.

timber slatted window as existing but with Bat access below
