## Homecheck Environmental

Report issued for the property at  
**Plot A to the Rear of Lion House  
The Street  
Rickingham  
Diss  
IP22 1DY**

Report Reference  
**300085200\_1\_1**

Report Date  
**18 August 2022**

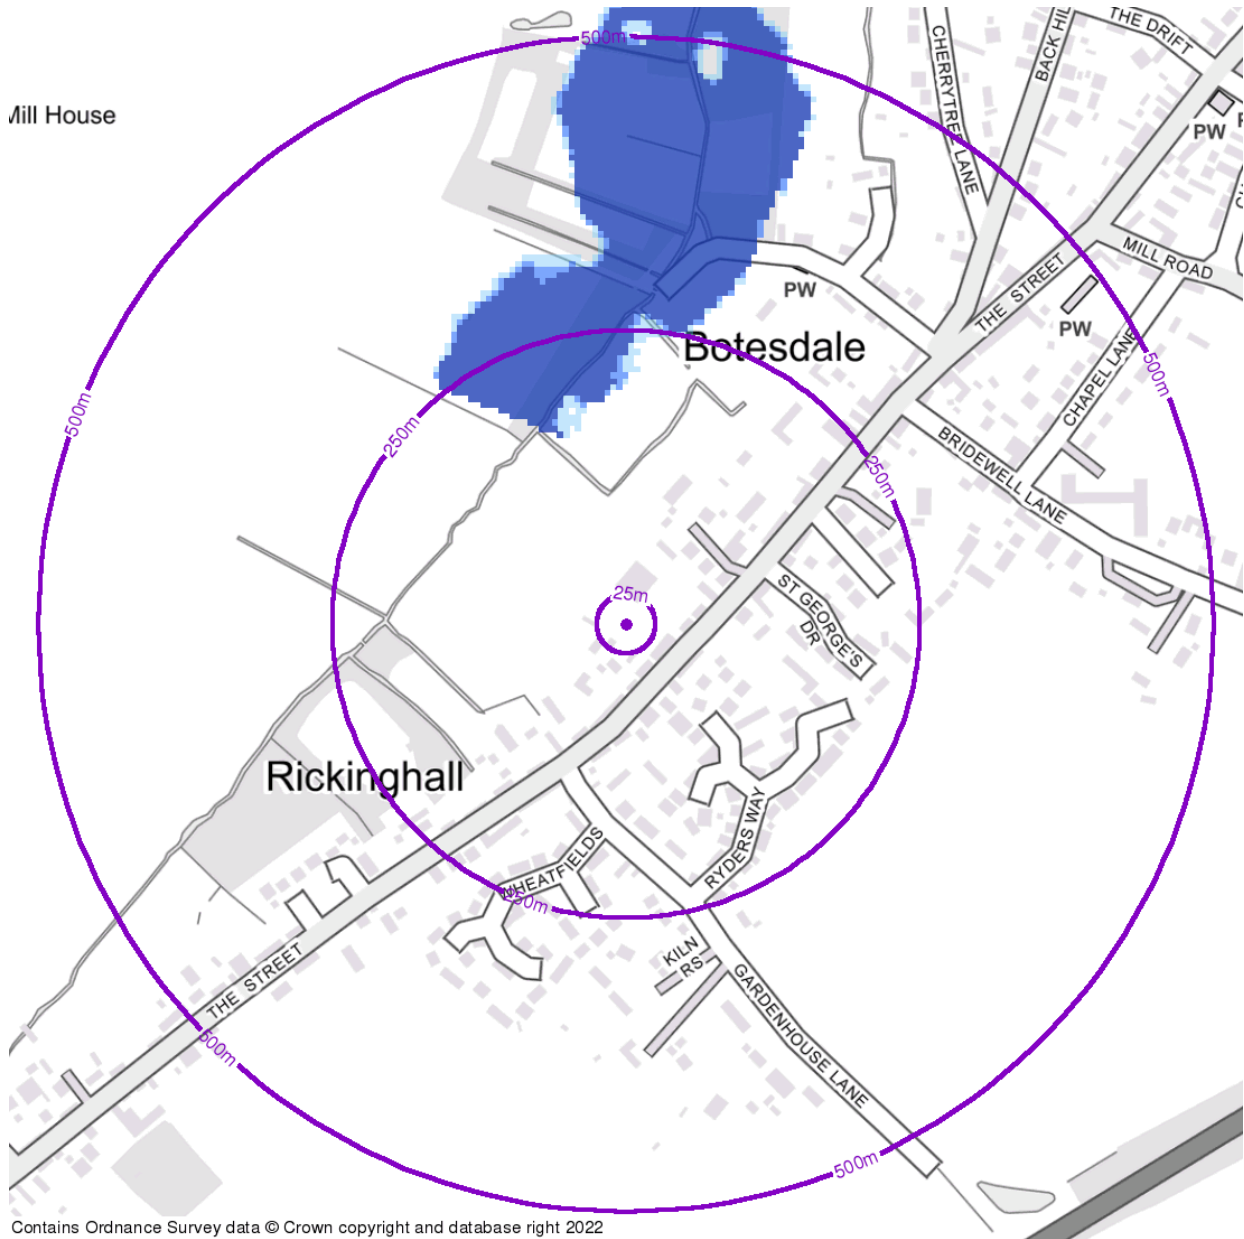
### Section 2a and 2b: River and Coastal Flood Map

The map detailed below shows the location of potential river and coastal flood risk. The potential risk has been modelled on the basis of an event occurring on average every 75, 200 or 1000 years.

Enquiry	Result	Contact
Is there a potential risk of river flooding within 250m of the property?	Yes	-
