Chilcombe
Hook Road
Greywell
Hampshire
RG29 1BT

13th October 2022

Homeowner Bat Survey

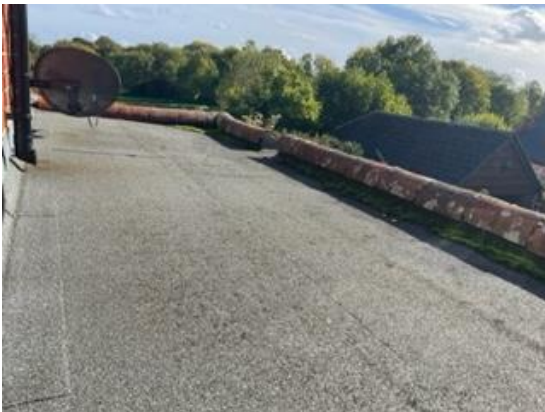
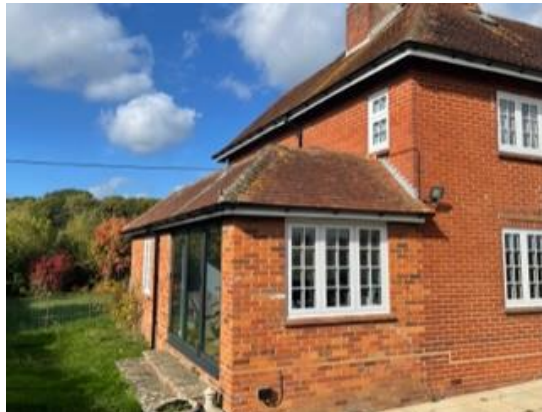
The roof area that is proposed to be modified is the main house roof: a large, clay tiled, pitched roof.

The roof is in good condition, with no obvious gaps or crevices that would allow for bats to enter.

The roof also has an integrated sky light which is well sealed and in working order.

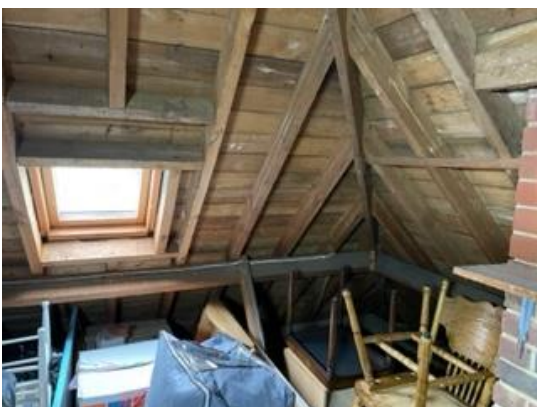
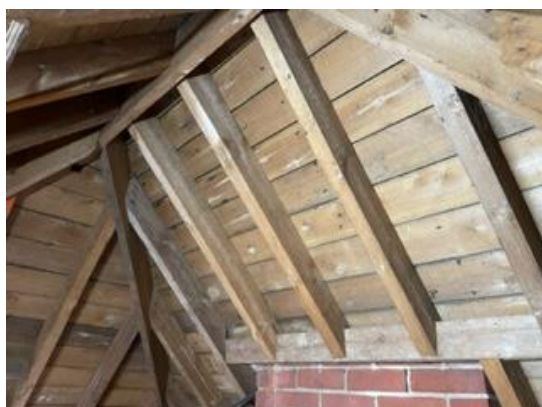
Internally, the area is boarded and insulated, with access from the second floor landing via a ladder.

It is currently used for storage.

The loft area has been inspected thoroughly and no bats or evidence of bats was observed.

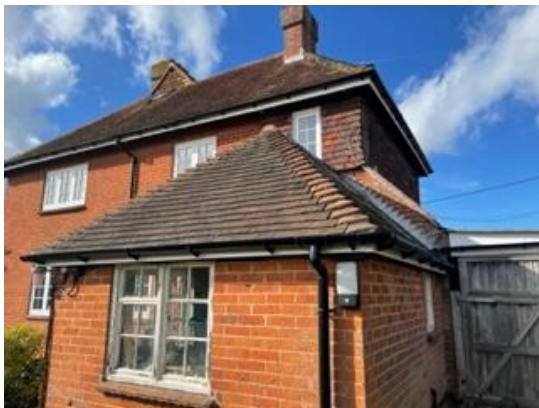
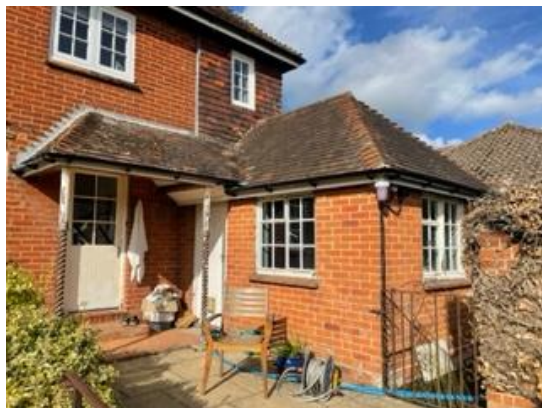
The existing Utility room roof is of pitched, clay tile composition, with no access to the void. The roof tiles and fascias are in good condition, with no sign of bats or bat nesting.

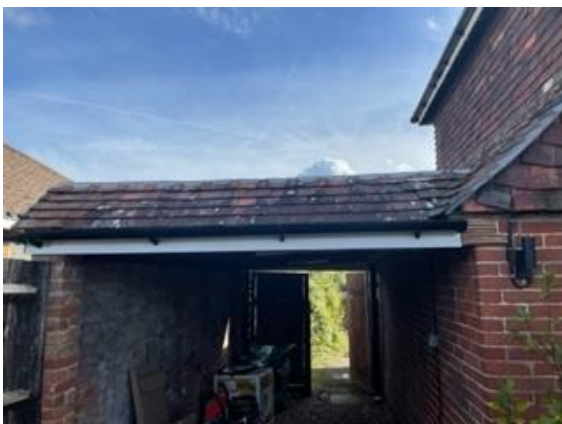
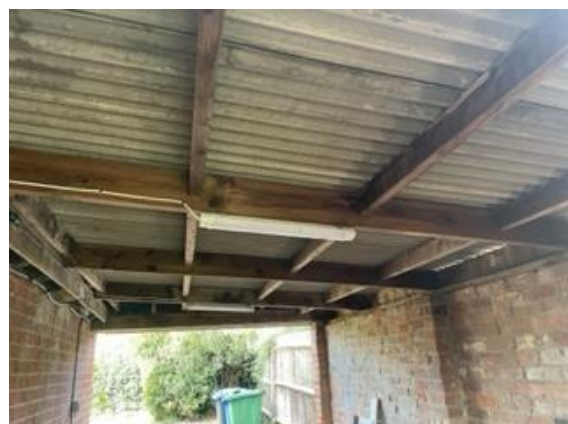
The existing carport has a flat roof with small tiled apron to the front. It is built with a timber frame and corrugated asbestos cement boards, forming a lean-to with the boundary wall. The underside of the roof is exposed and there are no signs of bats or bat nesting.
