Heritage Statement for Old Hall (EX18 7HH)

Prepared by Dr Helen Guyatt 23rd October 2022

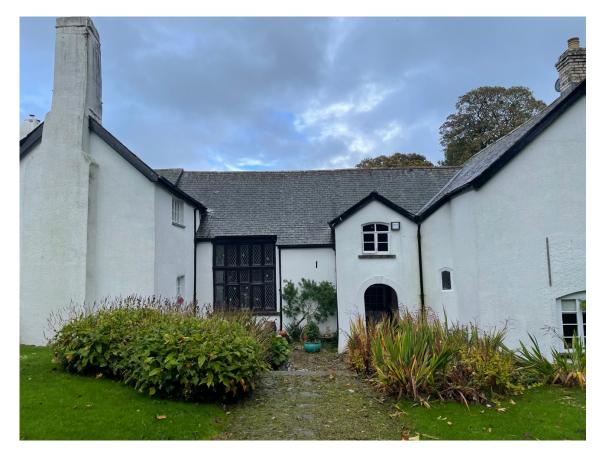
As noted above it is the medieval hall and its C16 features which justify its designation as a listed building. From the passage to the hall is a mid C16 oak plank-and-muntin screen – moulded on both sides (hall and passage). A minstrel gallery jetties in over the screen into the hall. Although the balustrade is relatively modern, the bressummer is mid C16. It is an oak beam with deep mouldings with the bottom large roll carved as a wreath of ribbon and beads. A C16 oak flat-arched doorframe containing an old plank door leads to a staircase and another smaller oak door onto the gallery. The hall has a large timber 5 light window probably built in C19 but in C17/C18 style. It contains leaded panes of glass in a geometric pattern (see photo above).

In summary, the property is located close to other listed buildings, but there are some new builds at one edge of the property near the main road. The house is hidden from view from most aspects of the road and adjacent land, even though it is in a potentially busy part of the village with the church and the village hall within 100 metres. If anyone comes to look into the property from the small gate then the view they see is the front of the house painted white (see picture above).
