HERITAGE IMPACT ASSESSMENT

PROPOSED CELLAR BEAM REPAIR TOGETHER WITH THE INSERTION OF INSULATION
BETWEEN THE KITCHEN FLOOR JOISTS

TY NEWYDD
LLANFECHAIN
POWYS
SY22 6XQ

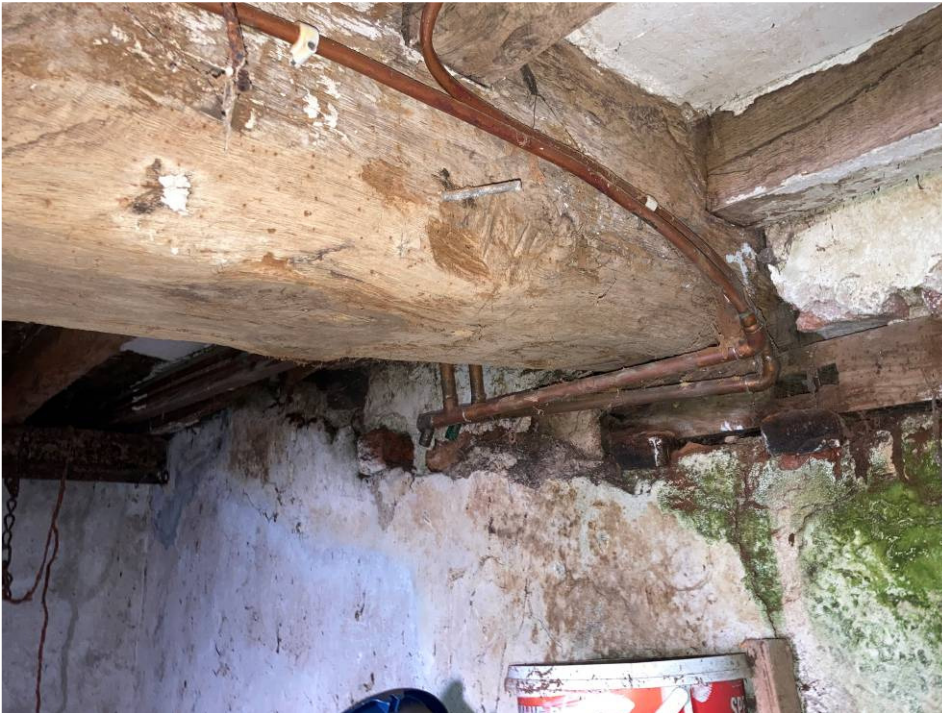
1.

Beam

It has since become apparent that a beam below the proposed Kitchen floor (visible from the cellar) has decayed and is in need of repair.

Following examination by a Chartered Structural Engineer, the proposals include fixing new steel beams either side of the existing timber beam together with the insertion of new padstones to replace the decayed timber bearers. The proposals allow for the existing beam to be retained. See Structural Engineer's calculations and supplementary letter.

Fix 150 x 90 PFC either side of existing beam with replacement concrete padstones.
See Cellar Floor Plan dwg - 16, Structural Engineer's calculations and supplementary letter.

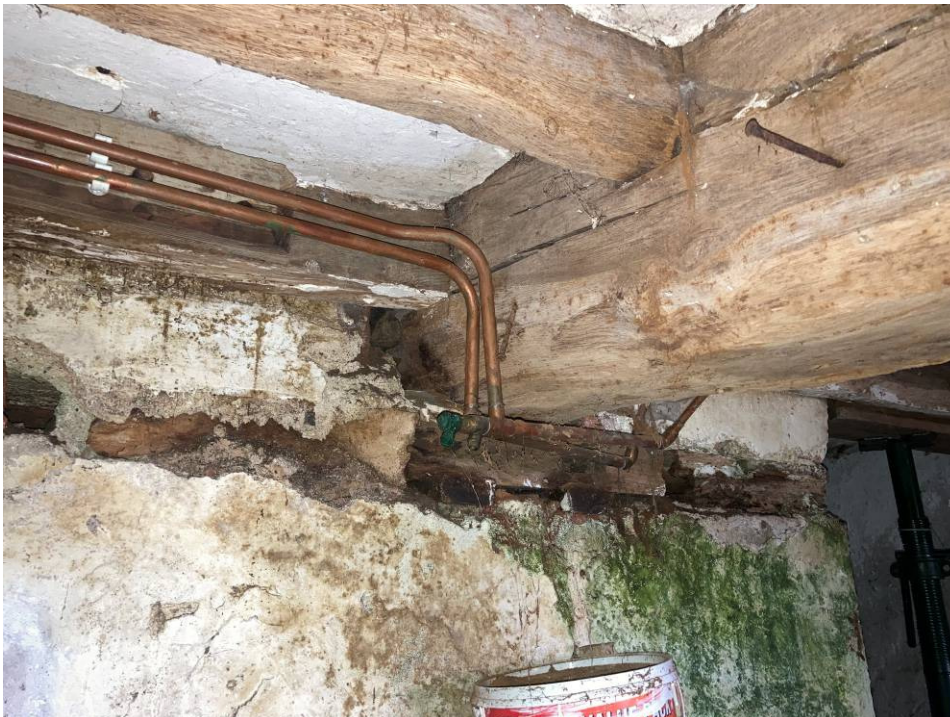
2.

Beam

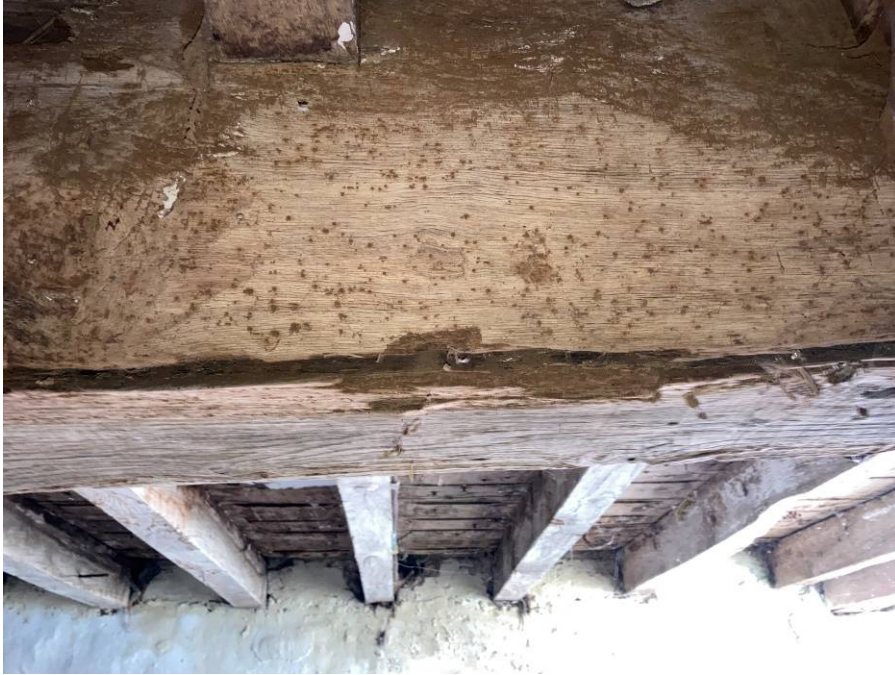
3.

Beam

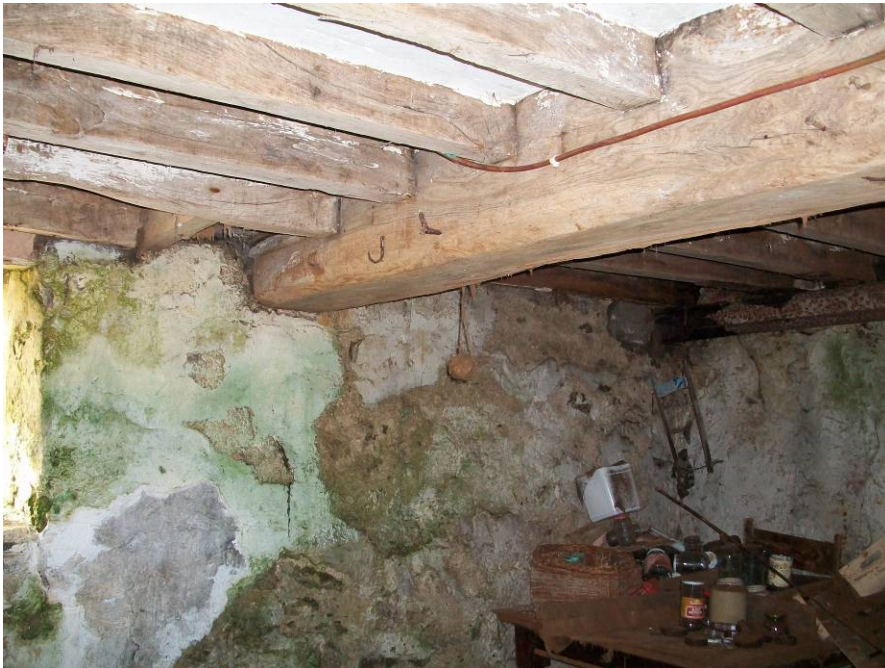
4.

Beam
