Newlands Farmhouse,
Newlands Lane, Purbrook,
Waterlooville, Hampshire,
PO7 5SH

Location & Block Plan

Roof Plan

North & South Elevations

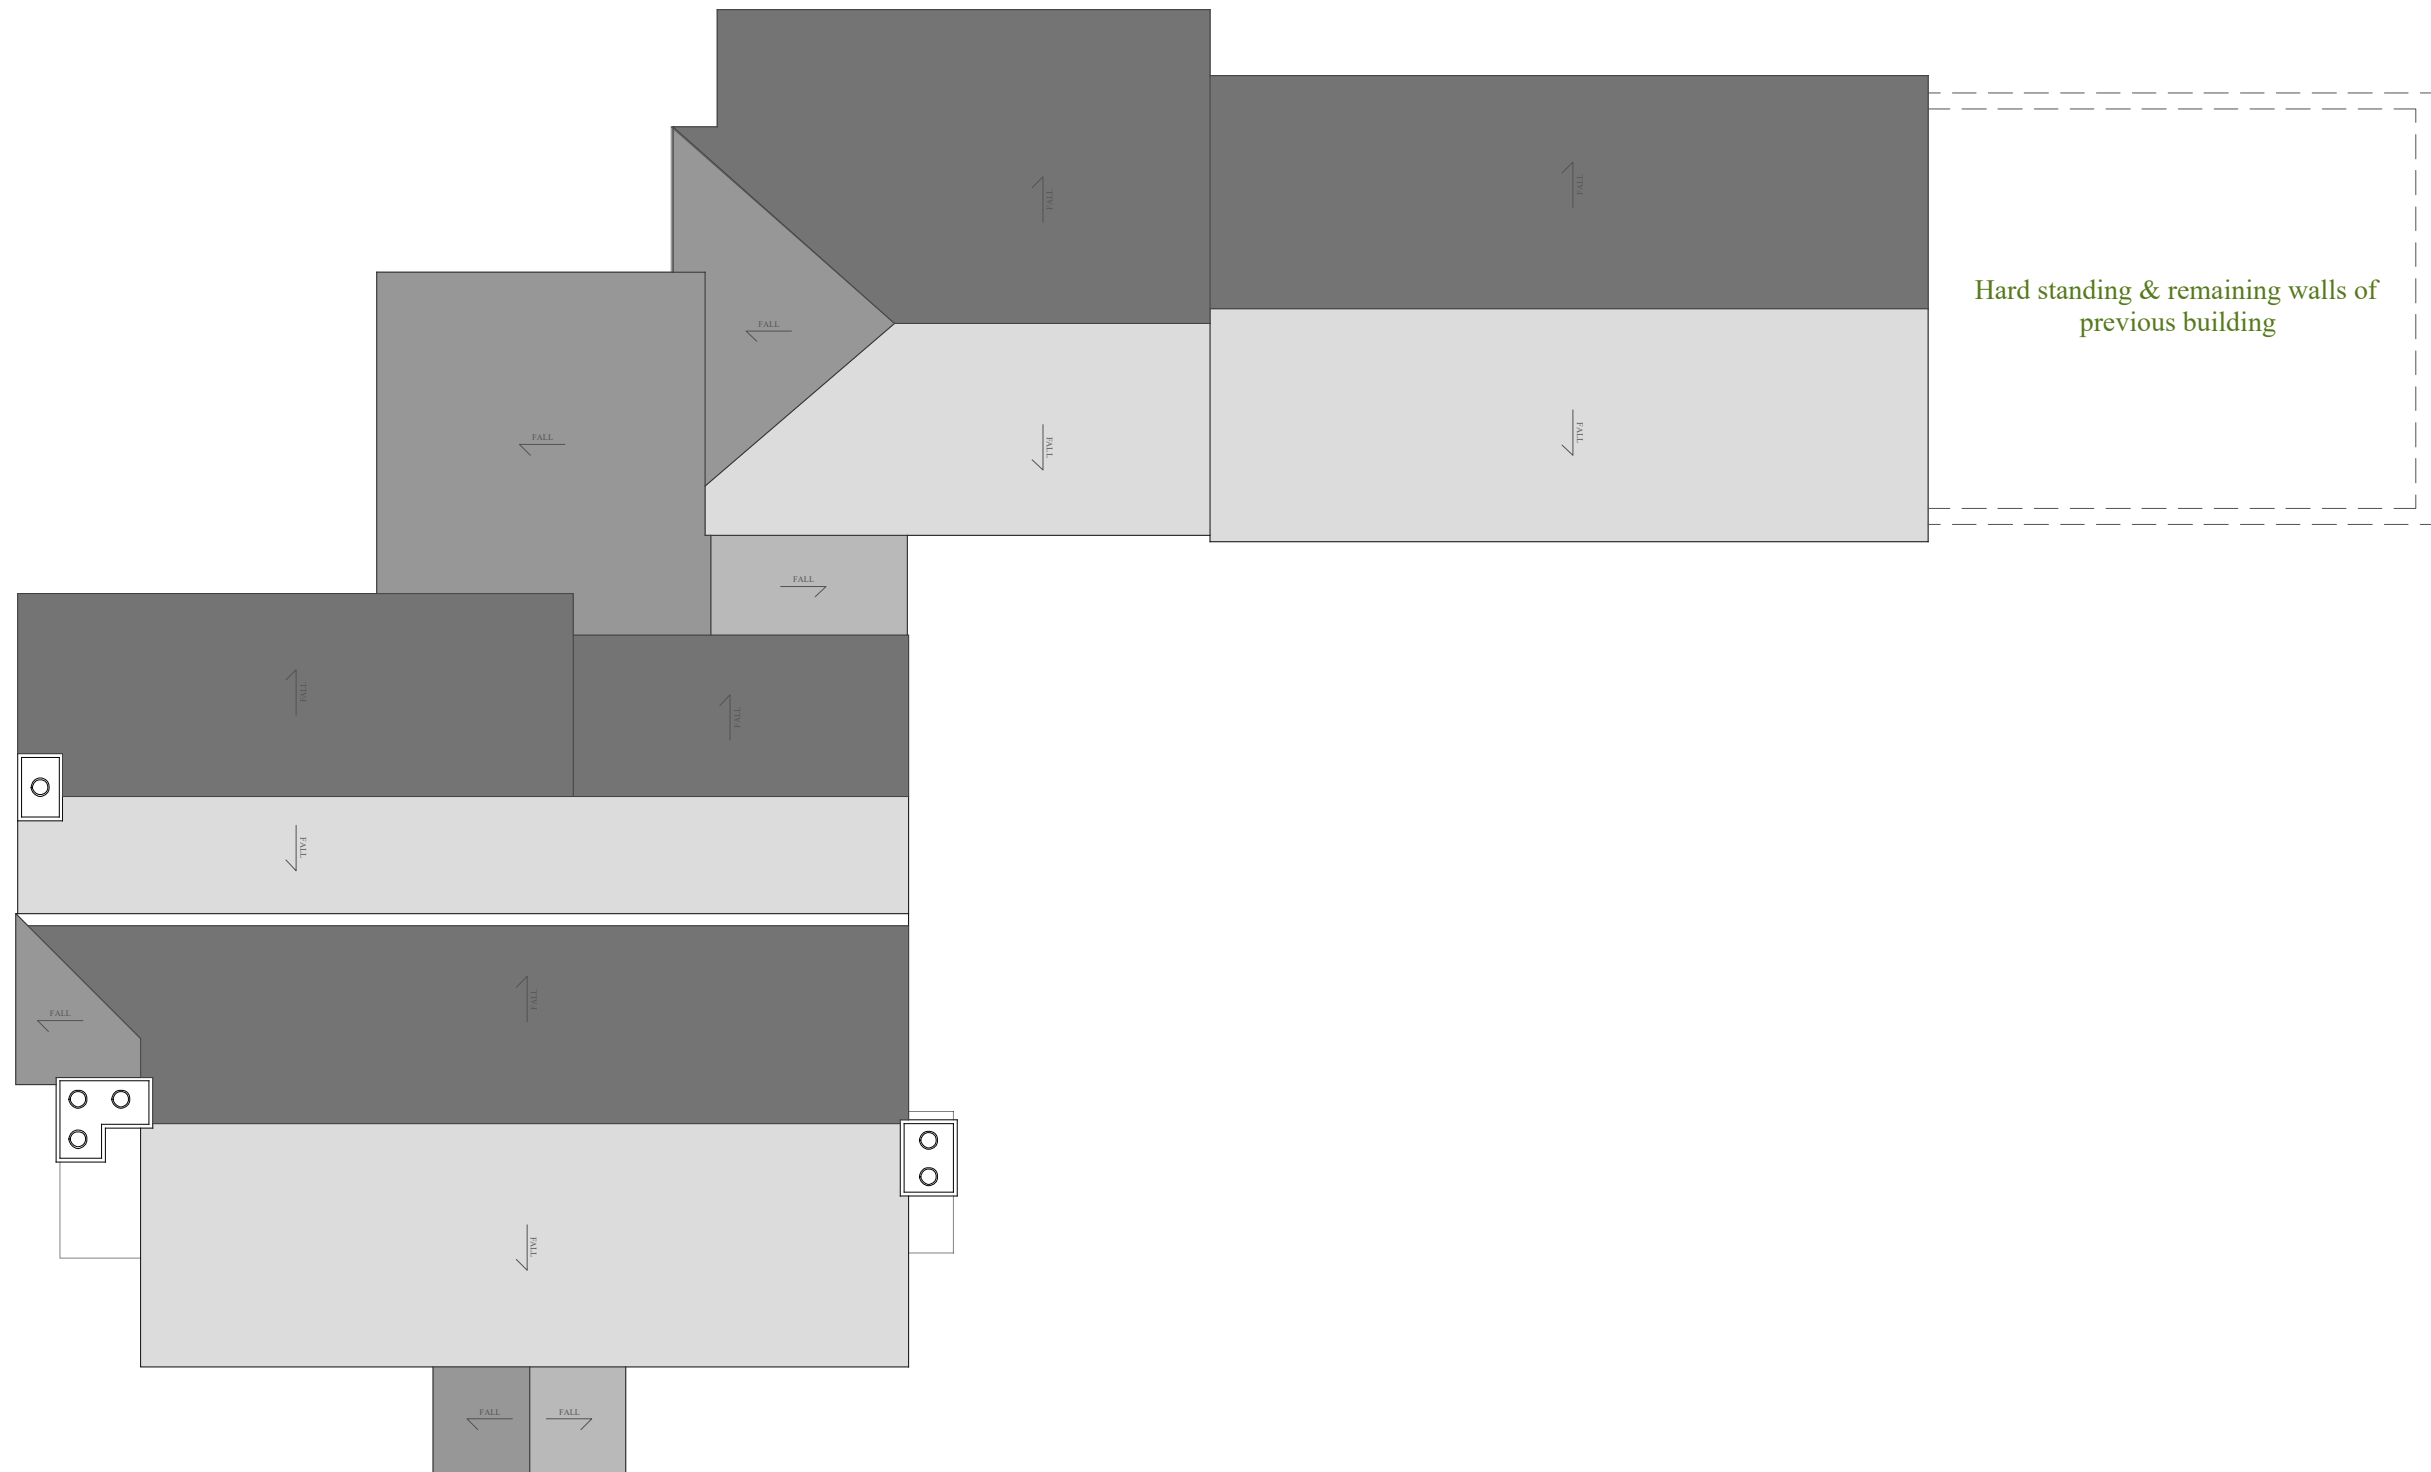
Hard standing & remaining walls of
previous building

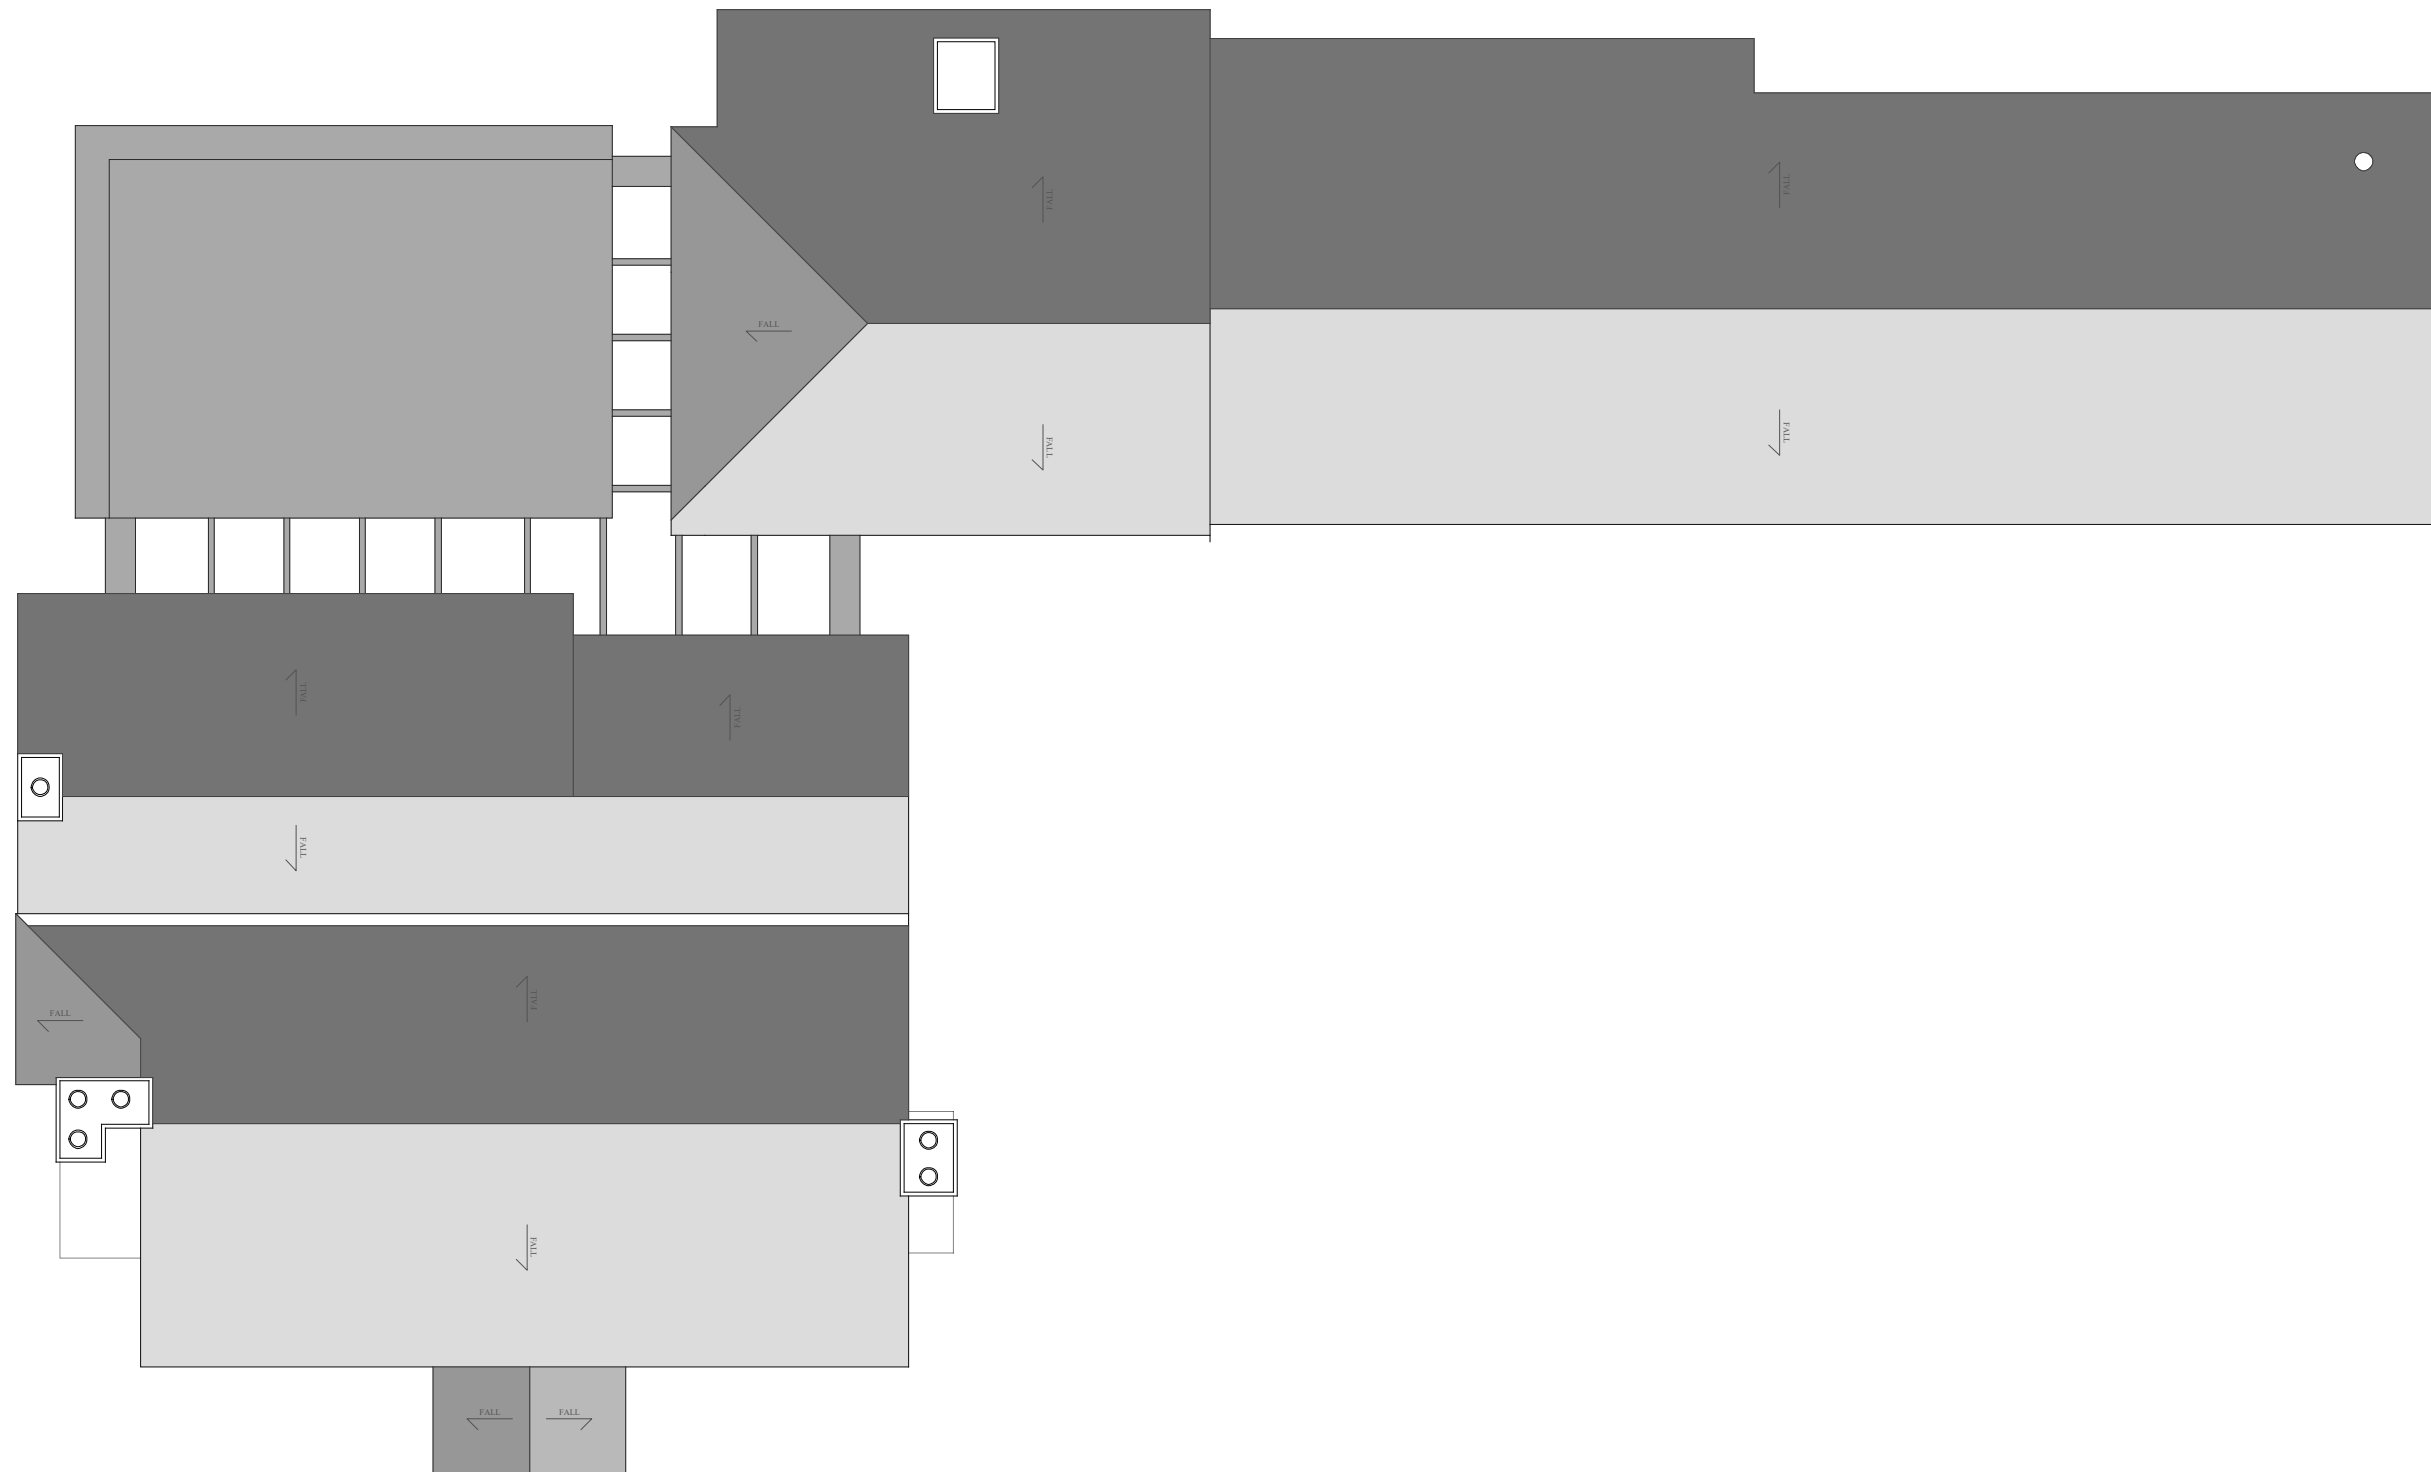
Approved brick chimney to
be replaced with metal flue

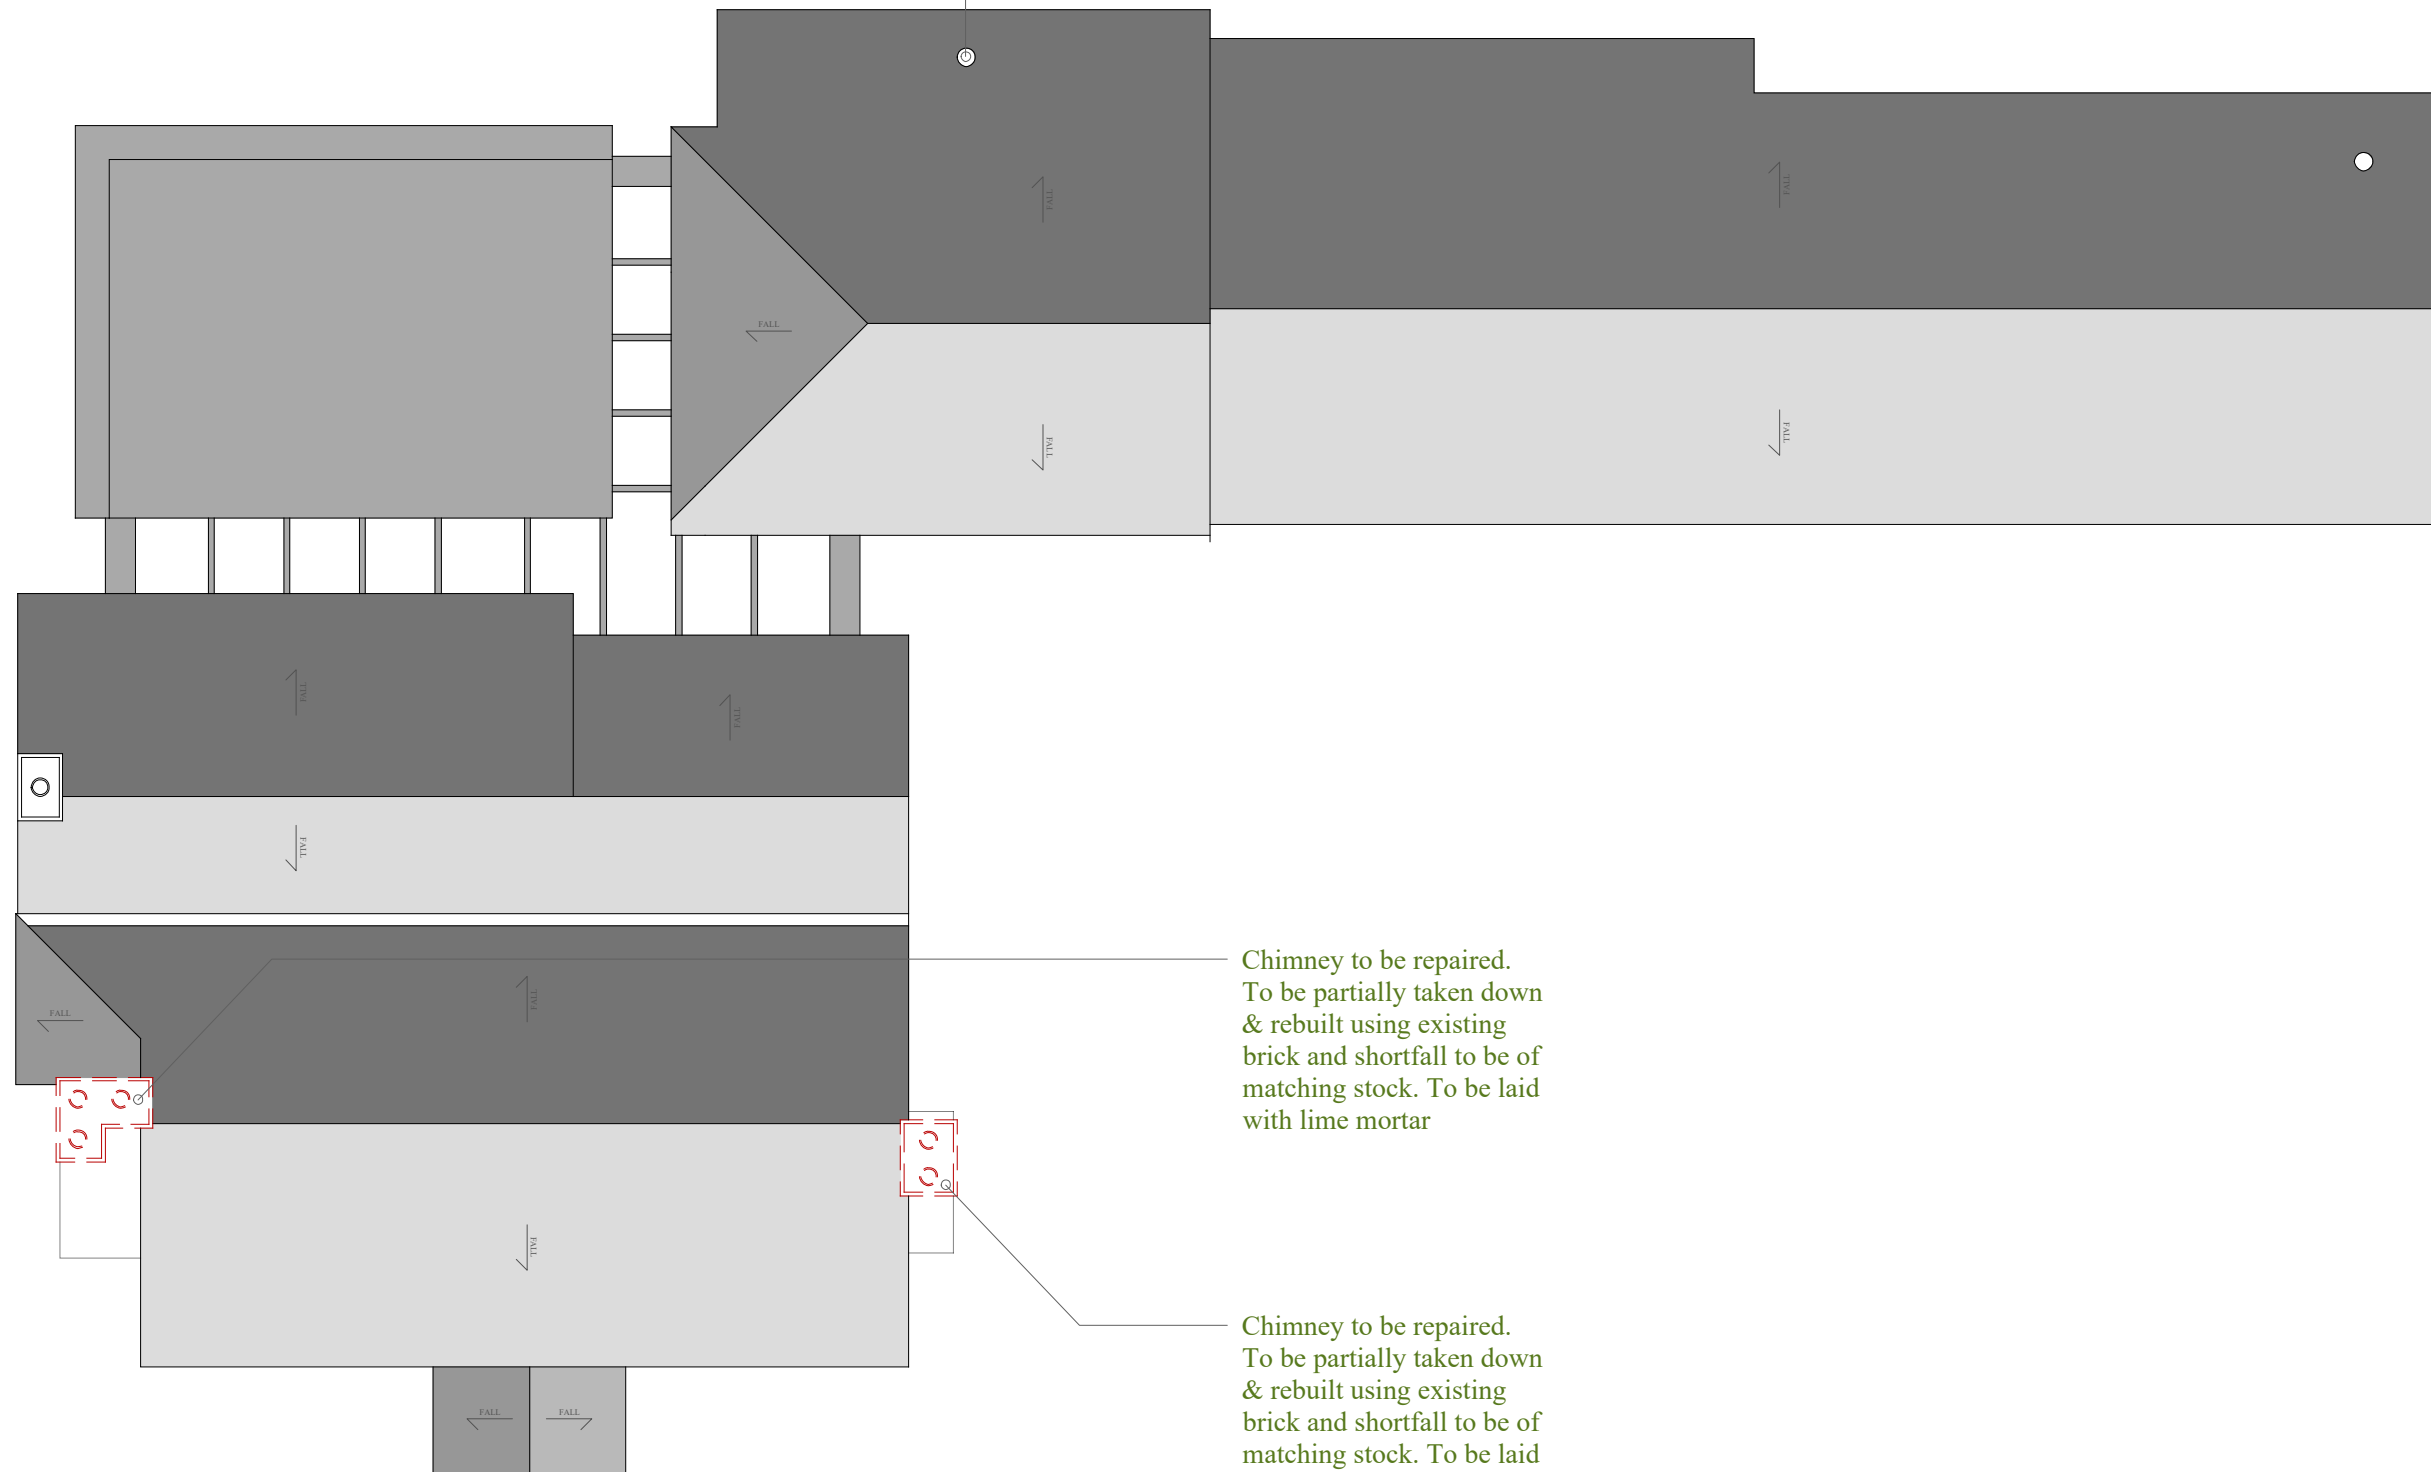
Roof Plan

Chimney to be repaired.
To be partially taken down
& rebuilt using existing
brick and shortfall to be of
matching stock. To be laid
with lime mortar

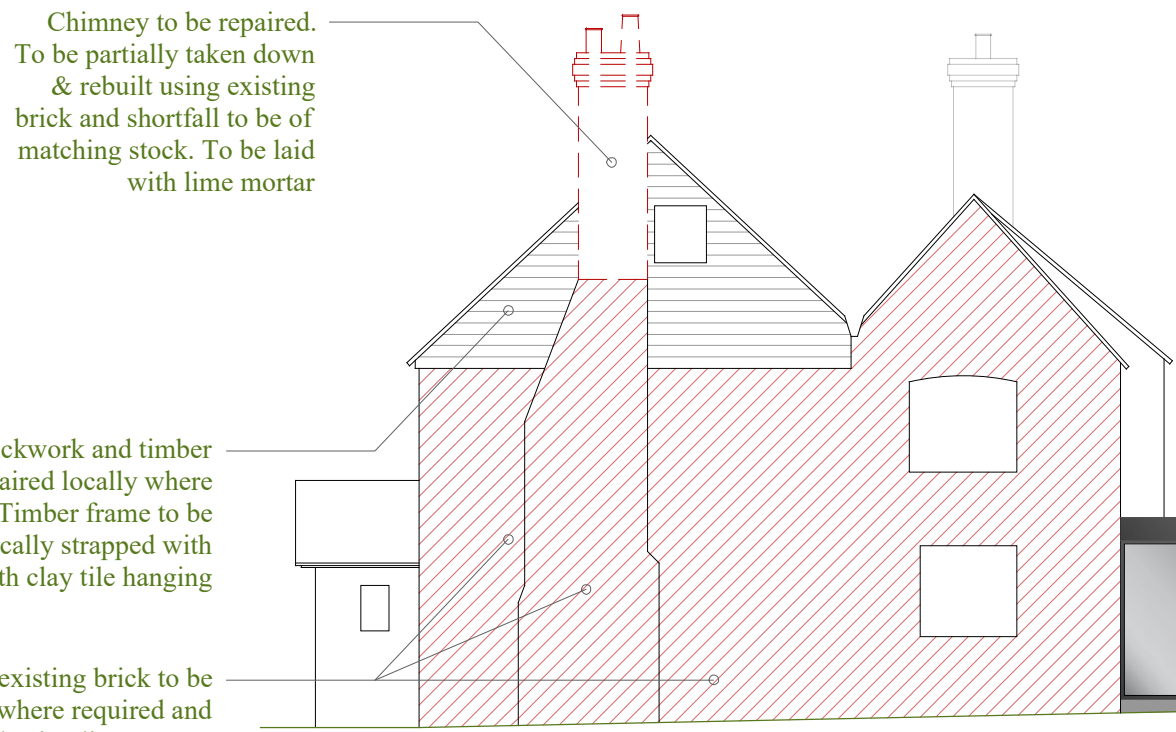
East Elevation
1:100 | PROPOSED

Chimney to be repaired.
To be partially taken down
& rebuilt using existing
brick and shortfall to be of
matching stock. To be laid
with lime mortar

Render stripped and revealed existing brickwork and timber
frame. Brick to be consolidated, repaired locally where
required and repointed using lime mortar. Timber frame to be
repaired where required and mechanically strapped with
12mm ply under battens. To be covered with clay tile hanging

Render to be stripped and revealed existing brick to be
consolidated, repaired locally where required and
repointed using lime mortar

Approved brick chimney to
be replaced with metal flue

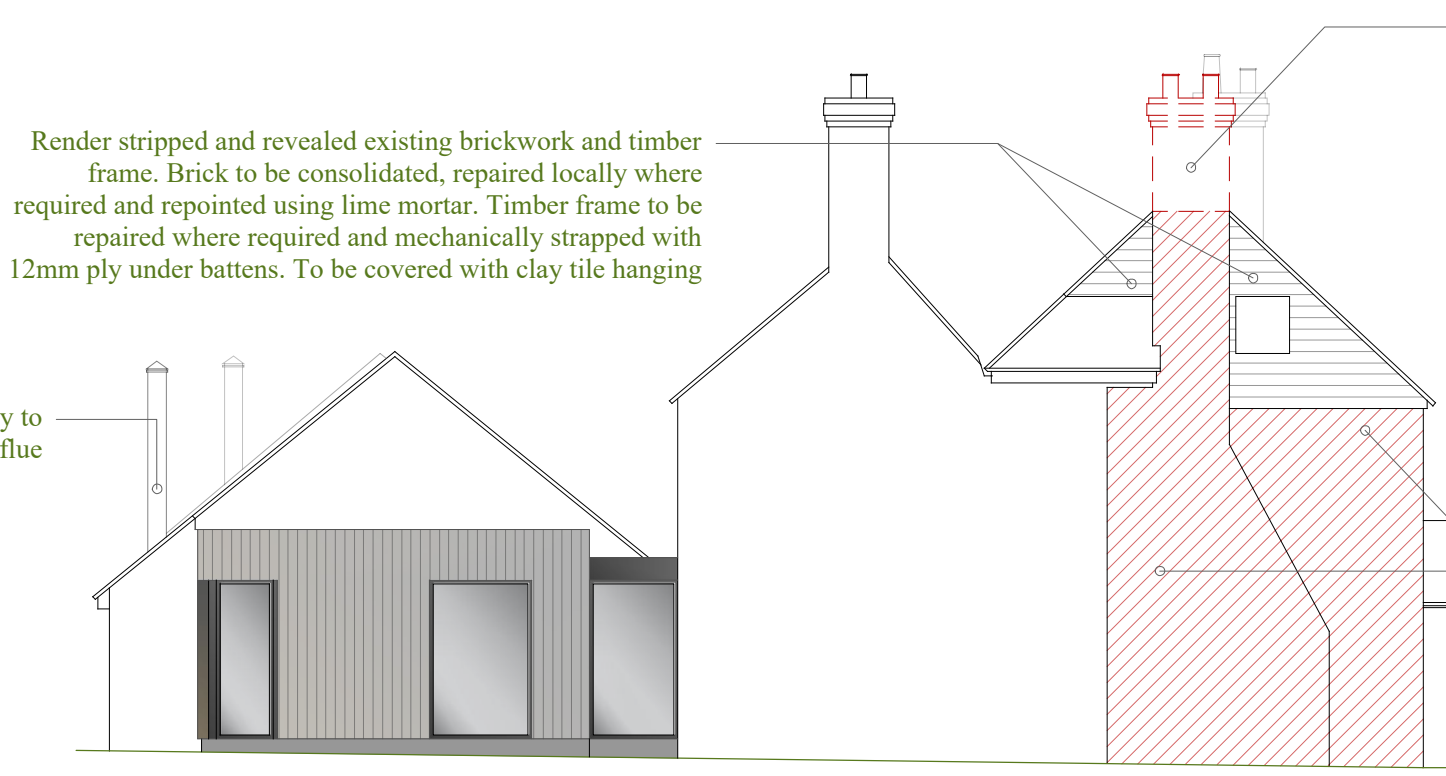
West Elevation
1:100 | PROPOSED

Render stripped and revealed existing brickwork and timber
frame. Brick to be consolidated, repaired locally where
required and repointed using lime mortar. Timber frame to be
repaired where required and mechanically strapped with
12mm ply under battens. To be covered with clay tile hanging

Chimney to be repaired.
To be partially taken down
& rebuilt using existing
brick and shortfall to be of
matching stock. To be laid
with lime mortar

Approved brick chimney to
be replaced with metal flue

Render to be stripped and
revealed existing brick to be
consolidated, repaired locally
where required and repointed
using lime mortar
