**Planning Permission: DC/22/1266/FUL Dwelling, Flax Farm, Stansfield Road,
Poslingford, Suffolk**

Planning Condition 5: Surface Water Discharge

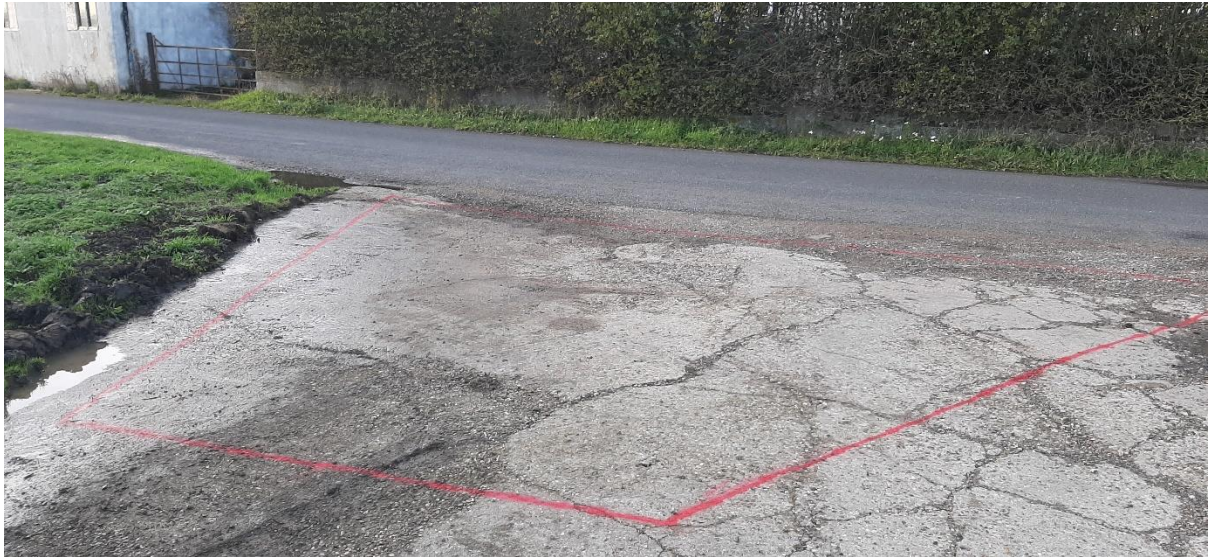
Figure 1 Existing access area sloping away from the highway

- (i) Using the existing agricultural access from site to the metalled highway, see Figure 1 below, which is made from concrete and slopes away from the highway with a fall of 1:55.
- (ii) Any excess surface water then drains into the nearby drainage ditch via land drain.

These arrangements will mitigate the risk of hazards due to rainwater accumulating in the access area and creating flowing water or ice on the highway. The existing arrangements have been in regular use by a wide range of agricultural vehicles for 50+ years with no known issues.
