**Survey & Analysis Including Heritage Statement for a Solar Installation
(Domestic) on the Lilford Hall Estate, Northamptonshire, PE8 5SG**

Nov. MMXXII

PROSPERI
Architecture & Design

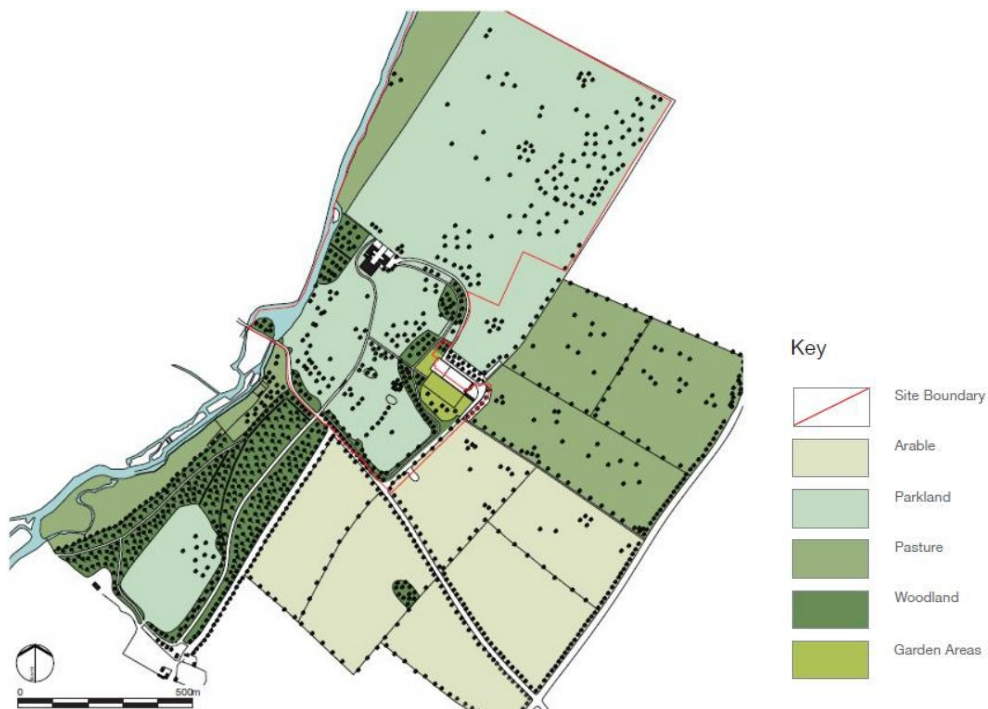
Fig. 3: Lilford Park c.1791

The 1791 plan shows the Lawn as a clearly defined of parkland sweeping up to and around the Hall with scattered trees and plantations and a drive to the southern entrance to the Hall. Plans of 1794 and 1810 indicate a drive from the north and it would seem that in the C18th and early C19th this was the main approach to the Hall, carefully laid out to conceal and reveal views.

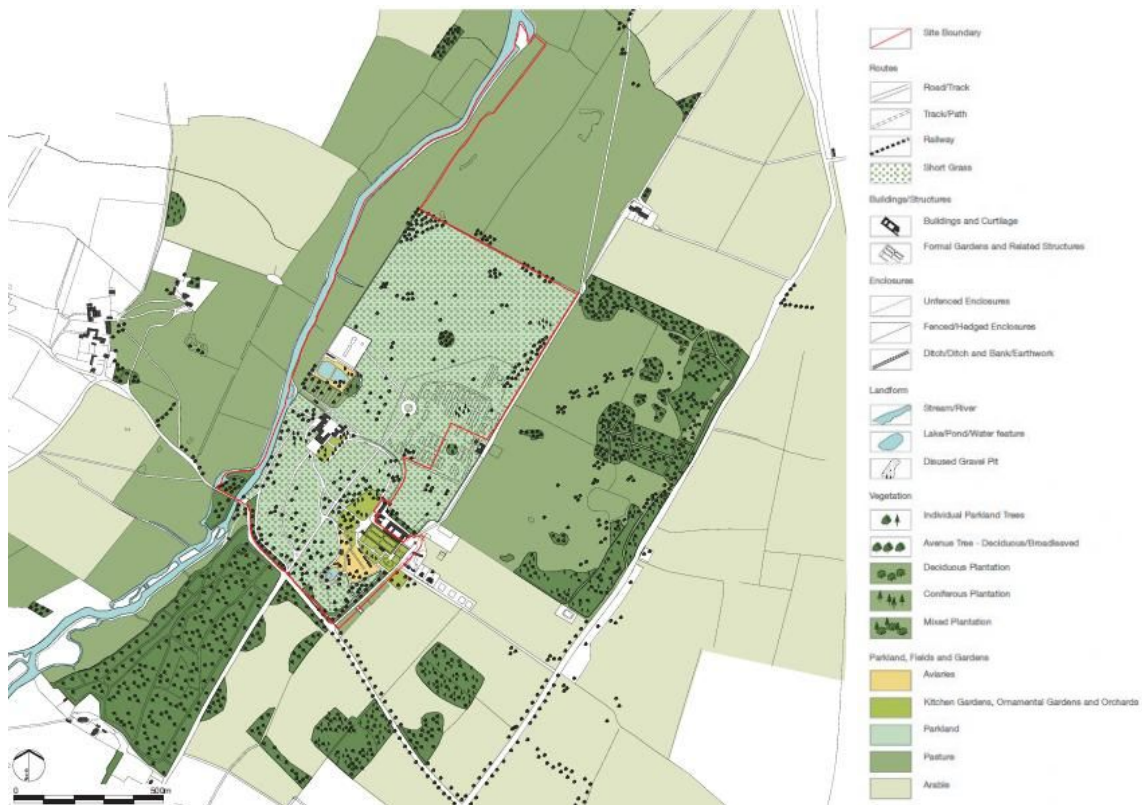
Fig. 6: Lilford Park c.1950

1940s – Lilford Park also served as the location for USAAF 303rd Station Hospital situated in the northern part of the park between 1943 and 1945. The hospital development of wards to serve 15,000 patients also involved the construction of a Ministry of Works road straight through the lawn with a bridge over the wall and ditch in the deer park, and a sewage works Post-war – After the war, the former hospital in the grounds was used to accommodate a Polish Technical School, a nursery was established with extensive new greenhouses in the outer garden. Many of the former Deer Park trees were felled.

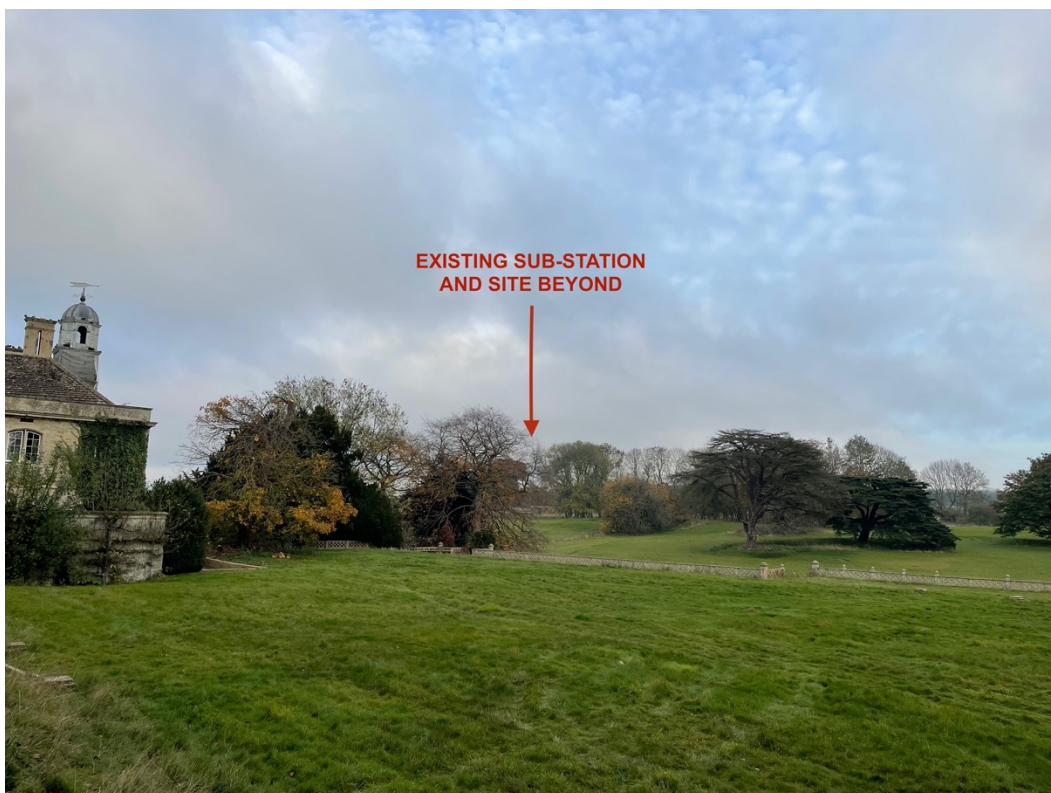
Fig. 10: View East to the Site from Lilford Hall

2.11 Lilford Hall sits approximately 286m from the proposed location of the solar panels. Even in winter, the Site is screened by existing trees such that it is not a feature of the distant view, and the proposed screening of the existing substation (which is just visible as part of the distant view from the southeast corner of the Hall as shown below) will improve the view from the Hall and mean that the overall effect of the scheme is positive.

2.12 The view to and from this significant Heritage Asset can be seen from the photographs below:

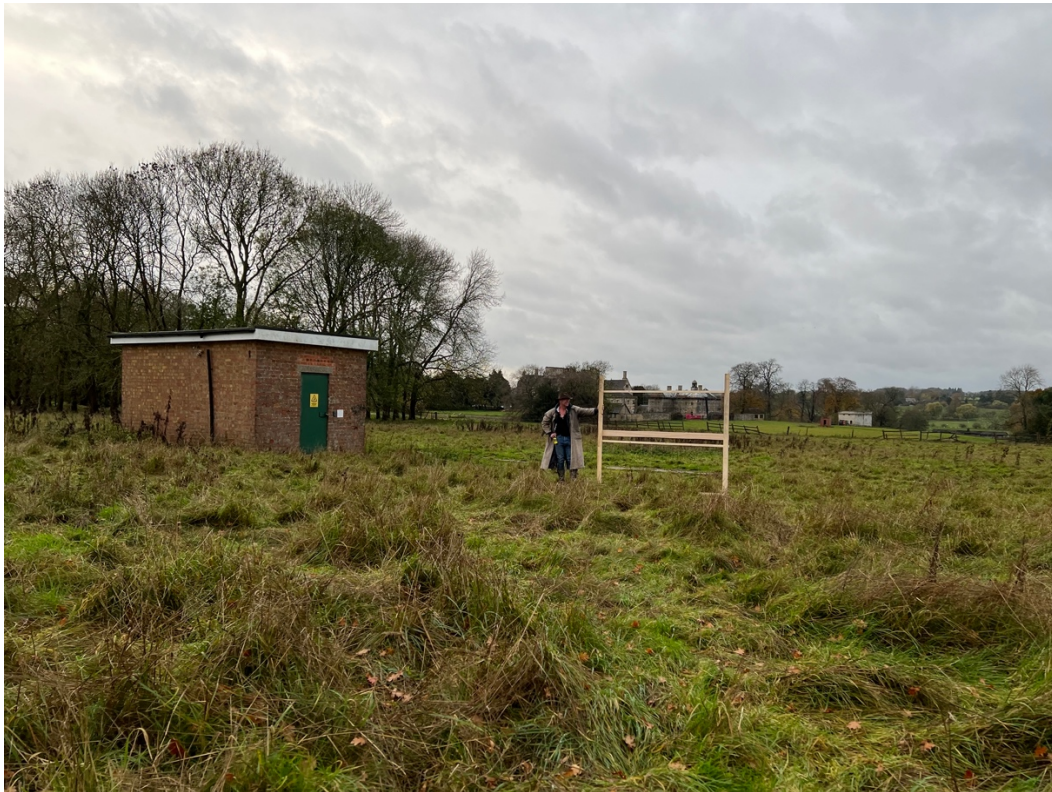
Fig. 11: View West from the site to the Stables, Coach House and Squash court

2.15 As can be seen in Fig. 11 Lilford Hall is already screened from the Site; with trees planted in clusters in front of the hedge, the effect from the pavilions and squash court will be of woodland and rural hedging consistent with the surrounding farmland as it is now and would have been prior to the construction of the WWII hospital. The photograph (Fig. 11) is taken from within the Site in the direction of the pavilions. The wooden frame is 2m to the cross strut, and it shows that a hedge of about 2m in height will screen the proposed arrays of solar panels on the Site from view from the pavilions, even without the further screening which will be provided by the planting of other trees and shrubs in front of the hedge. The intervening area will be used for habitat and biological enhancement in the form

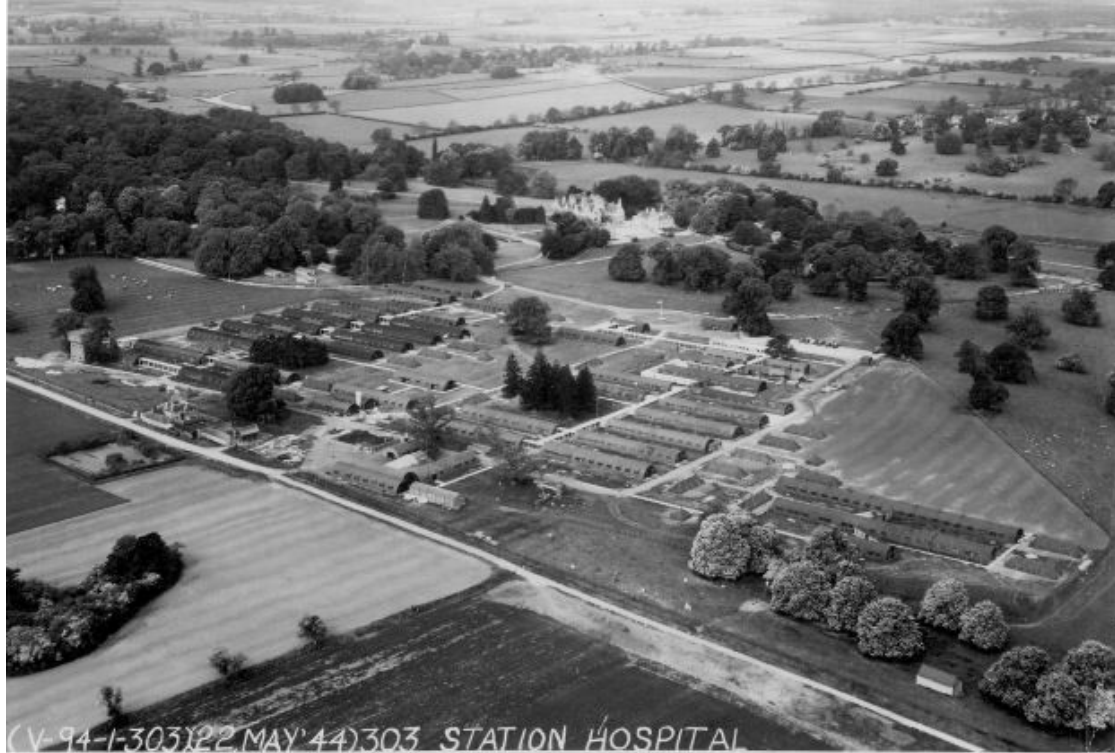
Fig. 12: Aerial view West showing WWII Station Hospital and Lilford Hall beyond (1944)

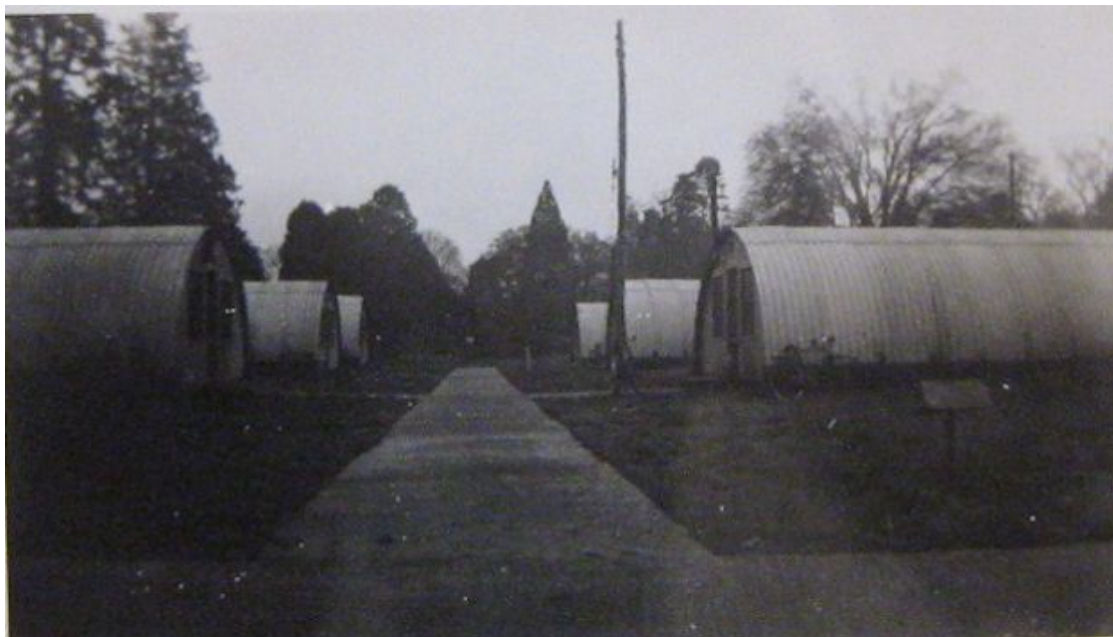
Fig. 13: Row of Nissen Huts within the Station Hospital complex (1944)

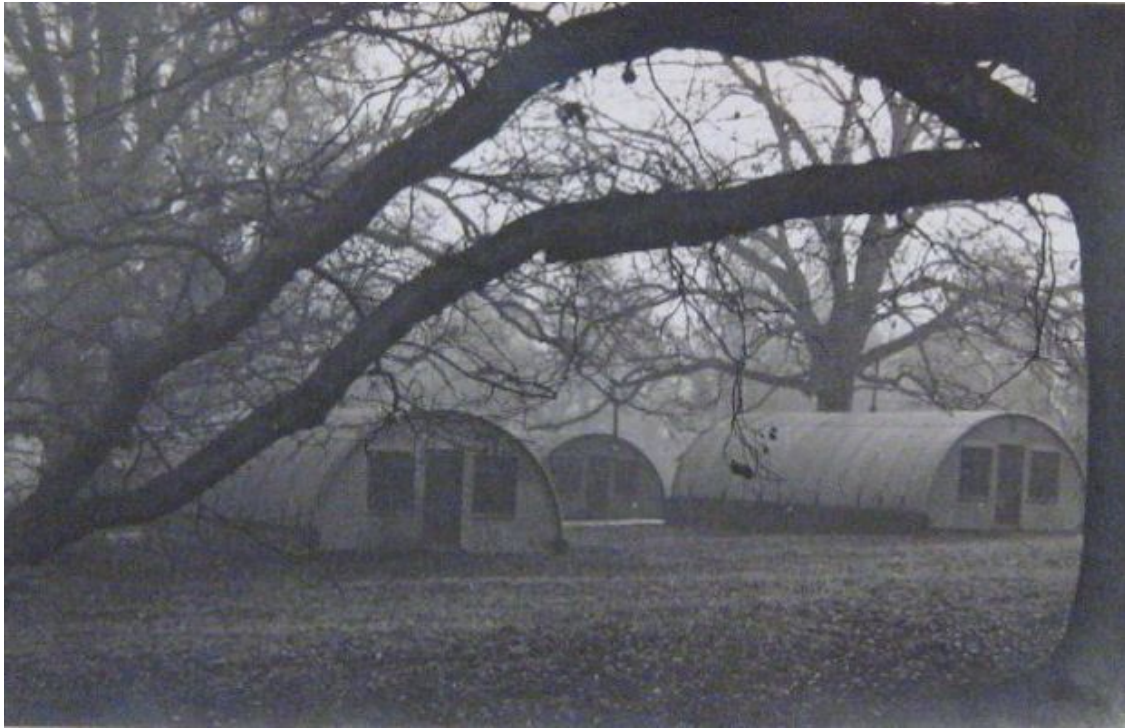
Fig. 14: Another row of Nissen Huts within the Station Hospital complex (1944)

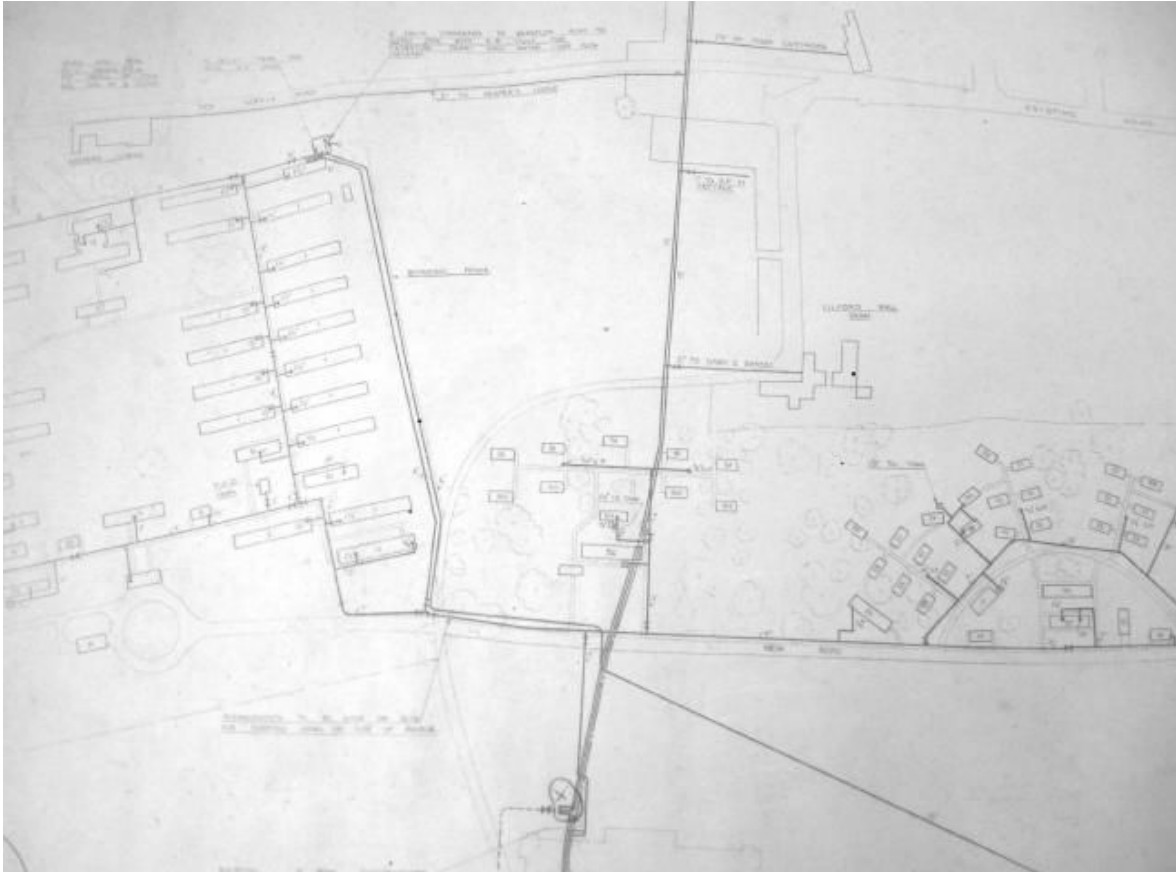
Fig. 15: Plan of WWII Station Hospital (1943)

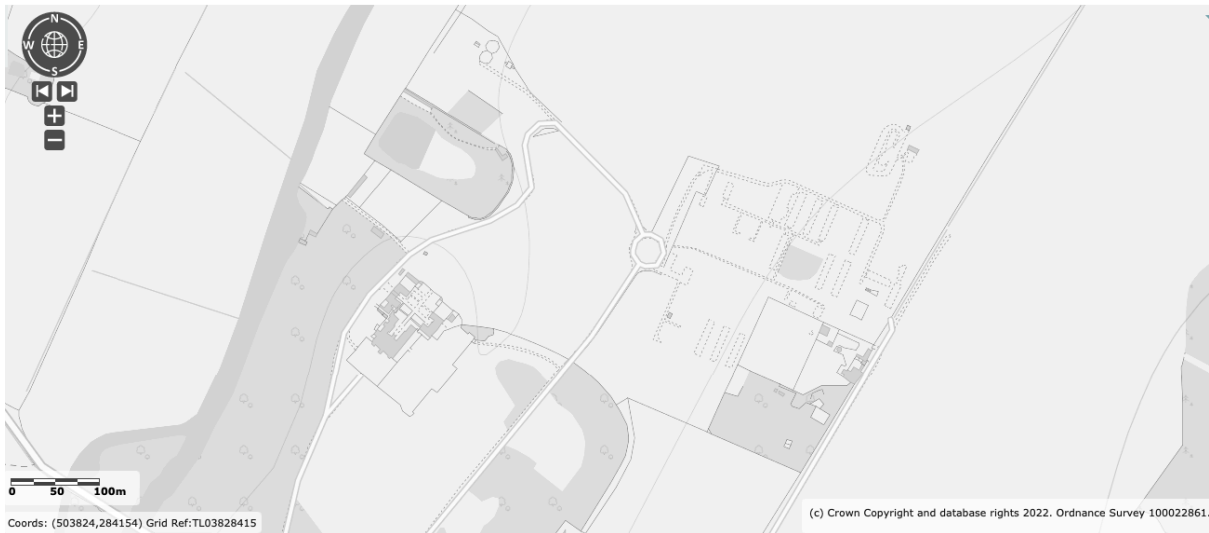
Fig. 16: Ordnance Survey map detailing layout from WWII Station Hospital (2022)
