CLOSE HOUSE
Dalton, Northumberland, NE18 0AA

EXISTING GROUND FLOOR

CLIENT | MR & MRS CHARLTON

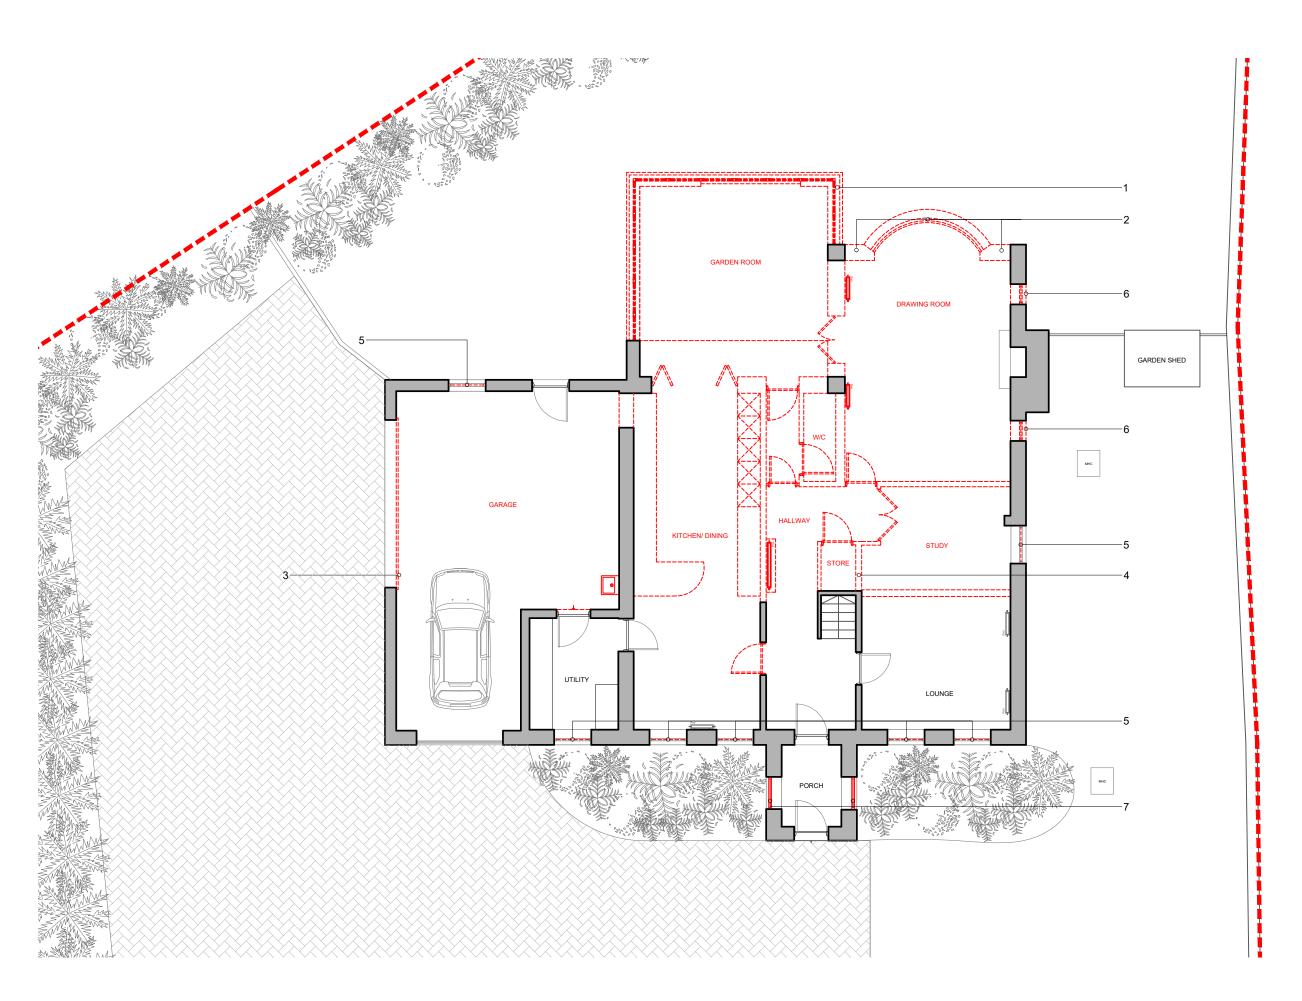
- Existing glazed walls and roof removed Existing curved bay and side walls removed Existing garage door removed Internal walls and partitions removed Existing windows to be refurbished Existing opening to be cut down to floor level, cill retained for re-use and window replaced Existing porch windows to be replaced with windows from master bedroom and refurbished to create two over two astragal pattern
