Carrycoats Hall
Garden Room & Terrace
2032

HERITAGE STATEMENT (Rev.A)

March 2023

HERITAGE STATEMENT: CARRYCOATS HALL GARDEN ROOM & TERRACE

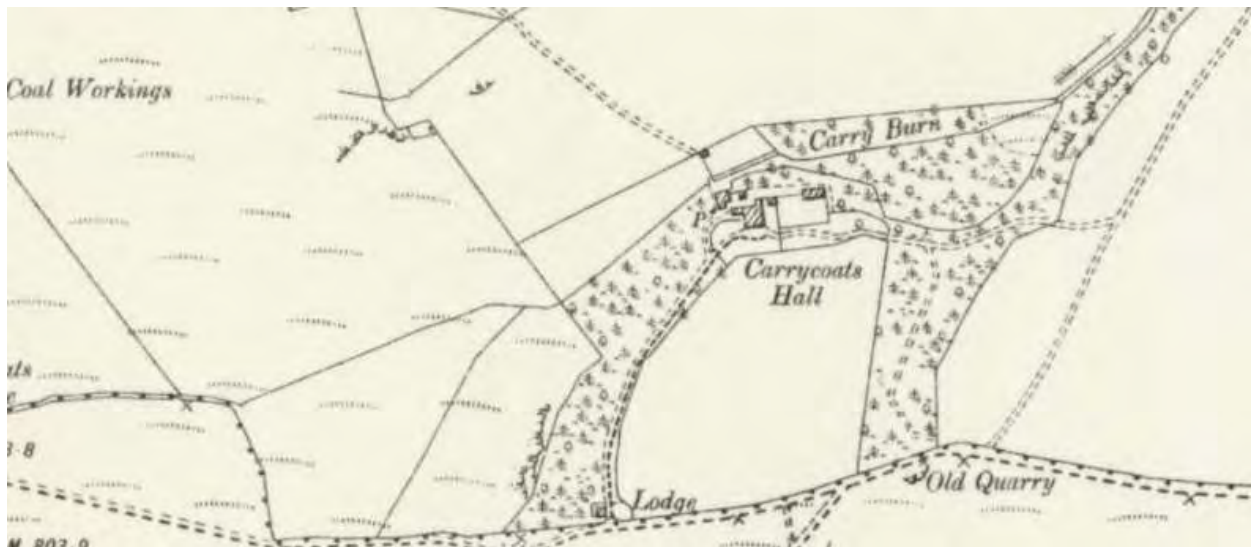
Apart from minor changes to the interior of the buildings these are currently similar to how they were constructed. Various C19 outbuildings and walls were added to the north and east which are curtilage listed, and the layout as shown on the 1888 – 1913 6" to 1 mile map below is unchanged.

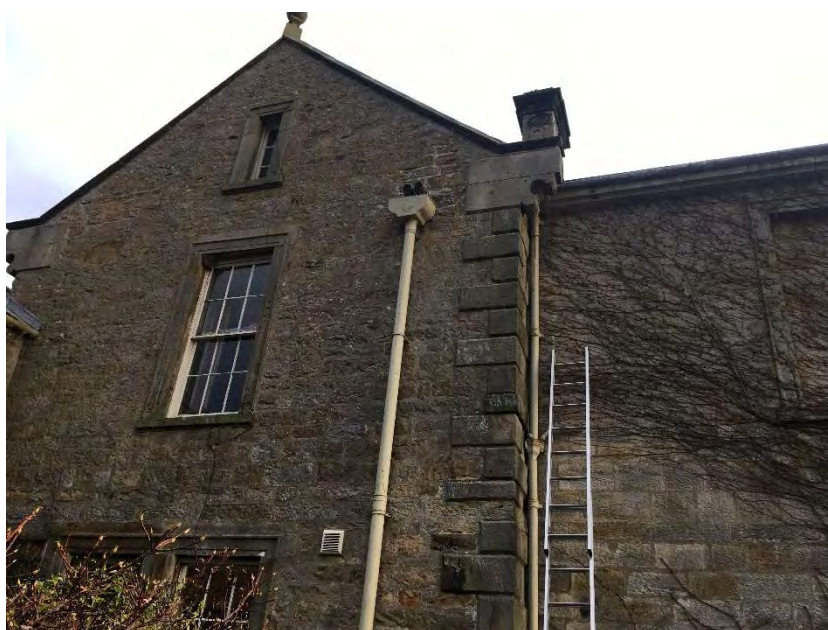
Photo 4
West elevation with screened oil tank in garden

The three south facing ashlar stone gables date from 1837 (*Burns at Carrycoats* ISBN0903 837 021), (see plans 2032 L1 & L6, and sketch Appendix 7.2). This work presumably blocked the south facing windows in Phase 2 and the latter was remodelled with new east and west facing windows to match the new south gables, which included the distinctive large kneeler stones, copings and ball finials (see photographs 1-5, 8 & 9).

9. Scrape away topsoil from terrace area (see plan 2032 L11), install shallow concrete foundation, average depth 150mm (see elevation 2032 L14), lay and compact sub-base and finish with stone flags and wide stone steps to west and south (see photographs 2 & 4).

10. Install cast iron ogee-section gutter and connect to existing cast iron rainwater pipe which is to be offset 450mm to south to miss proposed extension (see photographs 4, 5, 8 & 9).

11. Relocate extract fan from Kitchen on west gable (see photographs 4, 5, 8 & 9).
12. Lower floor in kitchen back to previous level to match rooms to east and south (see photographs 11 & 12).

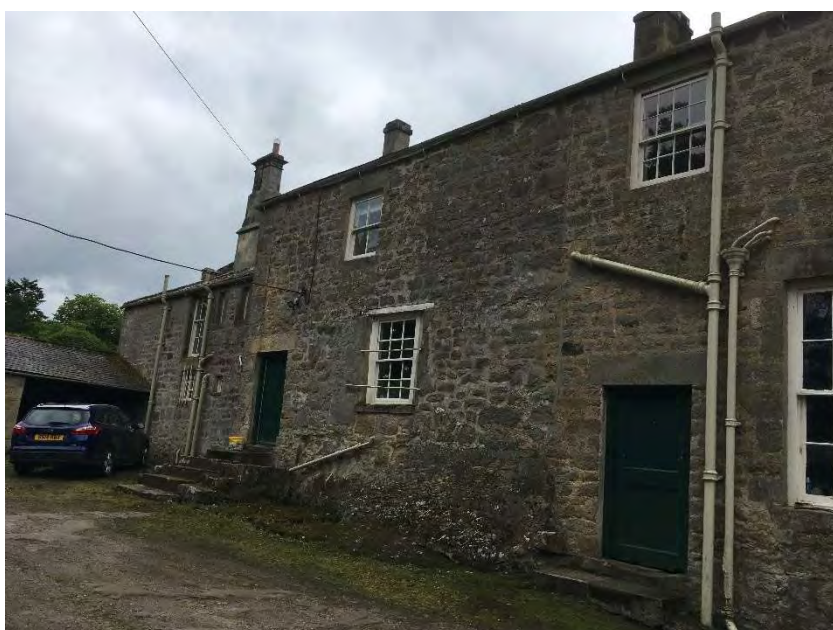
Photo 5
Close up of west gable showing
kneeler stones.

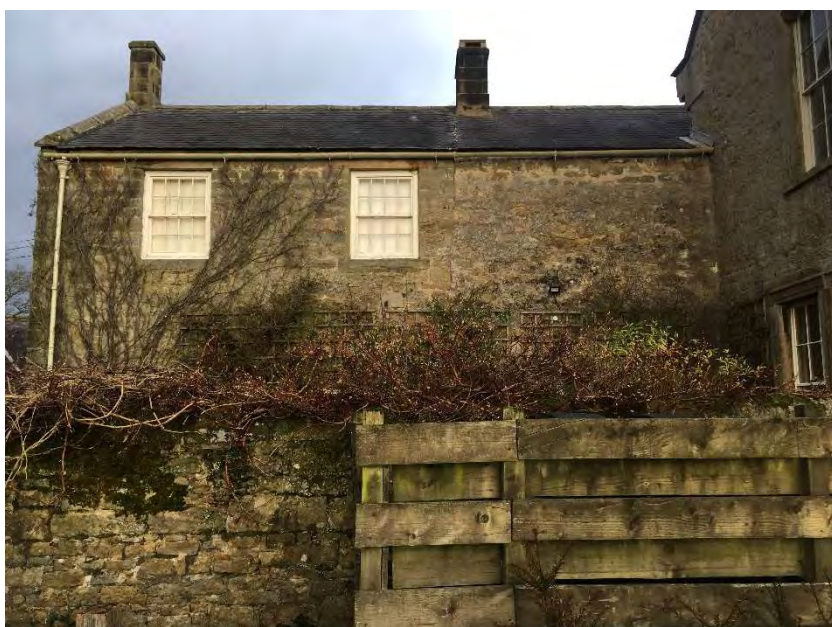
Photo 7
North Wing from south with oil tank
screen and garden wall in
foreground.

The west end of the north wing was extended in thinner walled rubble in 1887 (*Burns at Carrycoats* ISBN0903 837 021), (see plan 2032 L1, elevation 2032 L4, sketch Appendix 7.2 and photographs 2,3,7 & 10).

1. Dismantle 7 linear metres of garden wall with round topped copings, reform end and install new metal gate (see plan 2032 L11, elevation 2032 L14, detail 2032 A1 and photographs 7, 8 & 13).
2. Prop above existing west window to Kitchen and salvage pair of windows and stone surrounds for re-use in extension (see section 2032 L15). Remove 500mm of stonework below cill and form jambs each side using stone that has been removed (see photographs 8 & 9).
3. Remove macadam surfacing from extension (see plan 2032 L11 and photograph 8).

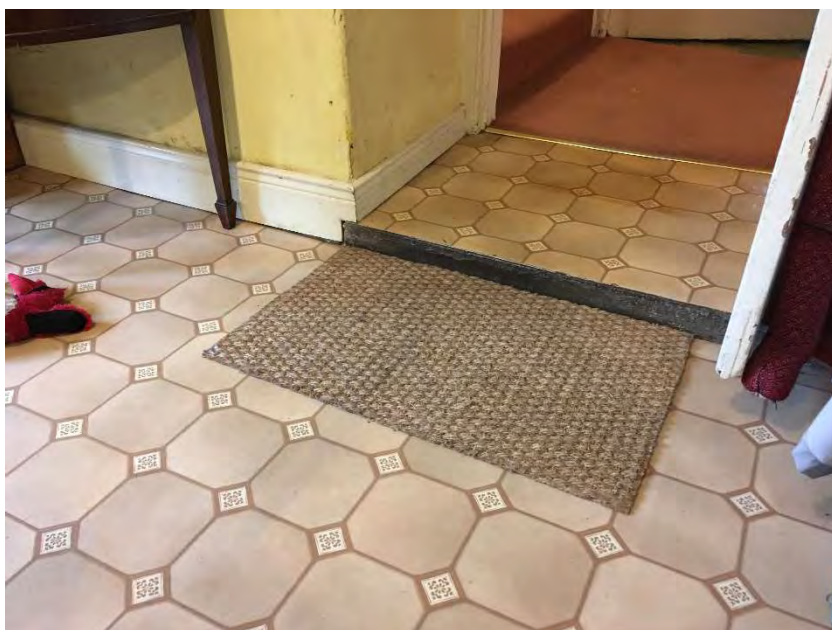
Photo 11
Vinyl flooring to kitchen over
cement screed with 90mm step up.

12. Removal of approximately 90mm of C20 concrete in kitchen will return the floor to its original level, leaving a full 160mm step up to the north wing.

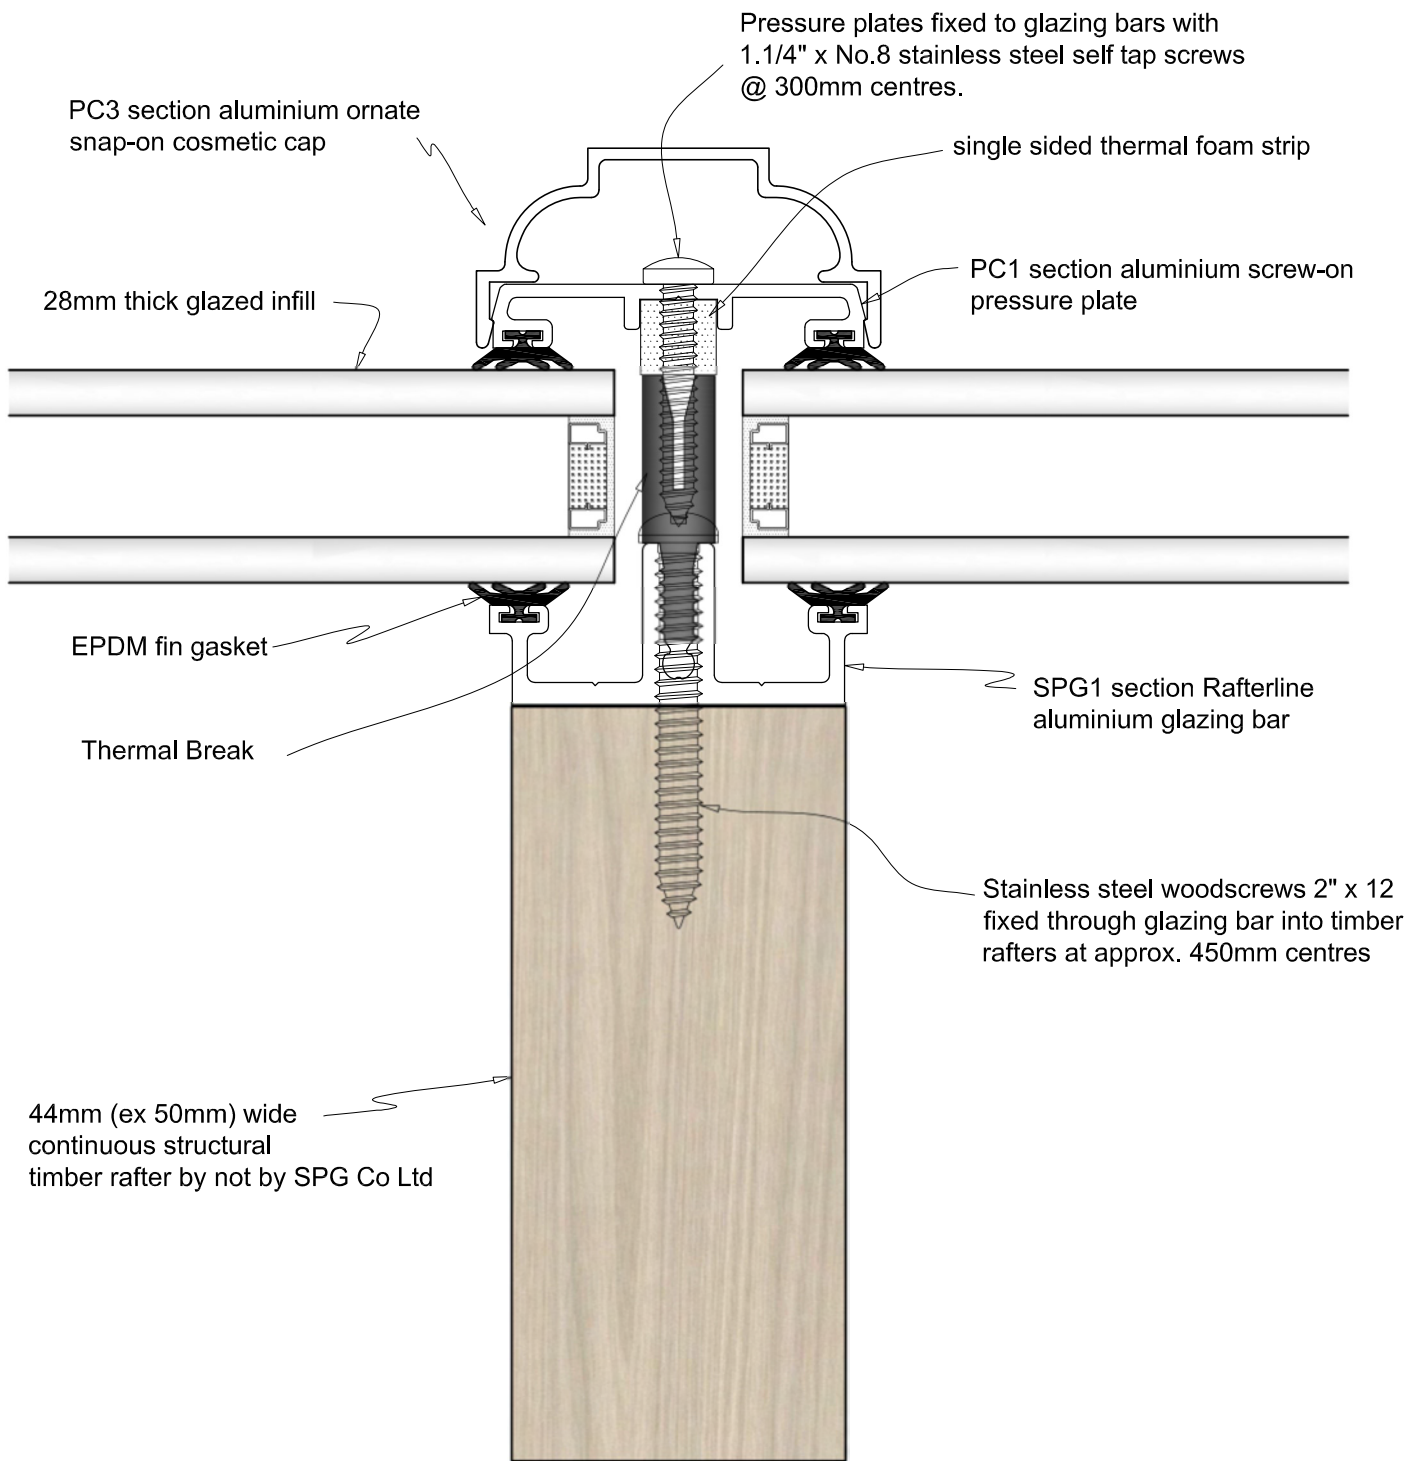
Drg No. RD-1021 < use this ref for downloading from our website	
Title : Rafterline Glazing details Section through Double Glazing bar	Scale: 1:1
download from www.patent-glazing.com/pdf/rafter --- for .pdf format download from www.patent-glazing.com/cad/rafter --- for .dwg format

6. The new roof will be finished in Welsh slate to match that on the Hall. The double glazed ridge light will be low profile and finished with lead flashings by The standard Patent Glazing Company (see Appendix 7.3). The roof will be supported on 4No. 100 x 75mm rectangular hollow steel portal frames which are to be built into the new stone piers on the south elevation and support the new roof structure (see section 2032 L15). These will be fixed through plates with removable anchor bolts into the south elevation of the north wing adjacent the walk-in lead gutter. (There will be no fixings required into the Hall west gable as the roof will be supported on the eastern-most truss). This gutter will be laid to fall to west, have 2No. drips and be lined in Code 7 lead (see roof plan 2032 L16). This will provide access to maintain the wall, windows and gutter above.

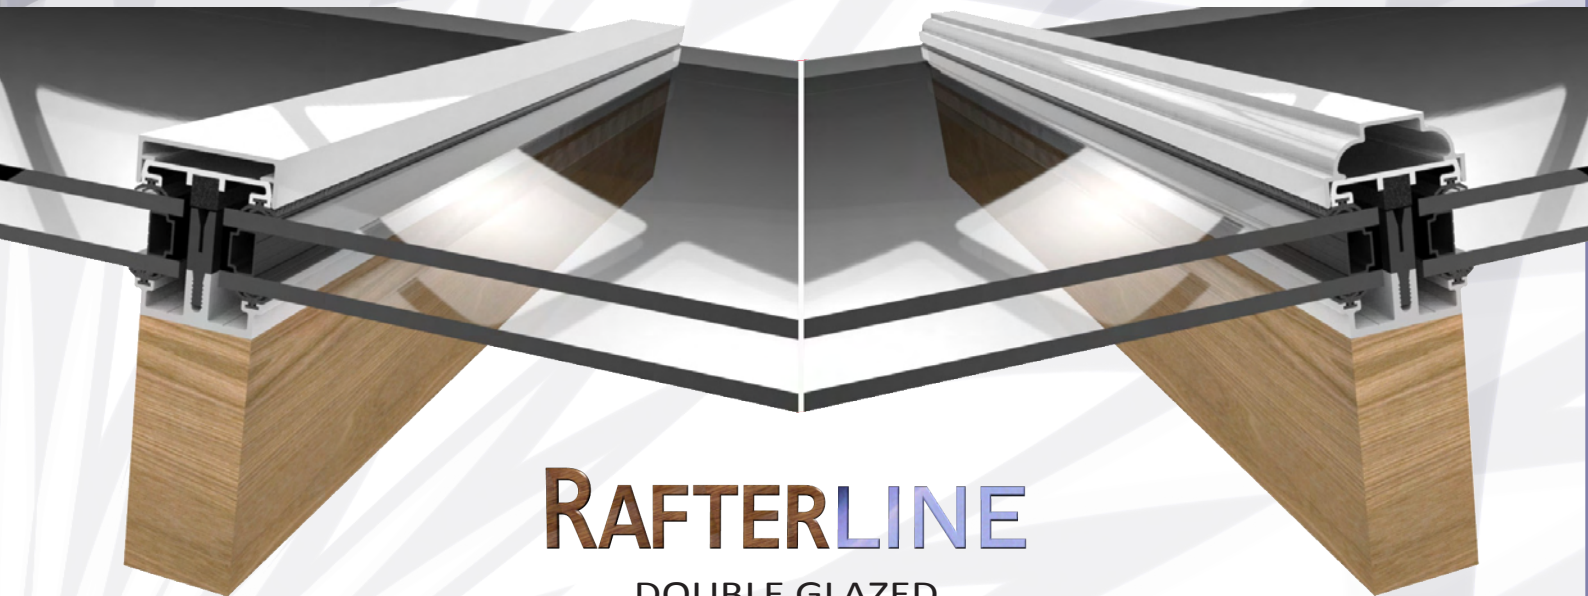
RAFTERLINE DOUBLE GLAZED

Rafterline SPG1 type thermally broken extruded aluminium Glazing Bar with screw-on PC1 capping and snap-on cosmetic square topped PC2 capping section - double glazed with 28mm thick double glazed units

Rafterline SPG1 type thermally broken extruded aluminium Glazing Bar with screw-on PC1 capping and snap-on cosmetic ornate topped PC3 capping section - double glazed with 28mm thick double glazed units

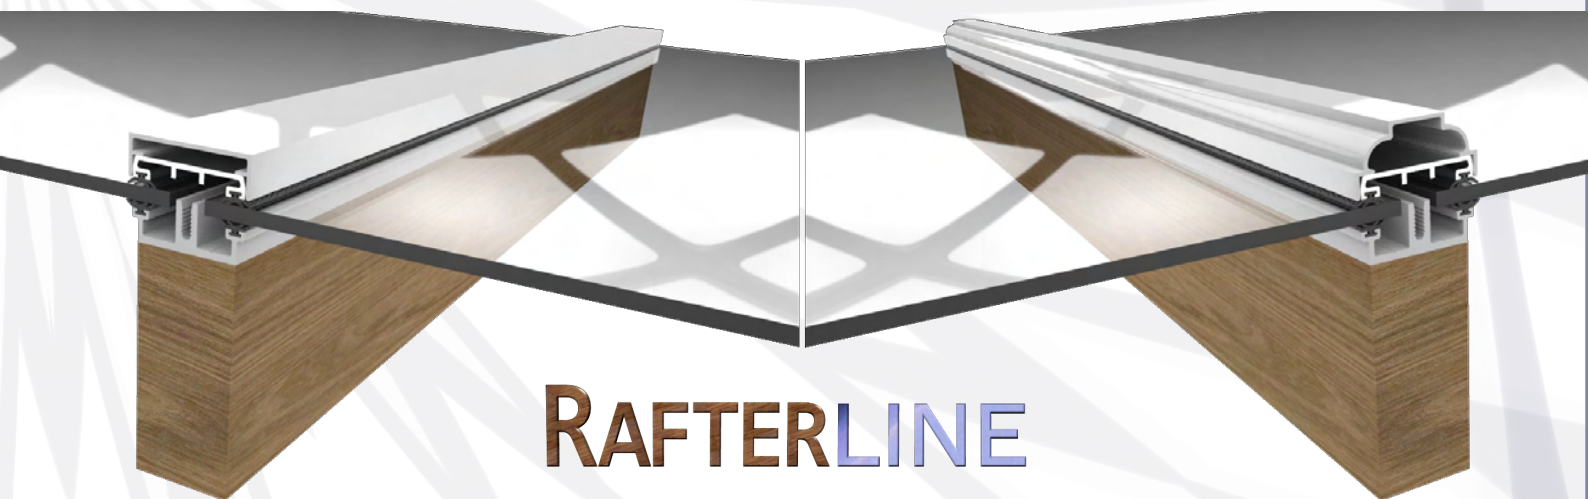
RAFTERLINE SINGLE GLAZED

Rafterline SPG1 type extruded aluminium Glazing Bar with screw-on PC1 capping and snap-on cosmetic square topped PC2 capping section - single glazed with 6mm thick glass

Rafterline SPG1 type extruded aluminium Glazing Bar with screw-on PC1 capping and snap-on cosmetic ornate topped PC3 capping section - single glazed with 6mm thick glass
