Proposed Extension and Internal Alterations to The Pheasantry, Wattisham

Timber Frame Repairs

5649 - 0510 P01

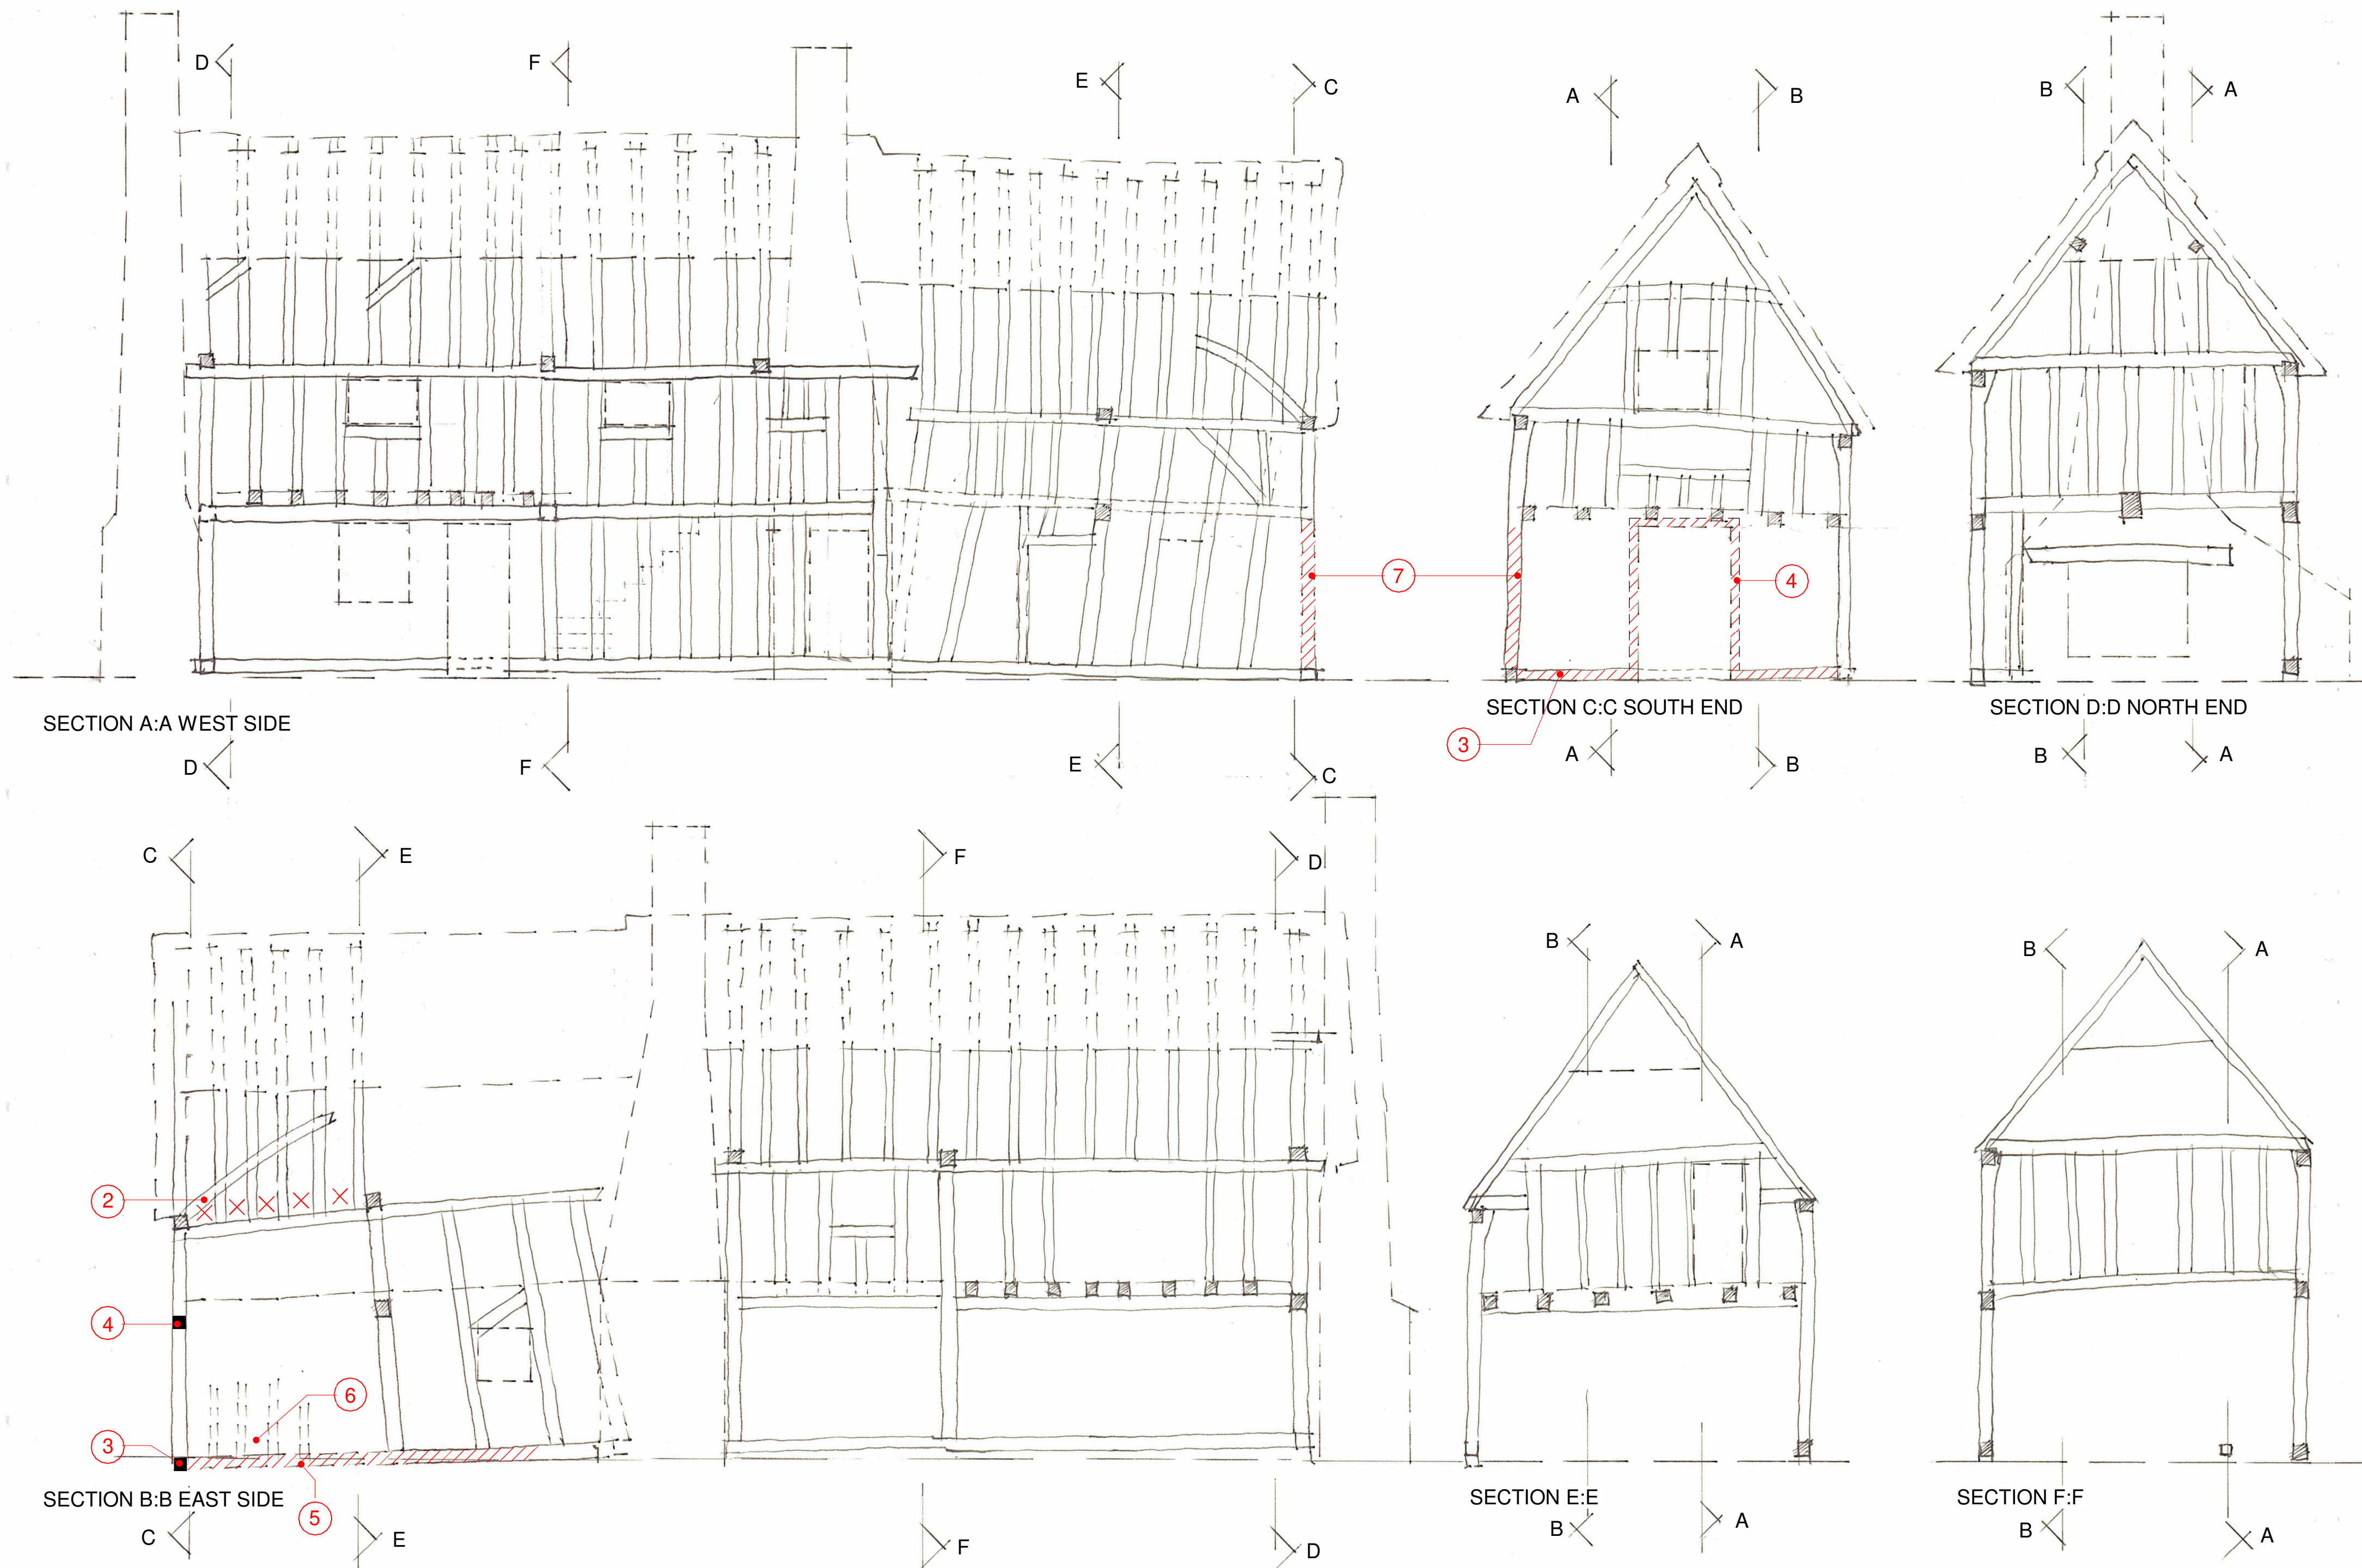
- 1) Splice lower end and rafters.
- 2) Remove fletton brick infill.
- 3) Replace rotten sole plate on raised position - Tenon fit existing studs.
- 4) Trim door opening with oak subframe.
- 5) Replace missing or damaged soleplate.
- 6) Re-tenon studs and post and fit to new plate.
- 7) Replace missing corner post.
