Project **WOODLANDS FARM
 BILDESTON ROAD
 RINGSHALL
 SUFFOLK**
EXTERNAL TIMBER FRAME REPAIRS – 2
 Scale **1:50,** Date **March 2023**
 Drawing No **21/205 – 14**

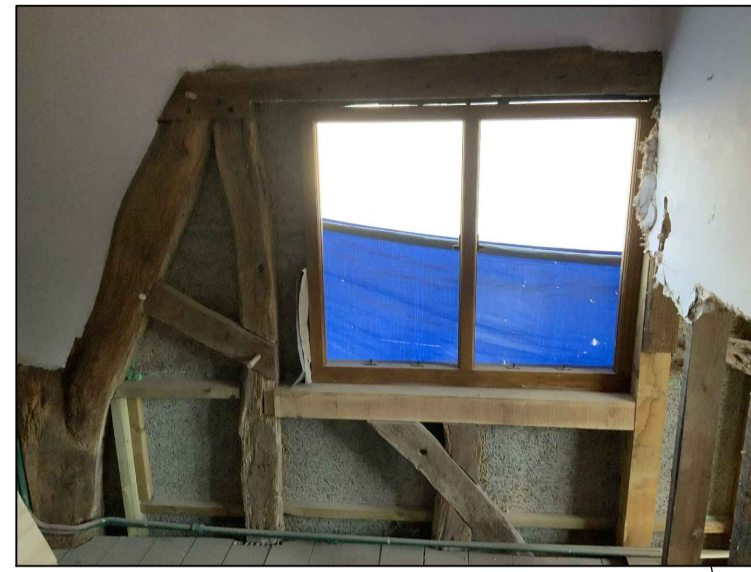
green oak repairs to window surround

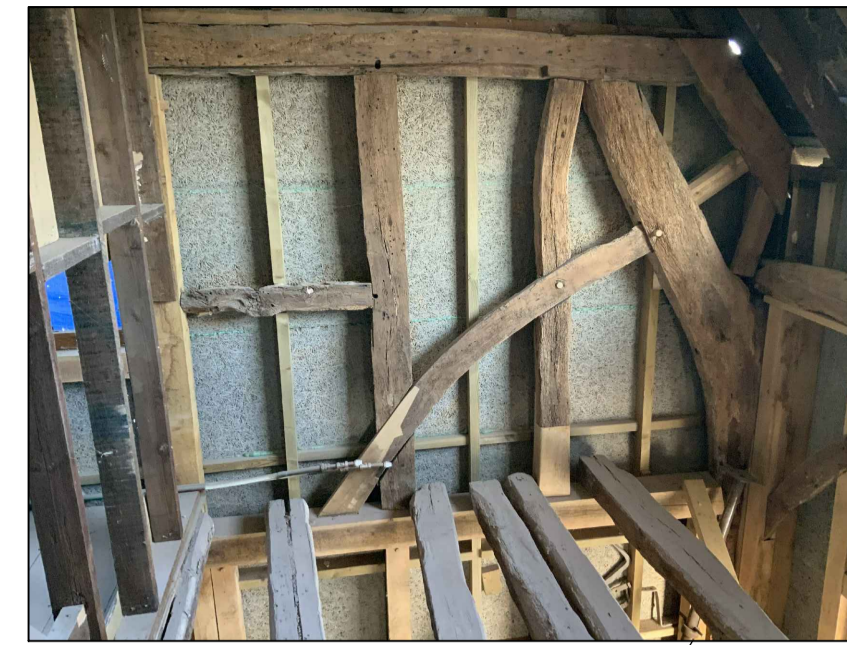
green oak repairs to base cruck, wall studs and brace

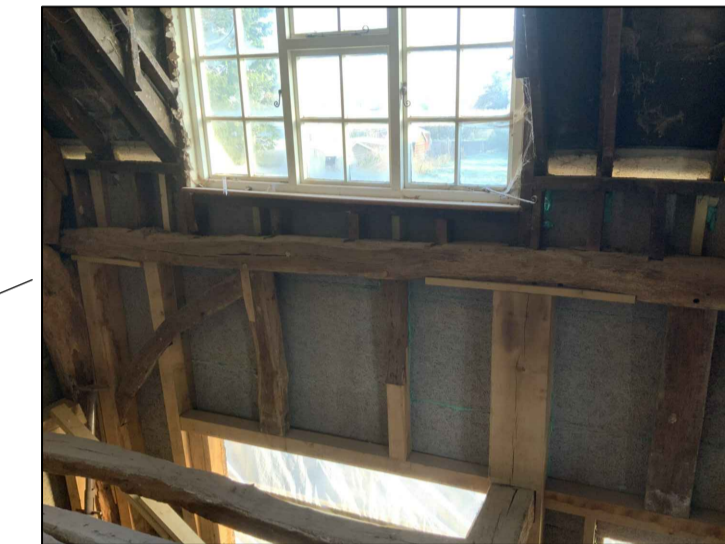
green oak repairs to wall studs

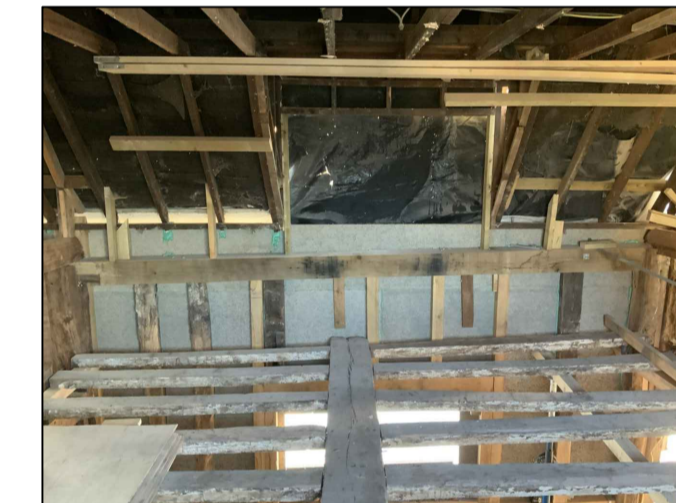
green oak wall stud replacements/repairs

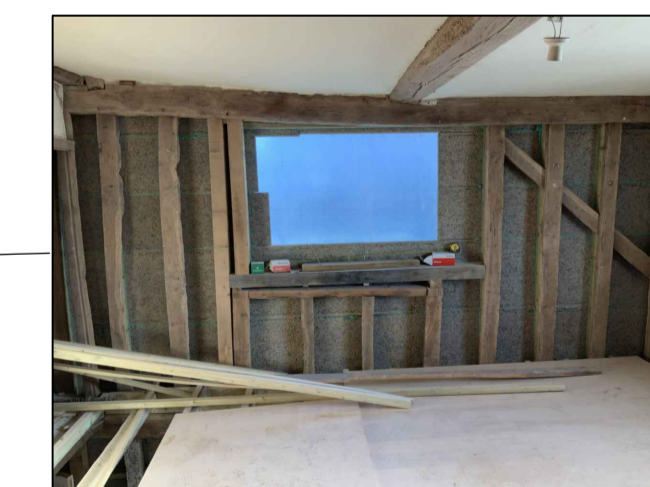
replacement and supplementary wall stud in green oak
