Design & Access and Heritage Statement

Applicant: Dr Kieron Smith & Mrs Sharon Smith
Address: Cricketers House, Turgis Green, Hants. RG27 0AH

Design and Access Statement

This application is for the removal of loose exterior paint at the property and painting with breathable mineral-based paint.

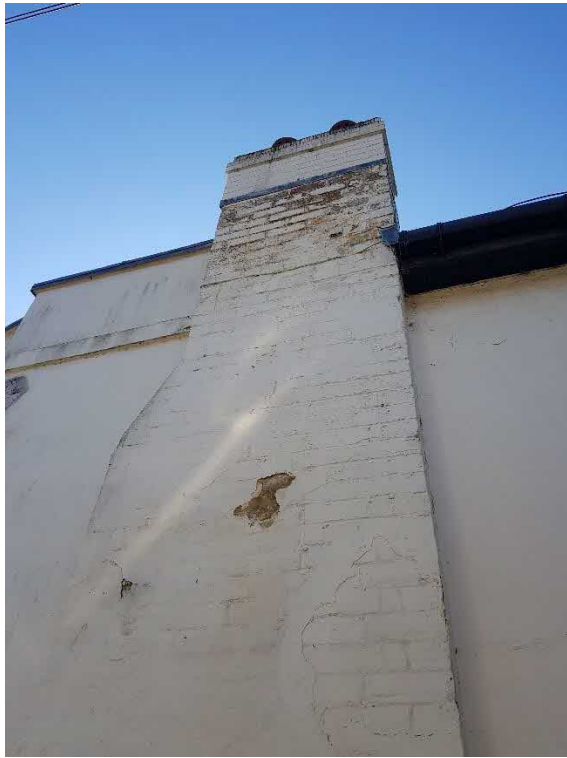
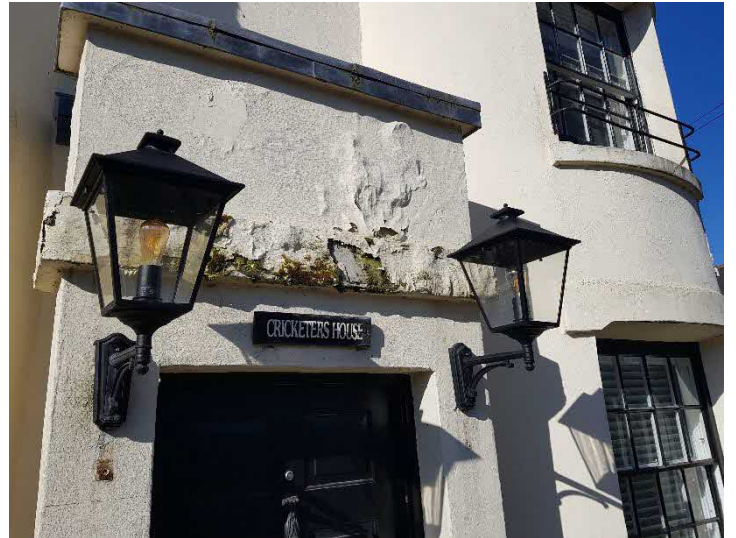
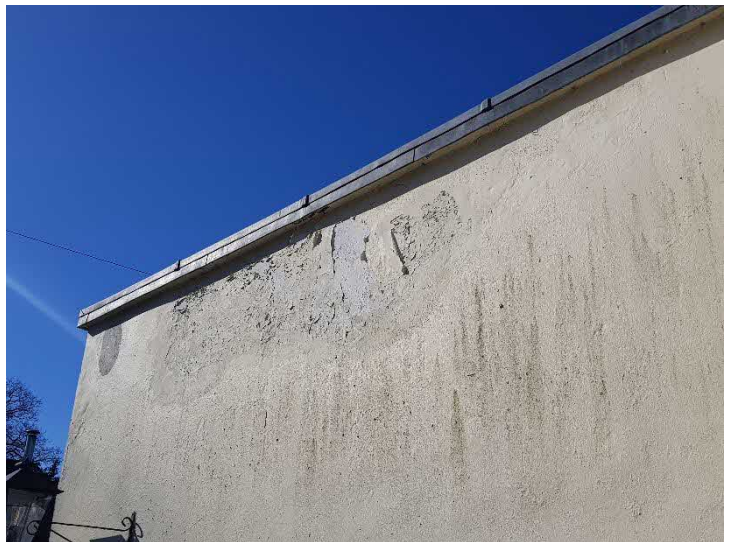
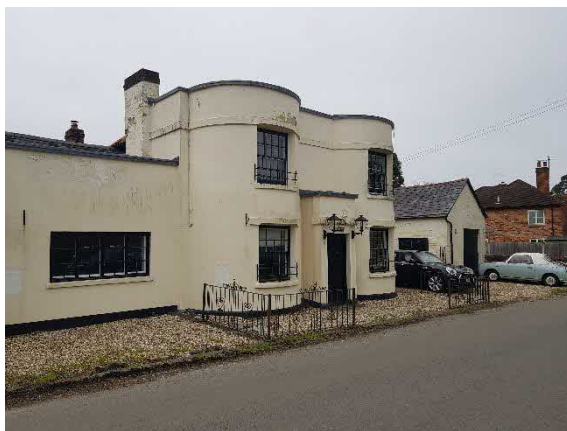
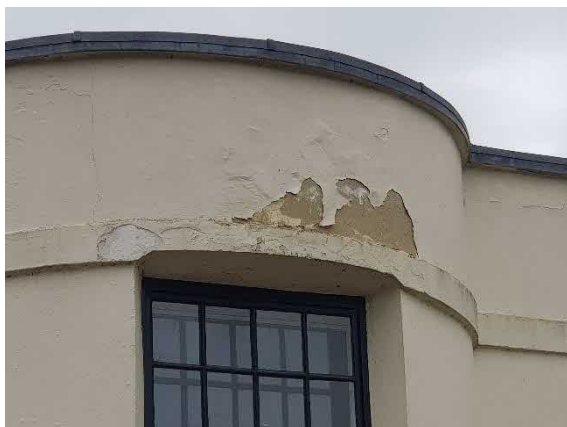
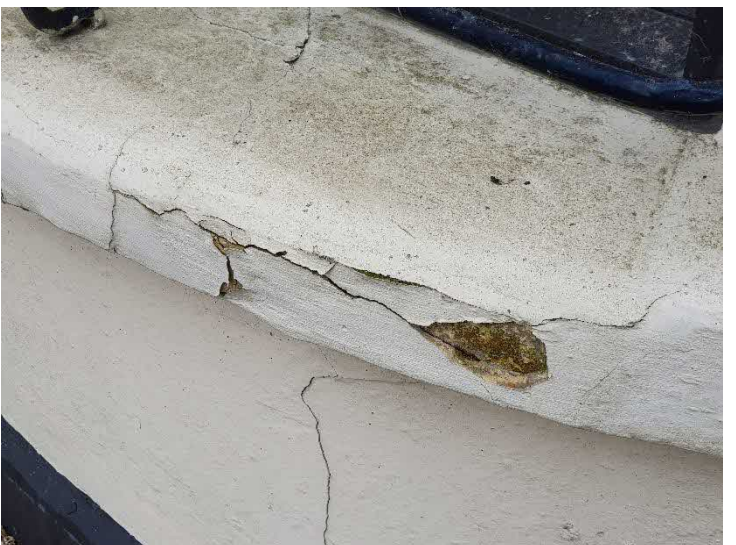
Appendix A. Exterior wall photos

The existing exterior paint comprises of several years of non-breathable paint on a lime base, the last known paint was carried out in 2013 with acrylic resin-based Dulux exterior paint. The current paint is peeling extensively, and internal walls are suffering from damp. The paint needs sympathetically removing and a mineral-based paint applied so that the building can breathe, this will also improve the aesthetic appeal of the property.

Photos taken April 2023

All loose, flaking and unstable material will be identified and then thoroughly removed using Keim STS 7M paint stripper (is a non-hazardous paint stripper based on aromatic hydrocarbons), then hot water, stiff brushes and broad bladed scrapers to get back to a sound edge; these edges will then be feathered in. Ensuring that any paint materials left remaining, and the underlying substrate is sound and adhering well. Any gloss or shiny surfaces will be thoroughly flatted down using sand or emery paper to create a good key.

All mould and fungal growth will be thoroughly removed by pressure washing and a stiff brush (steam cleaning where possible). Once the prepared surfaces have dried, they will be uniformly soaked with undiluted KEIM Algicide-Plus (a non-acidic fungicide wash) by brush or flood coating (not sprayed). Once the product has been allowed to act for at least 24 hours, KEIM coating systems can be applied onto the cleaned surface. Any cracks or where there is a need to equalise the surface should be filled using Keim Spachtel (silicate-based filler for all mineral substrates), a ready to use silicate mineral filler, brush or trowel applied to a pre-wetted surface and dressed back to the required level.

Any newly rendered/repared areas will be allowed to dry out for a minimum period of 15 days prior to the application of Keim Mineral Paint. Scaffolding will be erected for the work to take place.
