DRAWING TITLE
HOUSE - EXISTING & PROPOSED REAR ELEVATION

PROJECT NAME Double Glazed Windows

SITE ADDRESS
 Rectory Farmhouse, 39 Toghill Lane, Doynton, South Glos, BS30 5SY

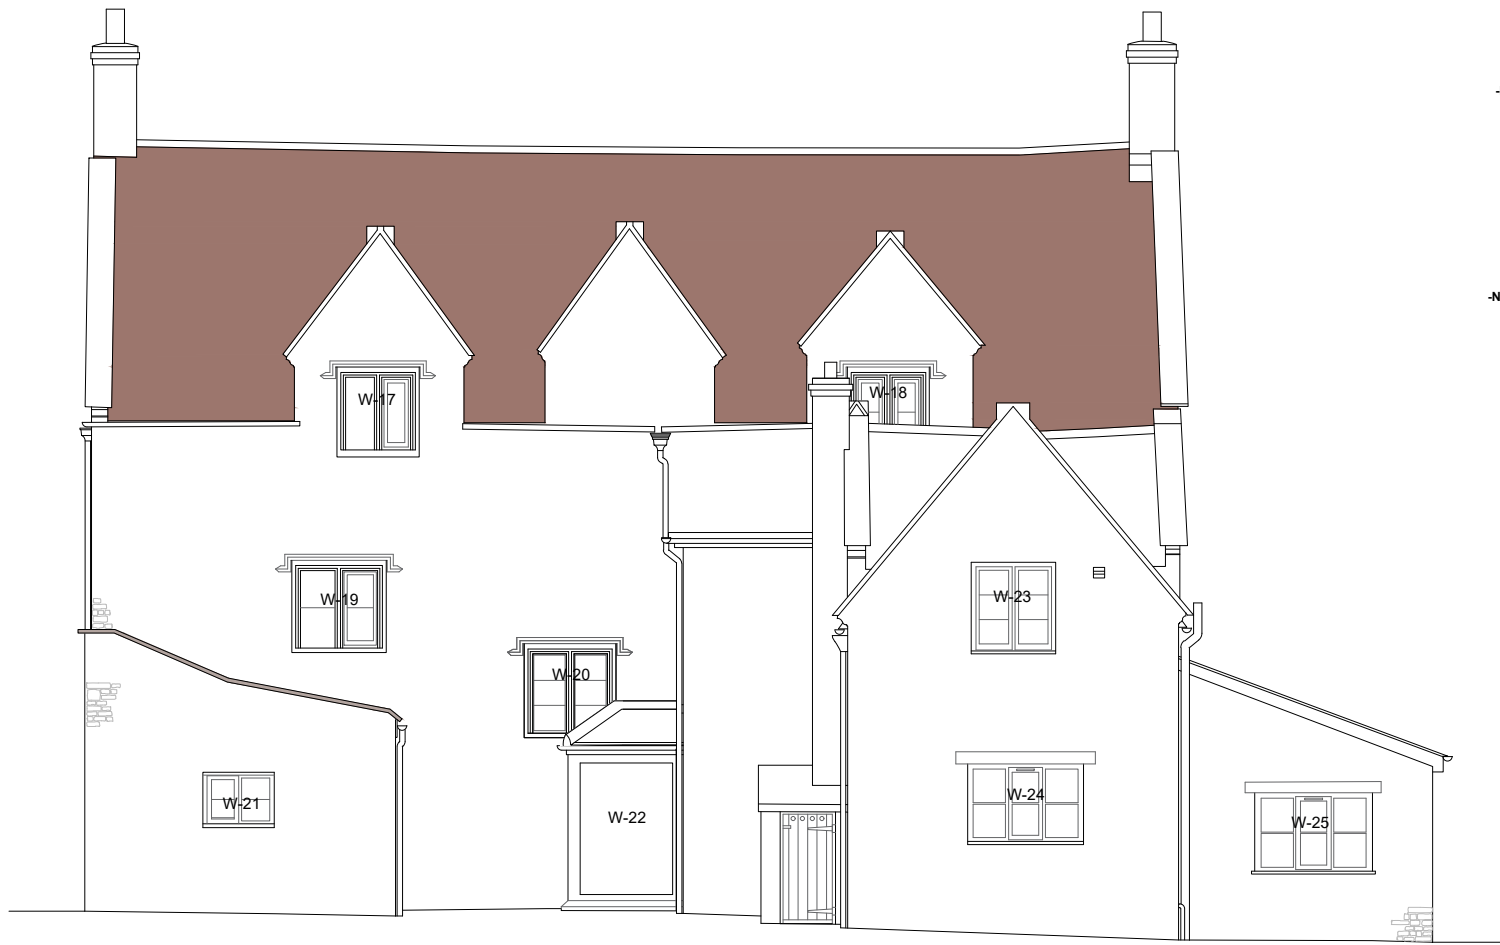
01 - EXISTING (REAR) ELEVATION (FACING NORTH EAST)

- W-17**
 -Original window opening
 -Original stone Mullions
 -Non original single glazed plate glass.
 -Non original single glazed (timber) casement.
- W-18**
 -Original window opening
 -Original stone Mullions
 -Non original single glazed plate glass.
 -Non original single glazed (timber) casement.

- W-19**
 -Original window opening
 -Original stone Mullions
 -Non original single glazed plate glass.
 -Non original single glazed (timber) casement.
- W-20**
 -Original window opening
 -Original stone Mullions
 -Non original single glazed plate glass.

- W-21**
 -Non original window opening
 -Non original steel lintel
 -Non original double glazed (timber) casement
- W-22**
 -Non original window opening to extension
 -Non original oak frame
 -Non original double glazed plate glass

- W-23**
 -Non original window opening
 -Non original steel lintel
 -Non original double glazed (timber) casement
- W-24**
 -Non original window opening
 -Non original concrete lintel
 -Non original double glazed (timber) casement

- W-25**
 -Non original window opening
 -Non original concrete lintel
 -Non original double glazed (timber) casement

Summary
 Generally where original window openings remain, the window units are highly likely to be non original. Single glazed units causing ongoing harm within the interior of the building. Character deviated from likely original condition. Refer to other documents submitted as part of this application.

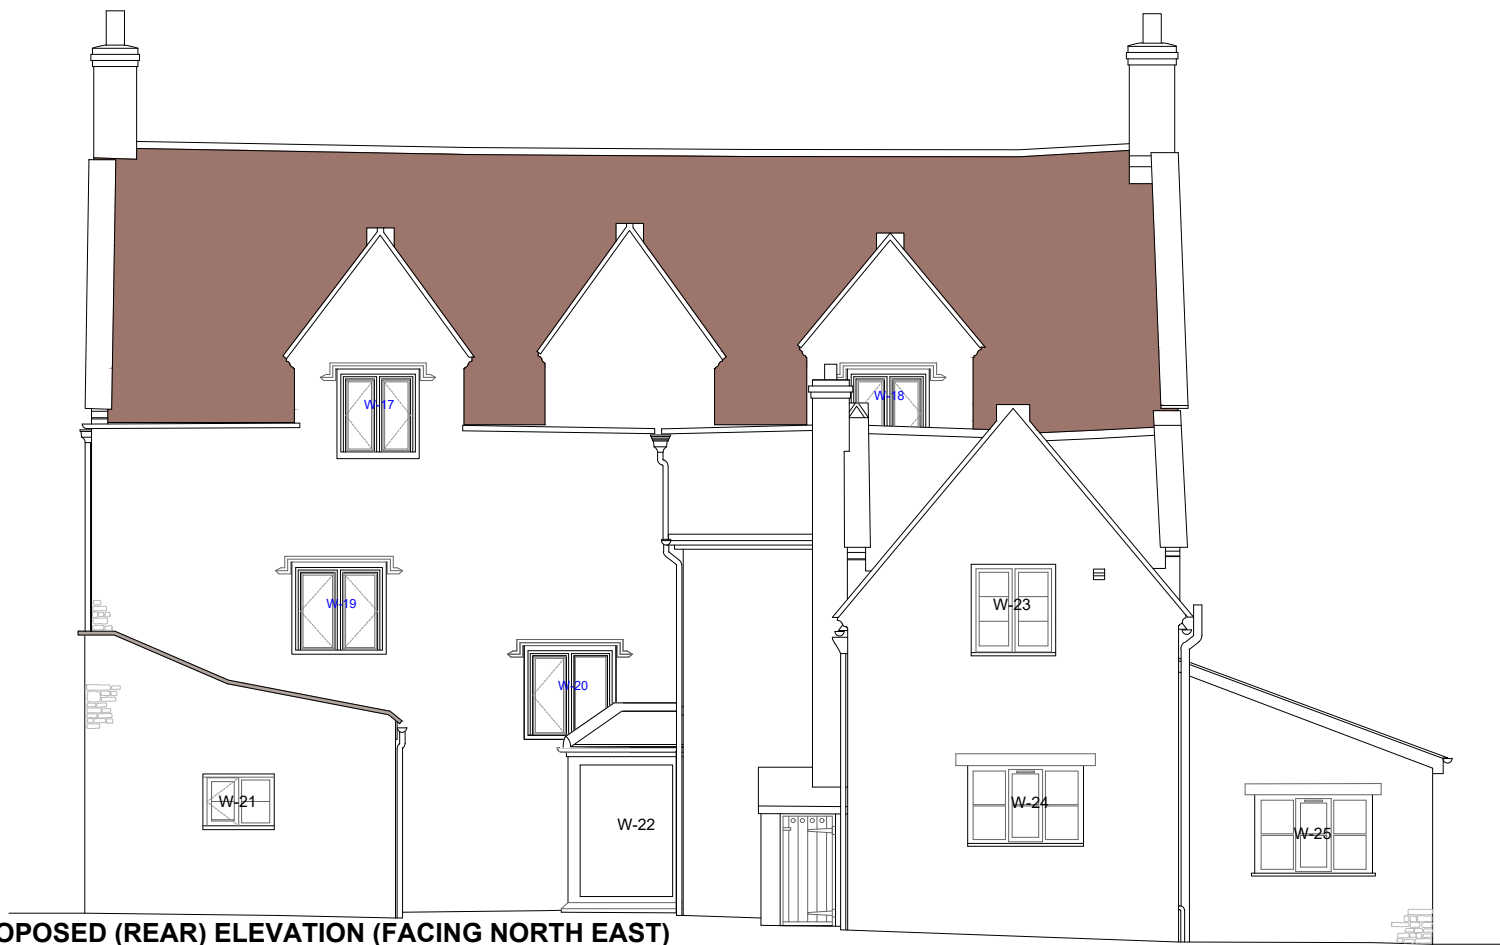
01 - PROPOSED (REAR) ELEVATION (FACING NORTH EAST)

- W-17**
 -Original window opening
 -Original stone Mullions
 -Proposed slimline glazing double glazed metal casement - see general window detail
- W-18**
 -Original window opening
 -Original stone Mullions
 -Proposed slimline glazing double glazed metal casement - see general window detail

- W-19**
 -Original window opening
 -Original stone Mullions
 -Proposed slimline glazing double glazed metal casement - see general window detail
- W-20**
 -Original window opening
 -Original stone Mullions
 -Proposed slimline glazing double glazed metal casement - see general window detail

- W-21**
 -Non original window opening
 -Non original steel lintel
 -Non original double glazed (timber) casement
- W-22**
 -Non original window opening to extension
 -Non original oak frame
 -Non original double glazed plate glass

- W-23**
 -Non original window opening
 -Non original steel lintel
 -Non original double glazed (timber) casement
- W-24**
 -Non original window opening
 -Non original concrete lintel
 -Non original double glazed (timber) casement

- W-25**
 -Non original window opening
 -Non original concrete lintel
 -Non original double glazed (timber) casement
