DRAWING TITLE
HOUSE EXISTING ELEVATIONS

PROJECT NAME **Double Glazed Windows**

SITE ADDRESS
 Rectory Farmhouse, 39 Toghill Lane, Doynton, South Glos, BS30 5SY

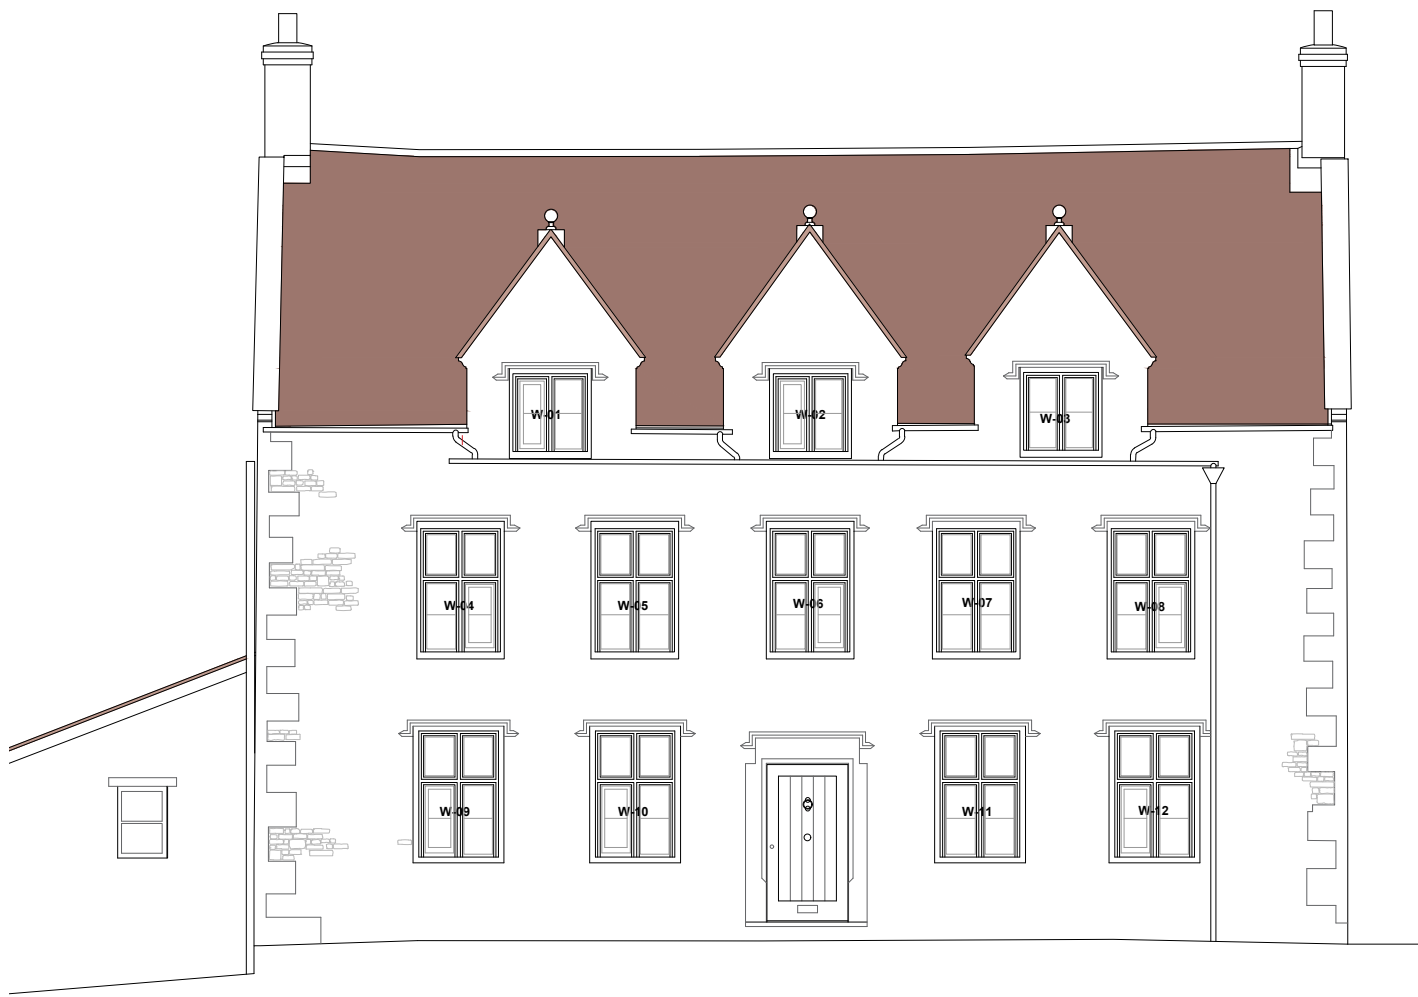
01 PRINCIPLE ELEVATION (WITHIN GARDEN - FACING SOUTH)

W-01
 -Original window opening
 -Original stone Mullions
 -Non original single glazed plate glass.
 -Non original single glazed (timber) casement.

W-05
 -Original window opening
 -Original stone Mullions
 -Non original single glazed plate glass.

W-09
 -Original window opening
 -Original stone Mullions
 -Non original single glazed plate glass.
 -Non original single glazed (timber) casement.

W-13 (no change)
 -Non original window opening
 -Non original concrete lintel
 -Non original double glazed (timber) casement

W-17 (no change)
 -Non original window opening
 -Non original concrete lintel
 -Non original double glazed (timber) casement

W-02
 -Original window opening
 -Original stone Mullions
 -Non original single glazed plate glass.
 -Non original single glazed (timber) casement.

W-06
 -Original window opening
 -Original stone Mullions
 -Non original single glazed plate glass.
 -Non original single glazed (timber) casement.

W-10
 -Original window opening
 -Original stone Mullions
 -Non original single glazed plate glass.
 -Non original single glazed (timber) casement.

W-14 (no change)
 -Non original window opening
 -Non original concrete lintel
 -Non original double glazed (timber) casement

W-03
 -Original window opening
 -Original stone Mullions
 -Non original single glazed plate glass.
 no opening window

W-07
 -Original window opening
 -Original stone Mullions
 -Non original single glazed plate glass.

W-11
 -Original window opening
 -Original stone Mullions
 -Non original single glazed plate glass.

W-15 (no change)
 -Original window opening
 -Original stone Mullions
 -Non original double glazed (timber) casement

W-04
 -Original window opening
 -Original stone Mullions
 -Non original single glazed plate glass.
 -Non original single glazed (timber) casement.

W-08
 -Original window opening
 -Original stone Mullions
 -Non original single glazed plate glass.
 -Non original single glazed (timber) casement.

W-12
 -Original window opening
 -Original stone Mullions
 -Non original single glazed plate glass.
 -Non original single glazed (timber) casement.

W-16 (no change)
 -Non original window opening
 -Non original steel lintel
 -Non original double glazed (timber) casement

Summary
 Generally where original window openings remain, the window units are highly likely to be non original. Single glazed units causing ongoing harm within the interior of the building. Character deviated from likely original condition. Refer to other documents submitted as part of this application.
