Site  
POTASH FARM,  
THE STREET,  
BRUNDISH,  
IP13 8BL,

Project  
PLANNING REGULARISATION

Details  
SURVEY -  
FLOOR PLAN + ELEVATIONS

Drawing number  
**2328 2**

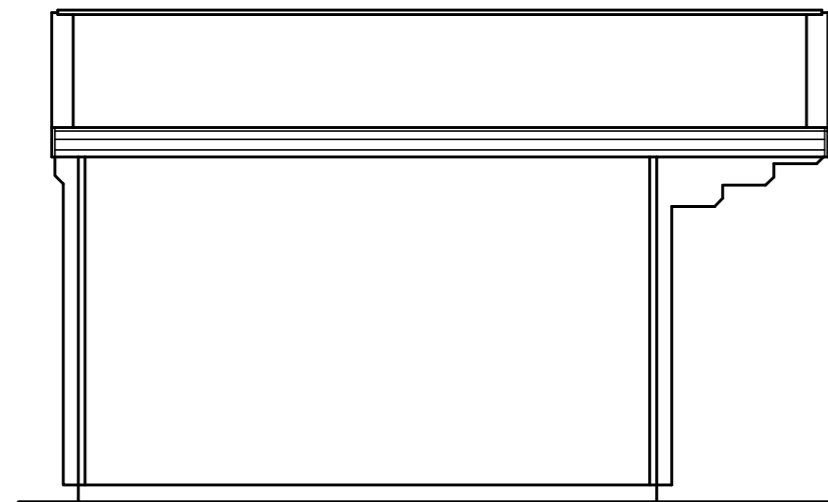
**Existing North West Elevation (Unit 1/2)**

- Metal Pantile Roof Sheeting
- Timber Windows + Doors
- Timber Shutters (Unit 1)
- Timber Construction
