**Proposed alterations and refurbishment works at
The Old Rectory, Norton Road, Tostock, Bury St Edmunds**

for Mr & Mrs Bowyer

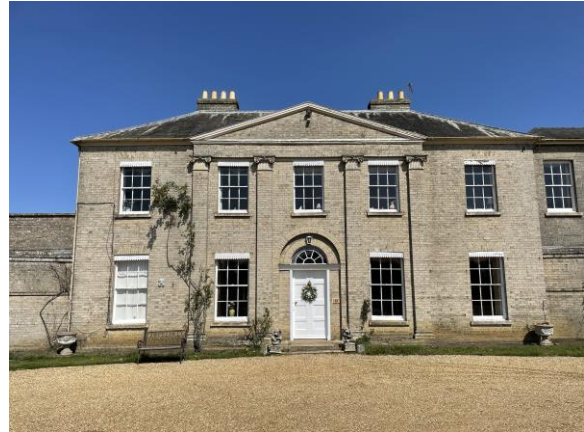
Front elevation of The Old Rectory

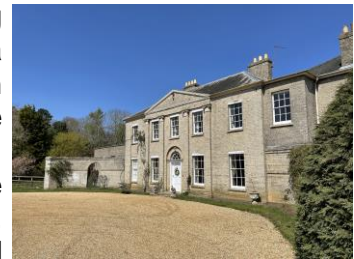
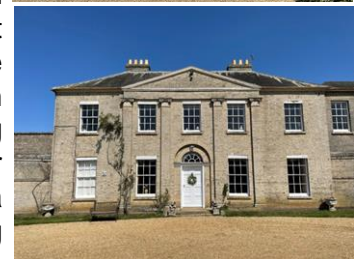
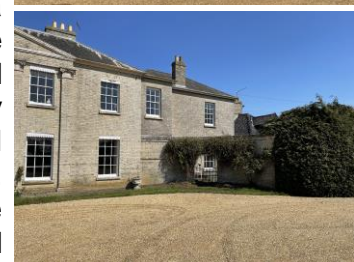
South (front) elevation:

The south / front elevation provides entry to the main dwelling coming from a gravel driveway. The elevation is finished with a buff brick. The roof is a dark grey natural slate multi-section hipped roof with white painted timber fascia and soffit and a white gutter, with several chimneys finished with matching buff brick. The front elevation is stepped back from the centre entrance section, with several steps either side of the entrance section. Some of the front elevation is hidden behind high level curved walls in a matching buff brick extending from the furthest most projected section of the front elevation to partially enclose the driveway. The curved walls have gated access through them with arched head openings, brick projecting courses and a projecting header detail. To the right of the front elevation is the later extension side wing of the property, which is constructed of a matching buff brick with a black pantile hipped roof, incorporating dormer windows, and connected back to the main dwelling by a matching buff brick wall. The side wing of the property cannot be seen fully from the driveway as it is hidden behind the curved wall section. To the left of the main entrance is the single storey ball room projecting from the main dwelling, with a parapet wall and stone capping detail hiding a decaying felt flat roof behind. All of the windows on the front elevation of the main dwelling are matching white painted sliding sash windows with vertical and horizontal glazing bars creating six upper and six lower panels in each window. All windows (where possible) are accompanied by a projecting stone cill and large header details approx. 300mm high, including white painted timber detailing within the window reveals of the centre most windows. The centre most bay contains projecting brick piers with stone header details and a projecting gable roof detail, with the white painted eight panel timber entrance doors with matching arched fanlight in the centre.

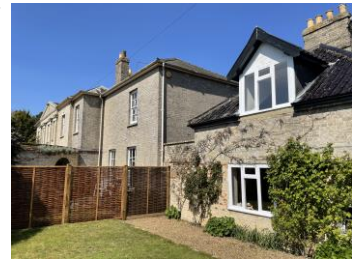
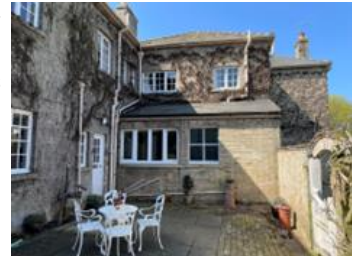
East (side) elevation:

The east / side elevation of the main dwelling is mostly hidden by the later side wing extension. The side wing extension is single storey with rooms in the roof space and dormer windows, it is finished with a matching buff brick to the main dwelling and a black pan tile hipped roof finish. The main dwelling behind is finished in a buff brick, with a dark grey natural slate hipped roof with white painted timber fascia and soffit and a white gutter, with several chimneys finished with matching buff brick. The roof is split up into different sections of gable roofs, with hidden valley gutters and small sections of flat roof. Some sections of elevation are visible from the rear internal courtyard, and have a mix of white painted timber casement windows and white painted crittall windows with a white painted timber surround within the reveal. Matching the front elevation, all windows have a projecting stone cill and a single header course approx. 150mm high.

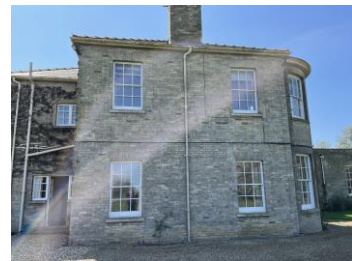
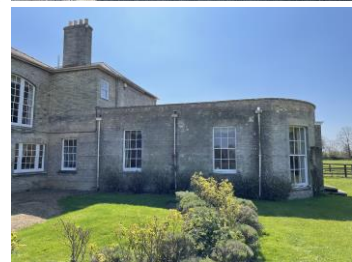
North (rear) elevation

The north / rear elevation is open to the rear garden, and is partially enclosed by the rear courtyard. The elevation is finished with a buff facing brick and the roof is a dark grey natural slate multi-section hipped roof with sections of flat roof with white painted timber fascia and soffit and a white gutter to the main two storey dwelling, with several chimneys finished with matching buff brick. The ball room projection to the right of the rear elevation is a single storey flat roof with a parapet hiding the felt roof behind. The windows in the rear elevation are a mix of white painted sliding sash windows with vertical and horizontal glazing bars creating six upper and six lower panels in each window (matching the front elevation) and white painted crittall windows with a white painted timber surround within the reveal. Matching the front elevation, all windows have a projecting stone cill and a single header course approx. 150mm high.

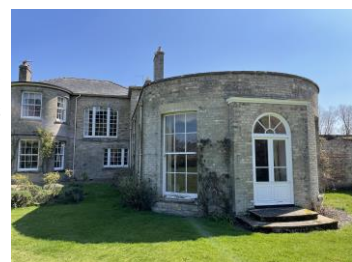
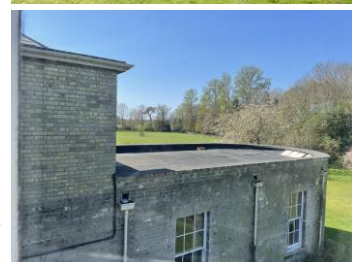
West (side) elevation

The west / side elevation is visible from the side garden on the property. The main feature of the west / side elevation is the single storey ball room projecting from the main two storey dwelling. The elevation is finished with a buff brick and the roof over the main two storey dwelling is a dark grey natural slate multi-section hipped roof with sections of flat roof with white painted timber fascia and soffit and a white gutter, with several chimneys finished with matching buff brick. The roof to the single storey ball room projection is a flat roof with a parapet and stone coping detail hiding the decaying felt roof behind. The windows in the single storey ball room projection and two storey main dwelling are white painted sliding sash windows with vertical and horizontal glazing bars creating six upper and six lower panels in each window. The west / side elevation features a half round two storey projection from the main dwelling with three windows per storey in and finished with a flat roof. There is an arched head large feature window looking into the stairwell in the west / side elevation and all windows are accompanied by a projecting stone cill and large header details approx. 300mm high. The ballroom also has a pair of white painted timber external fully glazed doors with a white painted timber panel fixed to the external side of the

glazing, covering the glazing in part. The door also features a single horizontal glazing bar

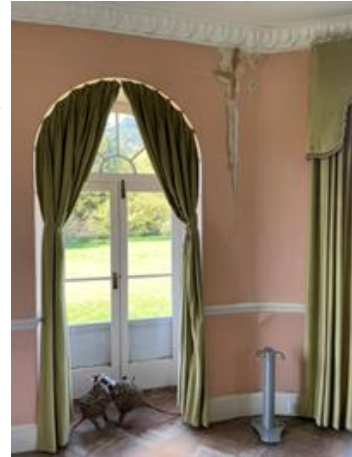
The Ballroom

The ballroom is a single storey projection to the west of the building, which includes large west and north facing windows and a west facing external pair of doors with a glazed arched head fan light above. The ceiling in the room is divided into four sections via three downstand beams. The room is finished with a wooden floor, decorative skirtings, dado rail and covings throughout. Due to the roof leaking and allowing water ingress into the walls and roof structure there are sections of plaster on the walls and ceilings which have begun to decay and come away from the structure. The works to the roof are required to avoid the damage becoming more severe.

- Replace the decaying felt roof finish on the single storey ball room projection with a new fibreglass finish as the existing flat roof is leaking and causing water ingress into the existing walls and roof.
- Install new elongated pyramidal style lantern roof light over the ballroom during the reroofing works.
- Temporary roof coverings may be required during works.
