Heritage and Supporting statement

**Proposed alterations and refurbishment works at  
The Old Rectory, Norton Road, Tostock, Bury St Edmunds**

for Mr & Mrs Bowyer

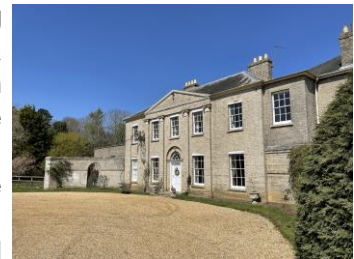
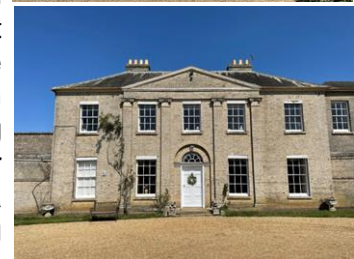
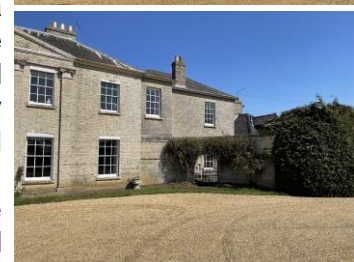
South (front) elevation:

The south / front elevation provides entry to the main dwelling coming from a gravel driveway. The elevation is finished with a buff brick. The roof is a dark grey natural slate multi-section hipped roof with white painted timber fascia and soffit and a white gutter, with several chimneys finished with matching buff brick. The front elevation is stepped back from the centre entrance section, with several steps either side of the entrance section. Some of the front elevation is hidden behind high level curved walls in a matching buff brick extending from the furthest most projected section of the front elevation to partially enclose the driveway. The curved walls have gated access through them with arched head openings, brick projecting courses and a projecting header detail. To the right of the front elevation is the later extension side wing of the property, which is constructed of a matching buff brick with a black pantile hipped roof, incorporating dormer windows, and connected back to the main dwelling by a matching buff brick wall. The side wing of the property cannot be seen fully from the driveway as it is hidden behind the curved wall section. To the left of the main entrance is the single storey ball room projecting from the main dwelling, with a parapet wall and stone capping detail hiding a decaying felt flat roof behind. All of the windows on the front elevation of the main dwelling are matching white painted sliding sash windows with vertical and horizontal glazing bars creating six upper and six lower panels in each window. All windows (where possible) are accompanied by a projecting stone cill and large header details approx. 300mm high, including white painted timber detailing within the window reveals of the centre most windows. The centre most bay contains projecting brick piers with stone header details and a projecting gable roof detail, with the white painted eight panel timber entrance doors with matching arched fanlight in the centre.

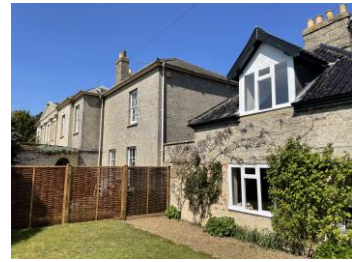
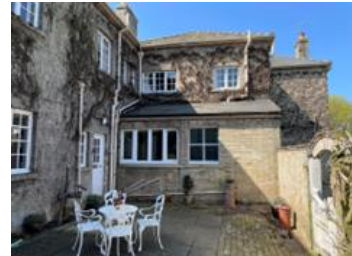
### East (side) elevation:

The east / side elevation of the main dwelling is mostly hidden by the later side wing extension. The side wing extension is single storey with rooms in the roof space and dormer windows, it is finished with a matching buff brick to the main dwelling and a black pan tile hipped roof finish. The main dwelling behind is finished in a buff brick, with a dark grey natural slate hipped roof with white painted timber fascia and soffit and a white gutter, with several chimneys finished with matching buff brick. The roof is split up into different sections of gable roofs, with hidden valley gutters and small sections of flat roof. Some sections of elevation are visible from the rear internal courtyard, and have a mix of white painted timber casement windows and white painted crittall windows with a white painted timber surround within the reveal. Matching the front elevation, all windows have a projecting stone cill and a single header course approx. 150mm high.

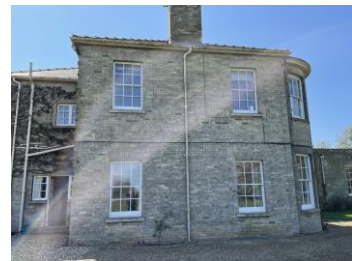
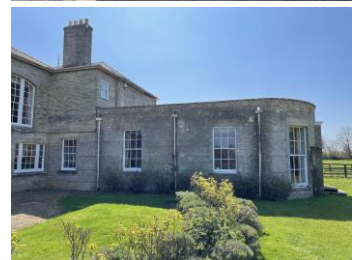
### North (rear) elevation

The north / rear elevation is open to the rear garden, and is partially enclosed by the rear courtyard. The elevation is finished with a buff facing brick and the roof is a dark grey natural slate multi-section hipped roof with sections of flat roof with white painted timber fascia and soffit and a white gutter to the main two storey dwelling, with several chimneys finished with matching buff brick. The ball room projection to the right of the rear elevation is a single storey flat roof with a parapet hiding the felt roof behind. The windows in the rear elevation are a mix of white painted sliding sash windows with vertical and horizontal glazing bars creating six upper and six lower panels in each window (matching the front elevation) and white painted crittall windows with a white painted timber surround within the reveal. Matching the front elevation, all windows have a projecting stone cill and a single header course approx. 150mm high.

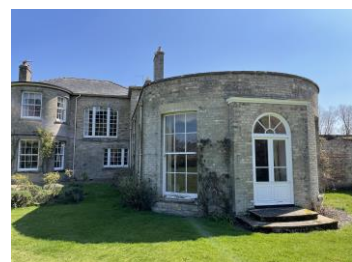
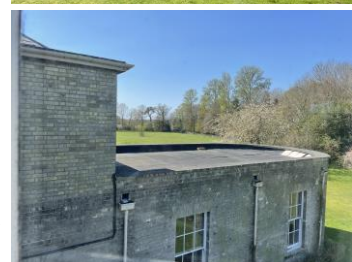
### West (side) elevation

The west / side elevation is visible from the side garden on the property. The main feature of the west / side elevation is the single storey ball room projecting from the main two storey dwelling. The elevation is finished with a buff brick and the roof over the main two storey dwelling is a dark grey natural slate multi-section hipped roof with sections of flat roof with white painted timber fascia and soffit and a white gutter, with several chimneys finished with matching buff brick. The roof to the single storey ball room projection is a flat roof with a parapet and stone coping detail hiding the decaying felt roof behind. The windows in the single storey ball room projection and two storey main dwelling are white painted sliding sash windows with vertical and horizontal glazing bars creating six upper and six lower panels in each window. The west / side elevation features a half round two storey projection from the main dwelling with three windows per storey in and finished with a flat roof. There is an arched head large feature window looking into the stairwell in the west / side elevation and all windows are accompanied by a projecting stone cill and large header details approx. 300mm high. The ballroom also has a pair of white painted timber external fully glazed doors with a white painted timber panel fixed to the external side of the

glazing, covering the glazing in part. The door also features a single horizontal glazing bar

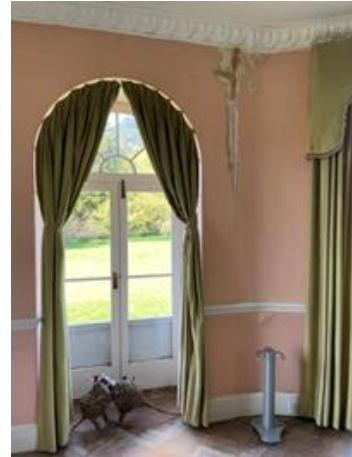
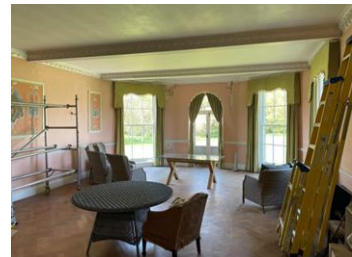
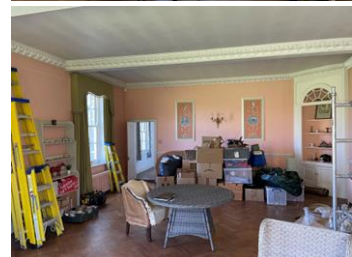
### The Ballroom

The ballroom is a single storey projection to the west of the building, which includes large west and north facing windows and a west facing external pair of doors with a glazed arched head fan light above. The ceiling in the room is divided into four sections via three downstand beams. The room is finished with a wooden floor, decorative skirtings, dado rail and covings throughout. Due to the roof leaking and allowing water ingress into the walls and roof structure there are sections of plaster on the walls and ceilings which have begun to decay and come away from the structure. The works to the roof are required to avoid the damage becoming more severe.

- Elongated lantern style roof light over ballroom – already under consideration via application DC/23/02497
- Reroofing works to existing ball roof flat roof behind parapet walls, replacing existing decaying felt roof with new fibreglass roof finish and accoupling details – already under consideration via application DC/23/02497

To install a new fibreglass roof finish to the single storey ball roof projection roof, with the addition of a new lantern style rooflight to the ballroom, which is already under consideration under application DC/23/02497. Internal alterations as listed above to adapt the dwelling to suit the new owners needs and the addition of an external access stair, verandah and replacement of existing windows which are outdated and decaying. The works are planned to be done while maintaining historic and important heritage features, reinstating previously removed features and renovating the existing fabric of the building to enable the structure to continue to be used into the future while maintaining its history.

A new fibreglass roof over the single storey ball roof projection, coloured to match with a lead finish and existing stone parapet copings are to be retained and reused. Proposed rooflight framing to be RAL7016 Anthracite grey. Proposed powder coated steel framed glazed verandah to be used, to be coloured dark grey with guttering and rain water down pipes to match that on the existing dwelling.
