Design and Access Statement

IMPLEMENT SHED, HORTON COURT

PARTIAL DISMANTLING AND BOUNDARY WALL REPAIRS

Horton Court, Horton, Chipping Sodbury, Glos BS37 6QR

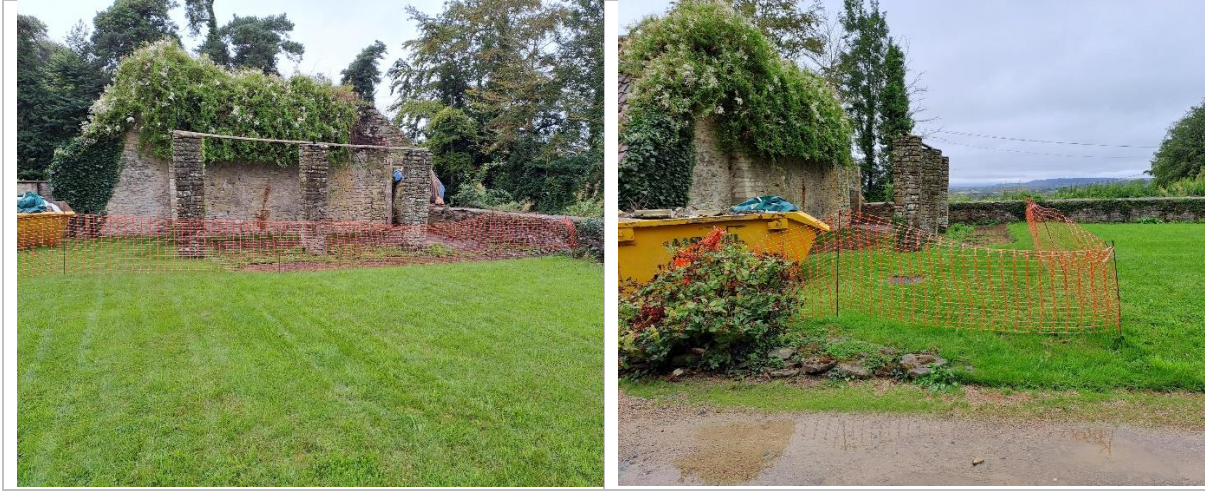
Photos showing the free-standing stone piers to the west of the Implement Shed
(NB Orange net fence was temporarily installed during dismantling work)

The structure will be fenced off to deter unauthorised entry by guests staying at Horton Court. The proposed line of the new fence is indicated in green on the 1:500 Site Plan. This has been chosen carefully to take account of the 3 no. stone piers that are left standing from a previous building in this area that has long since been lost (see photos below). The foundations to these piers are uncertain but there is evidence of some undermining, especially to the middle pier. The same approach of 'managed decline' is being taken with these structures, so should an unexpected pier collapse take place this fencing will ensure that the fall is contained within the fenced area and there is minimal risk to members of the public. The resulting fencing will start approximately 7m west of the Implement Shed and run south from the boundary wall for approximately 9.8m. It will be set back approximately 300mm from the front of the main part of the Implement Shed.

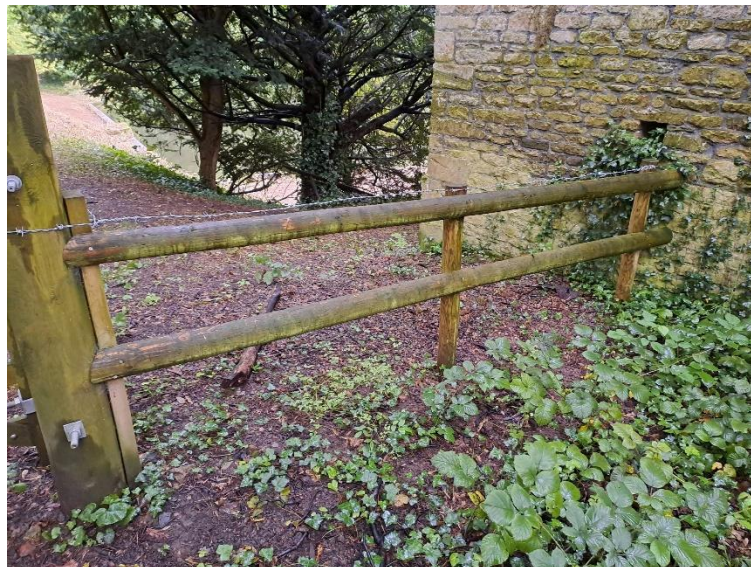
The 'managed decline' approach means that the building should be around for some time to come yet and therefore a more permanent form of fencing is thought to be more appropriate than a short-term form of fencing such as road irons and rope, chestnut paling etc. Therefore a 1m high timber post and rail fence is proposed, which will not rise too much above the existing boundary wall and will consist of round posts and 2 no. half-round rails, similar to the photo below, which shows a fence adjacent to the Horton Court Stable Block.
